Accelerating PV Cost Effectiveness Through Systems Design, Engineering, and Quality Assurance

Subcontract Report
NREL/SR-520-40335
July 2006

Phase I Annual Technical Report
4 November 2004 — 3 November 2005

J. Botkin
PowerLight Corporation
Berkeley, California

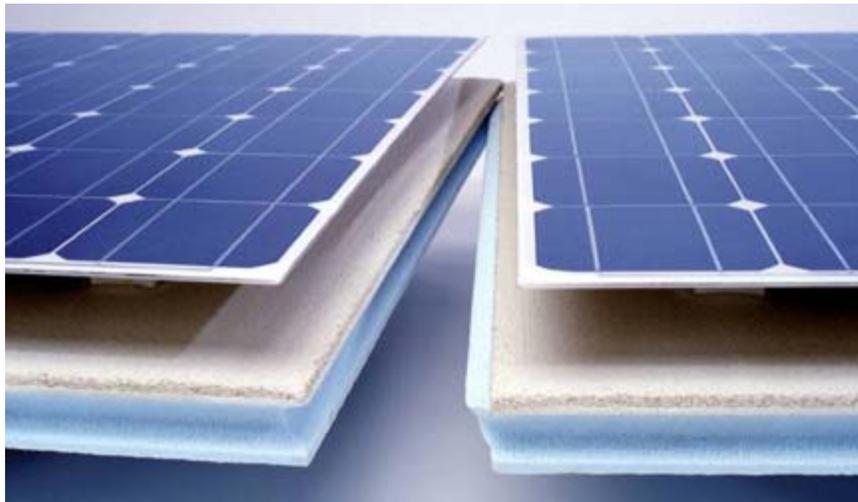
Figure 1: PowerGuard tiles showing interlocking tongue and groove profile.

PowerLight manufactures its flagship product, the PowerGuard tile, in a facility in Berkeley, California. PowerGuard building-integrated photovoltaic roofing tiles generate electricity from solar energy. A PowerGuard tile consists of a flat plate photovoltaic (PV) laminate mounted onto a flat, rigid, extruded polystyrene (XPS) board. The XPS board is covered with a cementitious coating. Two edges of the XPS board are routed into a tongue profile, while the other two edges are given a groove profile. This design allows PowerGuard tiles to be assembled adjacent to each other in an interlocking fashion, as shown in Figure 1 below.

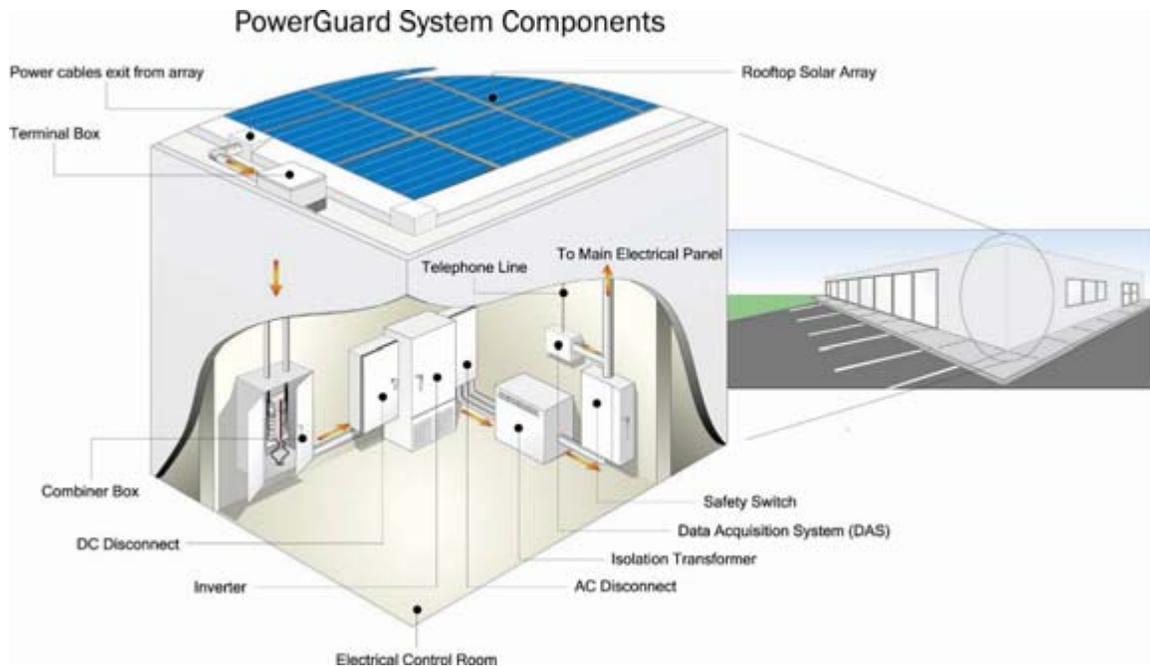
Figure 2: Building cross-section showing PowerGuard System Components

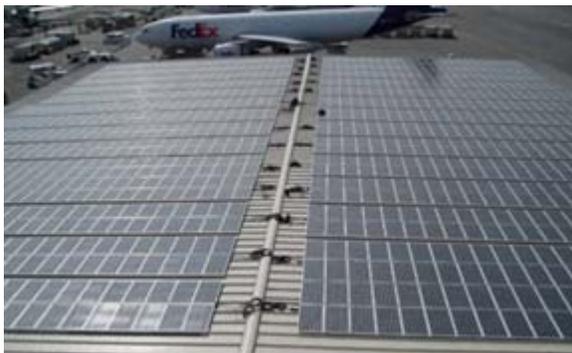
Figure 3: RMR System

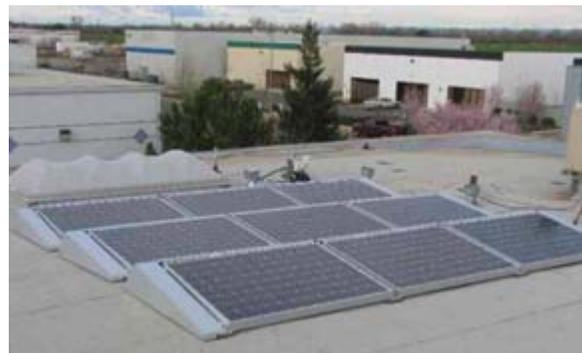
Figure 4: RFT10 Array

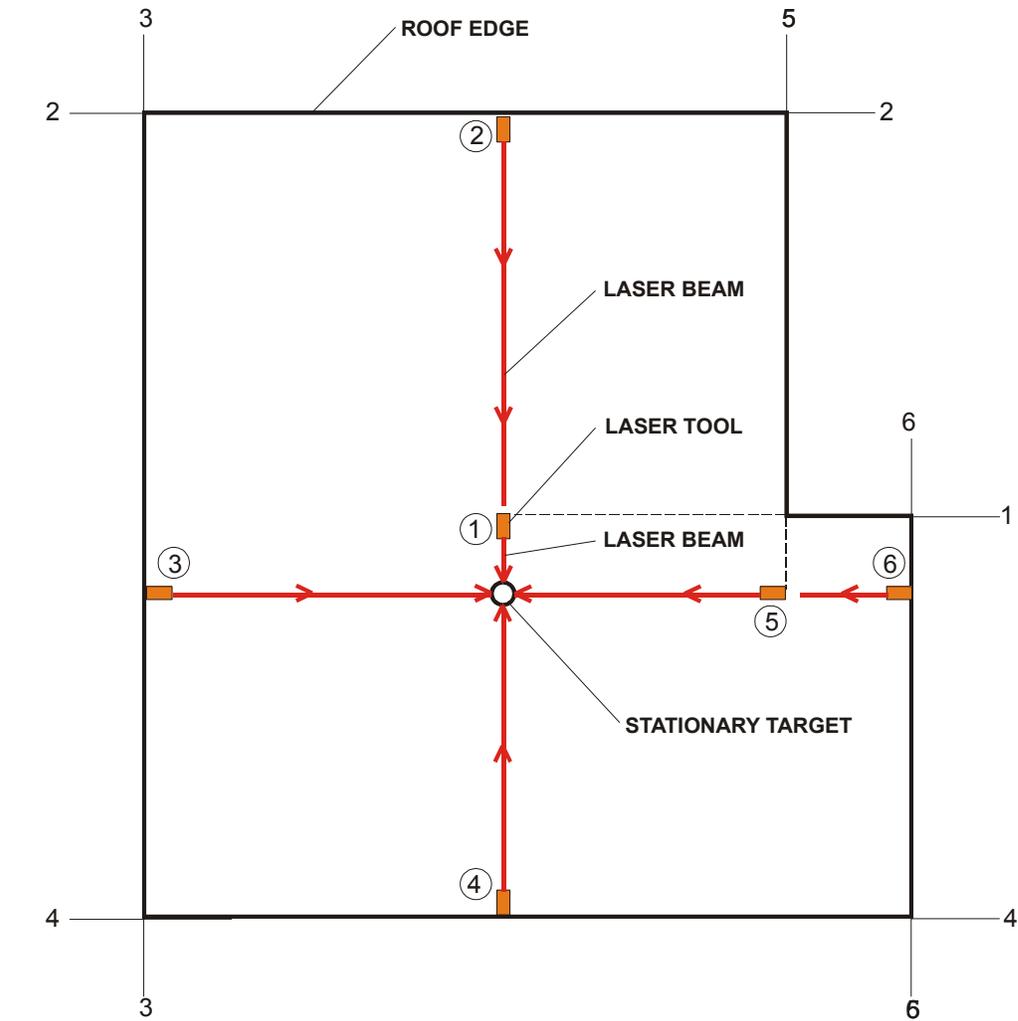
SAMPLE ROOFTOP

① INDIVIDUAL MEASUREMENT I.D. NUMBER, STORED IN LASER TOOL MEMORY

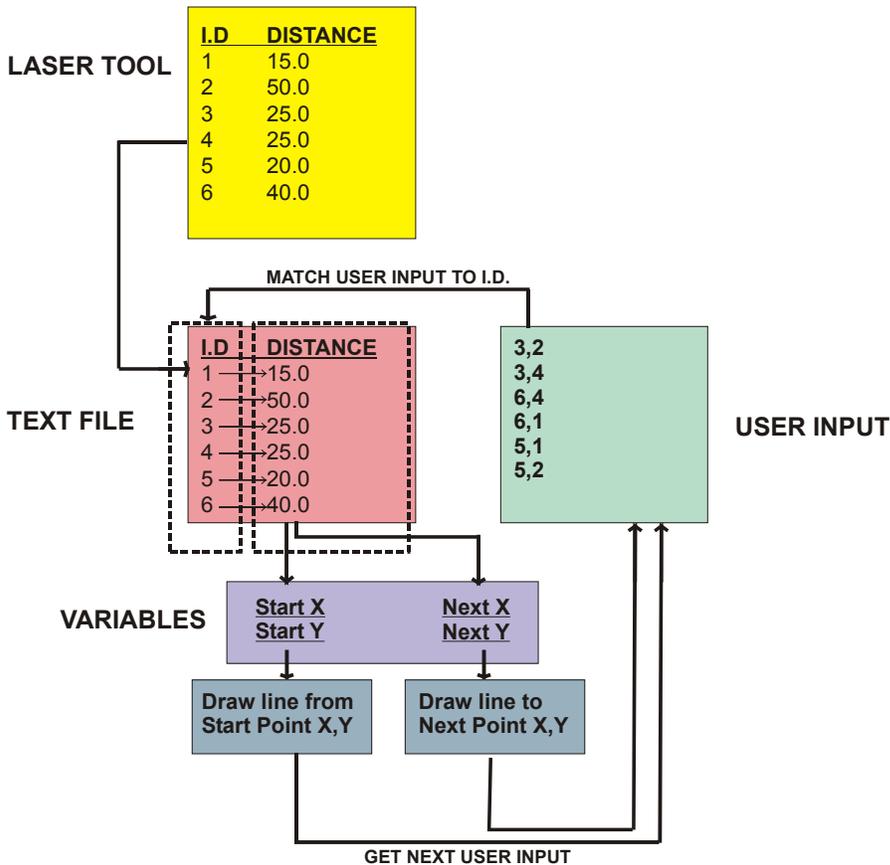
Figure 6: Basic flow-chart for processing audit data in CAD tool

PowerLight is developing Visual Basic (VBA) software to read the distances from this text file and draw lines from point to point to create an accurate layout of the rooftop. The software flow chart is illustrated in Figure 6. The VBA software queries the CAD operator to input two ID numbers to define the first point of the drawing. These ID numbers are then found in the text file, and the corresponding distance is passed to the VBA software variables to be used as X and Y coordinates of the point in CAD.

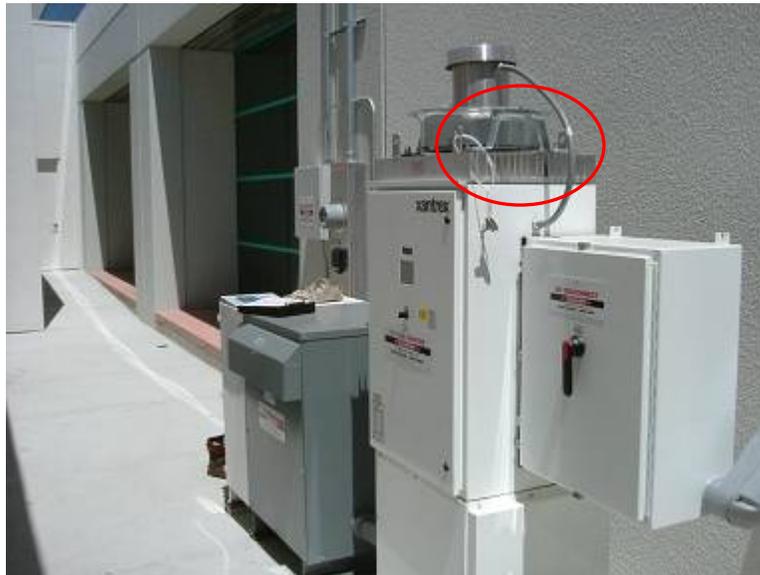
PowerLight's standard data acquisition system is in the middle background of the photo (circled) behind the glass jar-style energy meter.

Figure 7: Xantrex S-Series inverter installation with PowerLight DAS

The real-time Xantrex Graphical User Interface (GUI) will improve our ability to monitor the site and increase system availability in two ways. Information will be available in real time, giving instant notification of inverter status, including specific fault information when the inverter is in a faulted condition. In addition, the GUI will enable some remote inverter control, allowing PowerLight staff to reset many faults and restart the inverter from our offices in Berkeley, eliminating the lag time between fault notification and on-site reset. Figure 7 shows the installed inverter at Site 24. The communications module of the inverter is mounted on the left hand side of the inverter (not visible in photo).

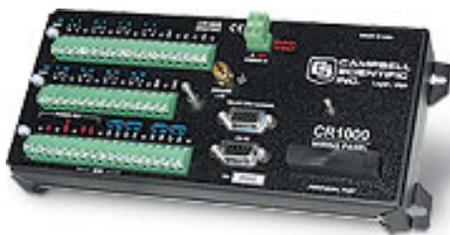
Figure 8: Campbell CR1000 Data Logger

Based on these conclusions, PowerLight installed a Campbell CR1000 logger, shown in Figure 8, at a major customer site in Oakland for further evaluation. The installation occurred without any problems and to date the unit is performing very well.

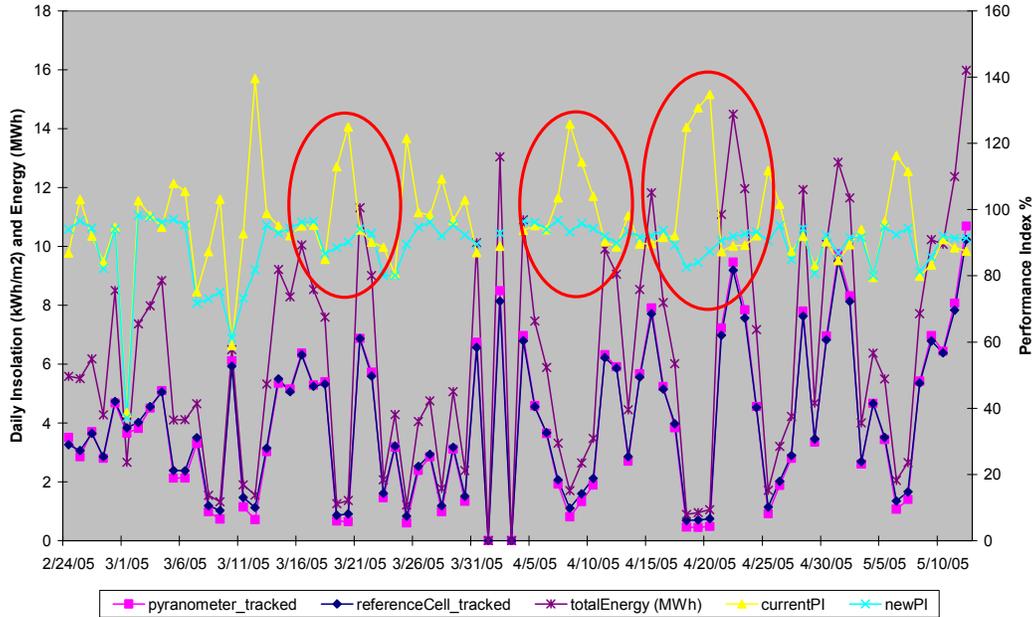
Sample System PI as Calculated from Reference Cell and Pyranometer Data Charted Against Energy Produced and Insolation Measured by these Instruments

Figure 9: Comparison of site performance index using a reference cell and pyranometer.

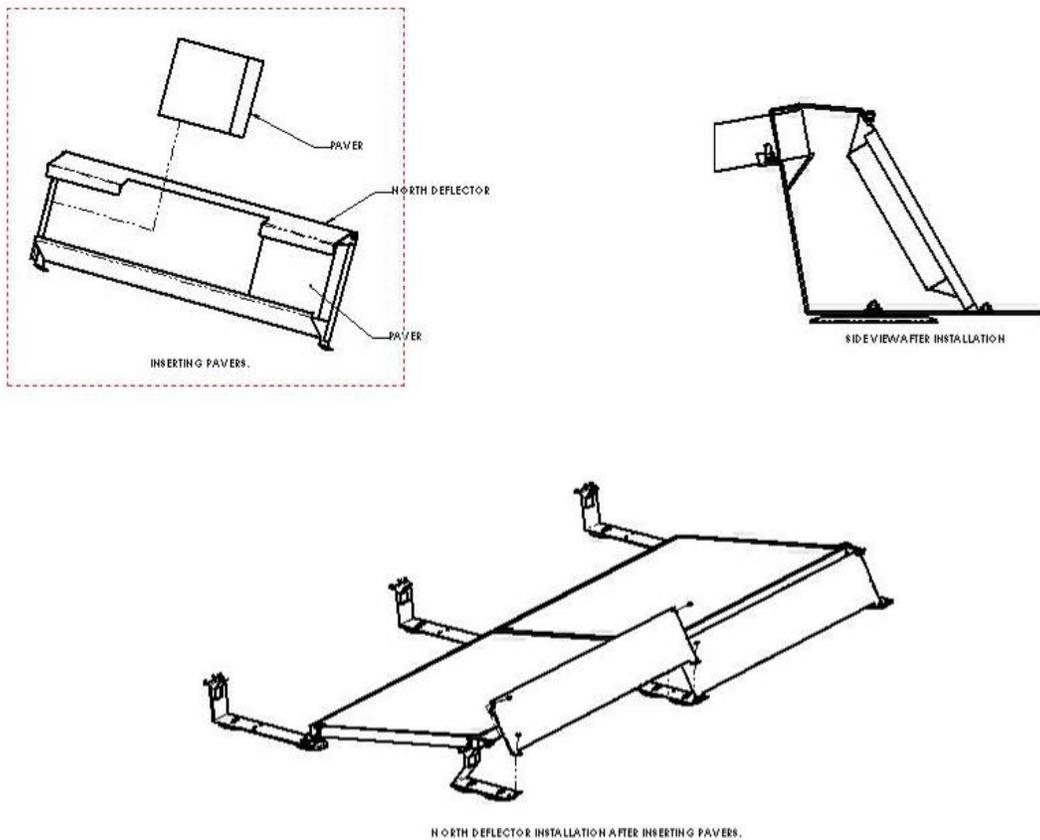
Figure 10: Deflector designed to hold pavers

The finished design of the foamless product is shown in Figure 10 through Figure 12. Figure 10 shows the wind deflector, which now can accommodate concrete pavers to adjust the specific weight of the array.

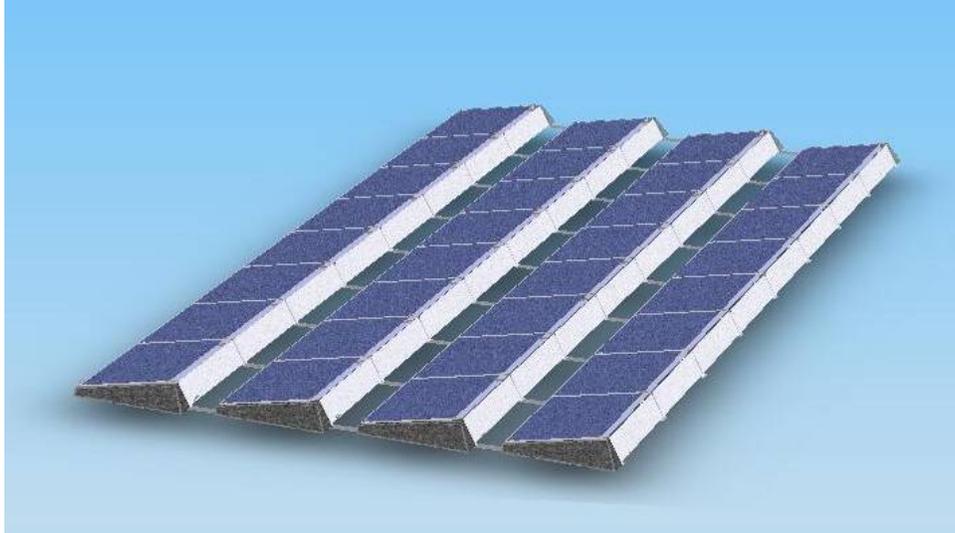
Figure 11: Rendering of array of foamless tiles

Figure 11 shows a rendering of an array of foamless tiles. Wind deflectors are installed on the east and west end of each row. The northwest corner of the array is shown in Figure 12 with the wind deflectors removed from one tile.

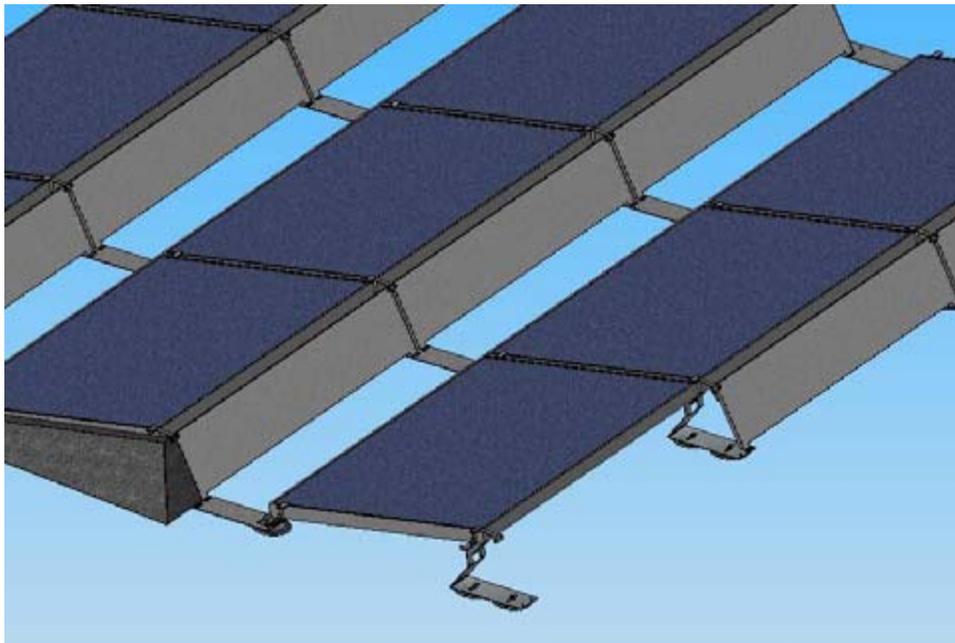
Figure 12: Detail of array showing northeast corner

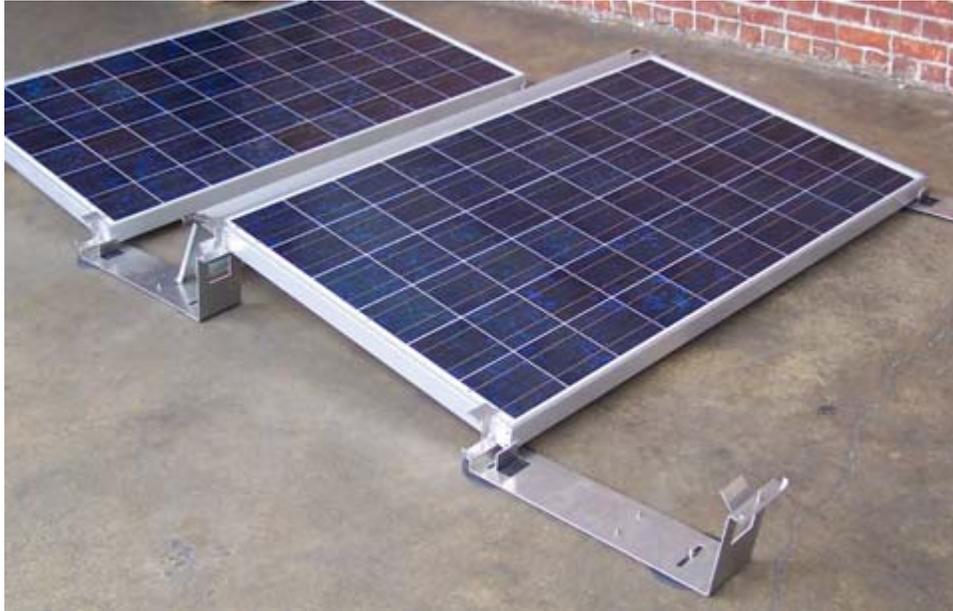
Figure 13: Foamless Product

Figure 13 through Figure 15 show photographs of the current design of the foamless product.

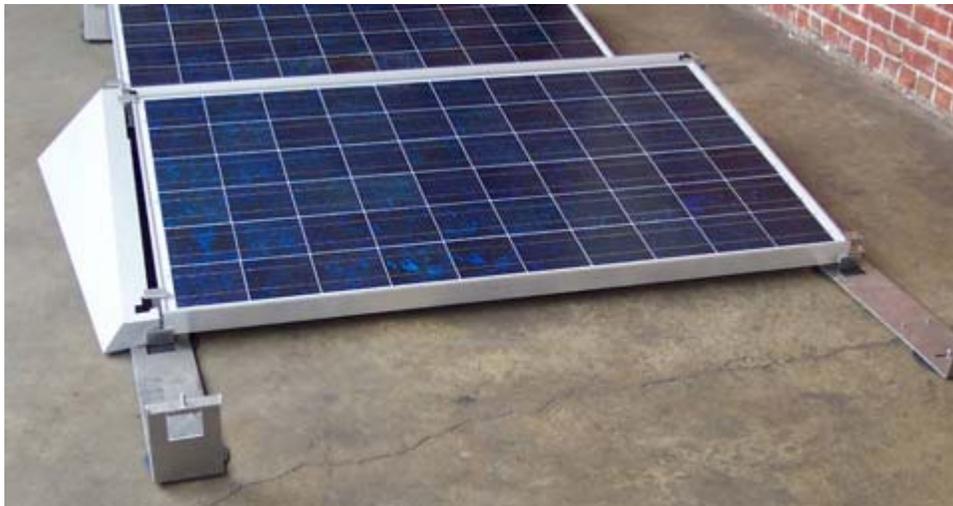
Figure 14: Foamless Product - with west wind deflector installed

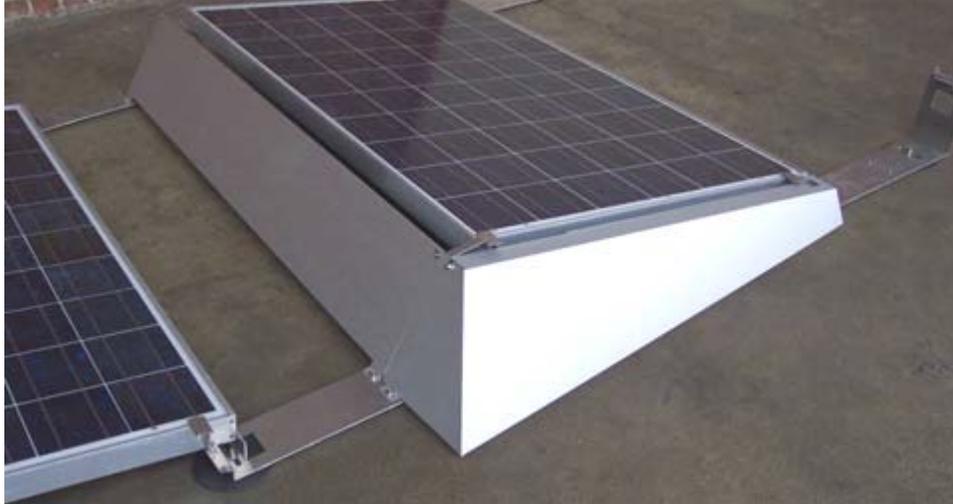
Figure 15: Foamless Product – showing north and west wind deflectors

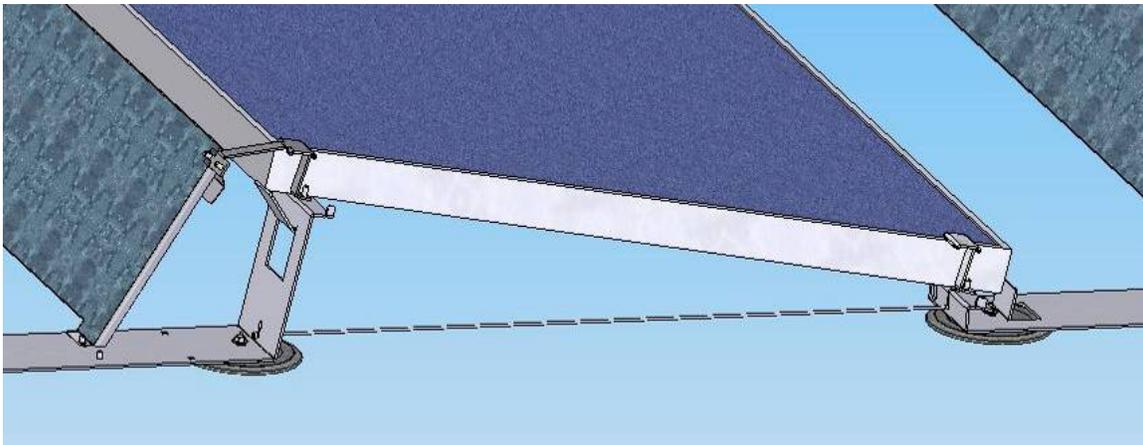
Figure 16: Wire rope connecting supports

The changes to the RFT10 design are shown below. A wire rope was incorporated into the design to allow the array to transfer lateral loads, as discussed above. The wire rope is shown in Figure 16. At each end of the wire rope, a swaged-on ball engages a keyhole slot that is stamped into each end of each support piece. Figure 17 and Figure 18 show the engagement of the ball with the keyhole slot in the supports.

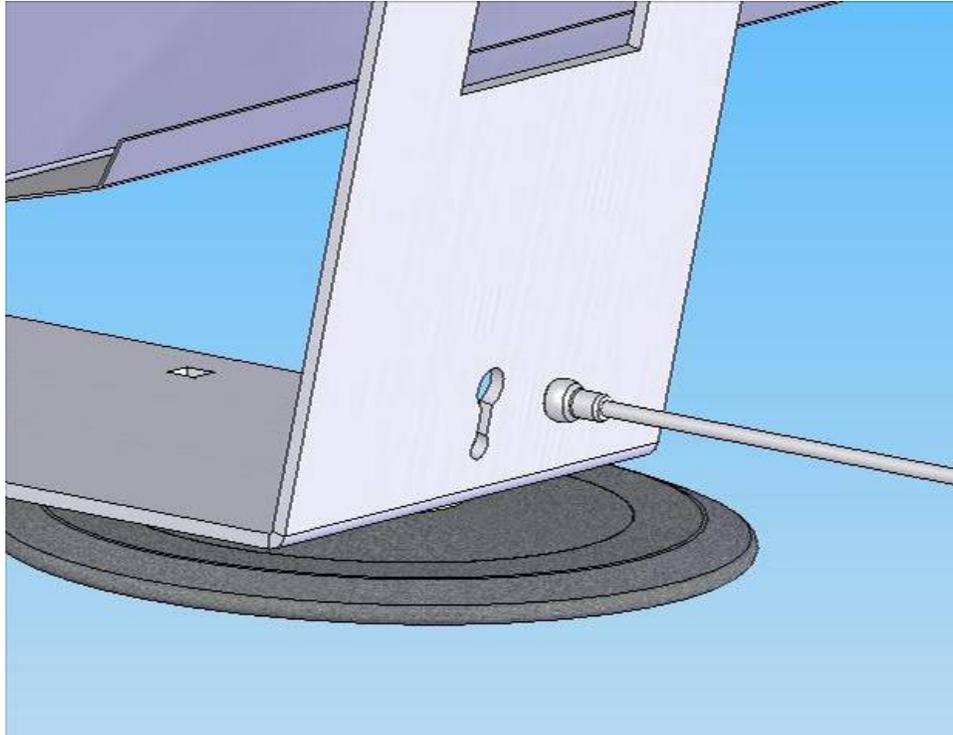
Figure 17: Ball on wire rope engaging keyhole slot in south end of support

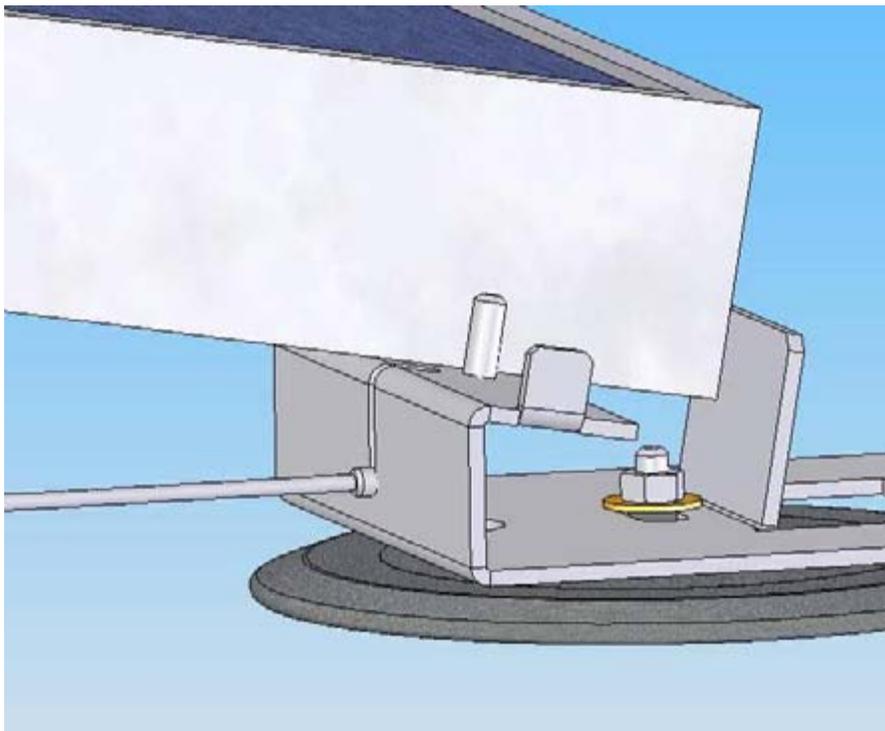
Figure 18: Wire rope and keyhole slot in north end of support

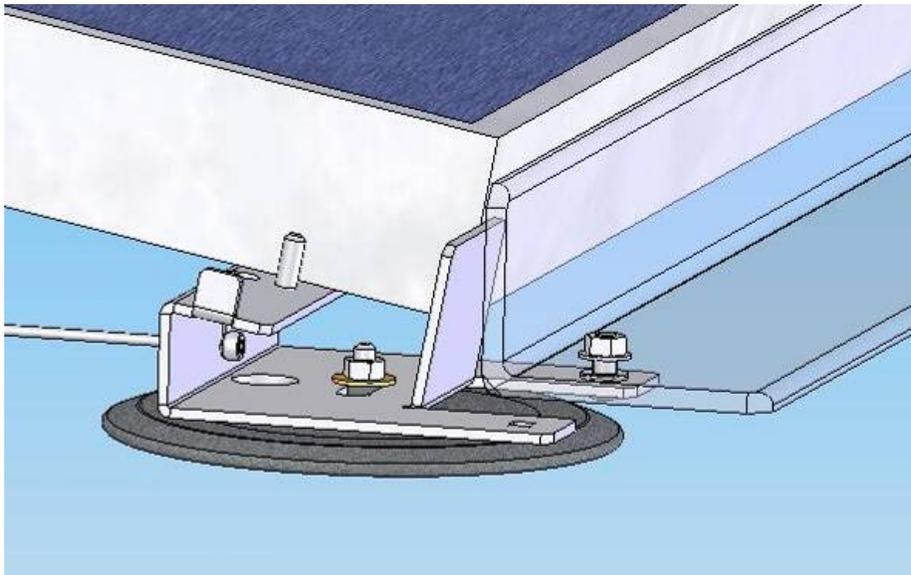
Figure 19: Attachment points for spreader bar on southern support

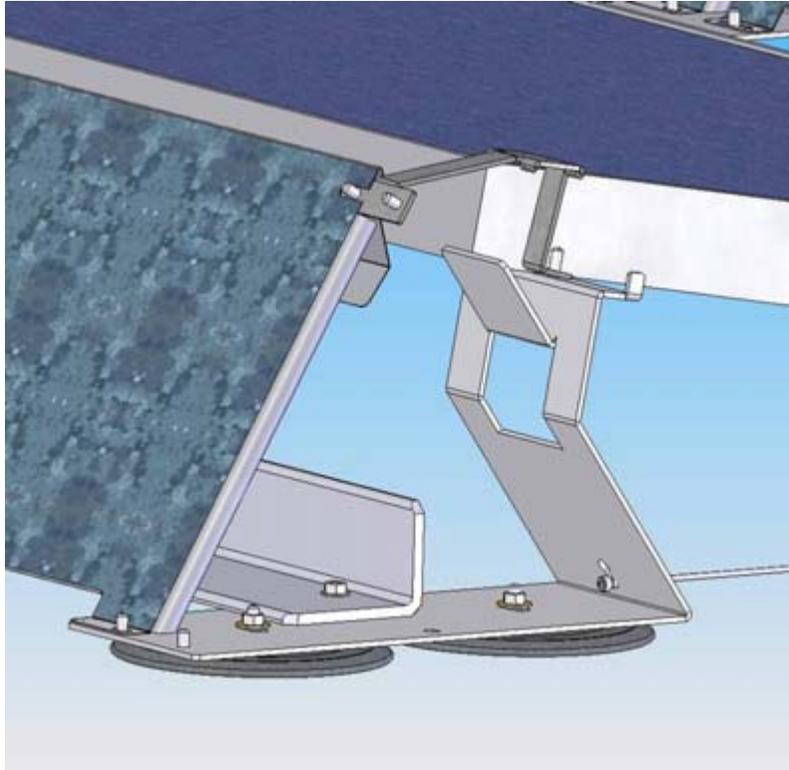
Figure 20: Attachment of spreader bar to northern support

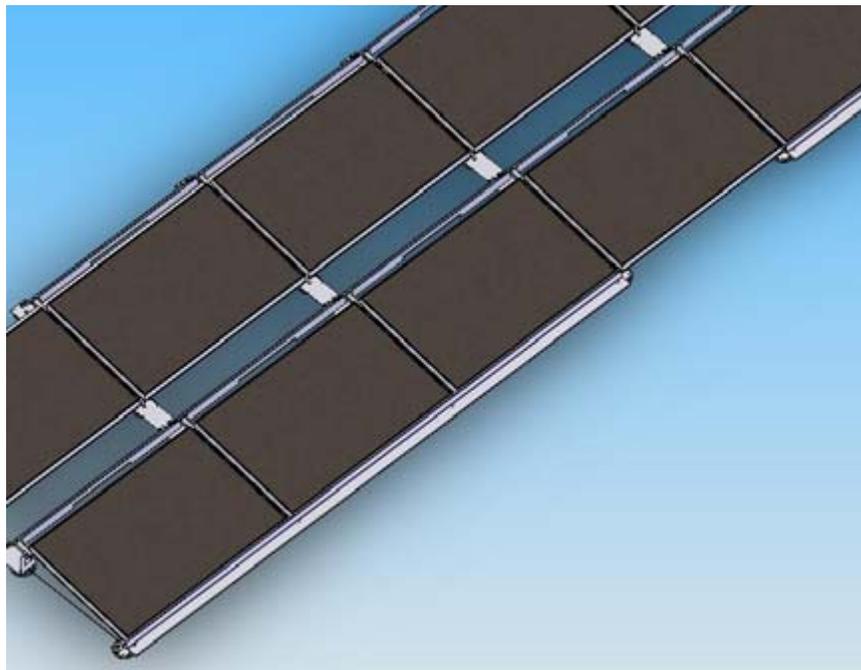
Figure 21: Spreader bar spanning four supports

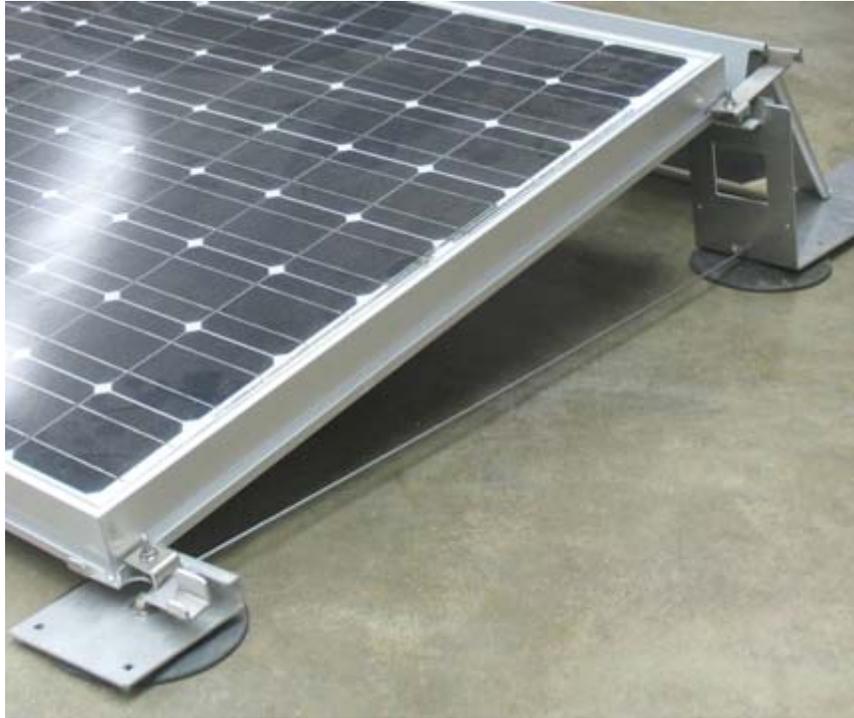
Figure 22: Prototype parts with securement features

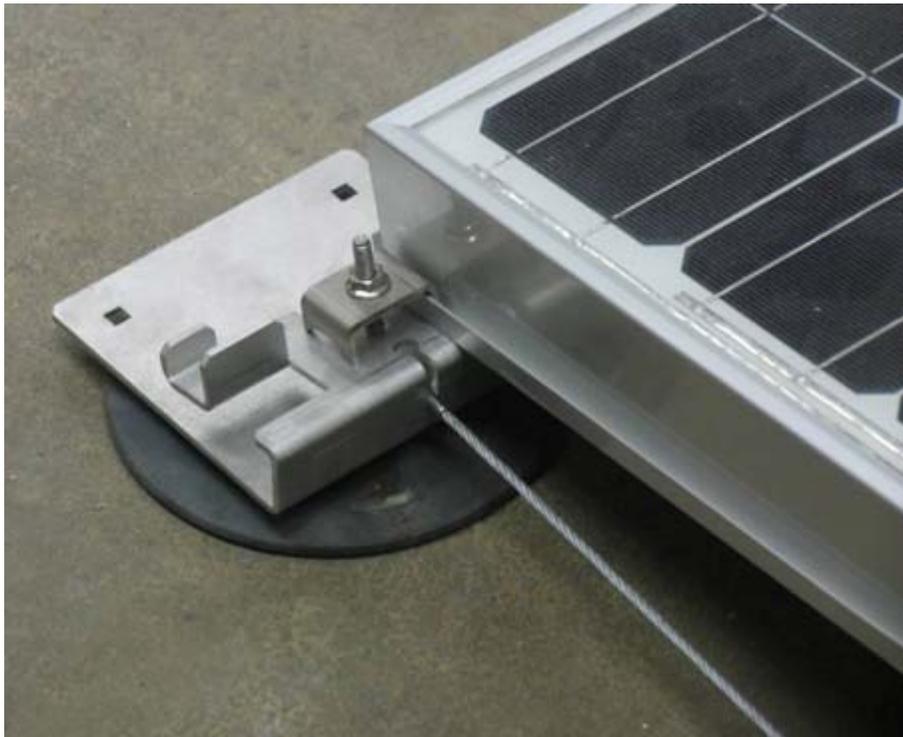
Figure 23: Southern support with keyhole slot and spreader bar attachment points

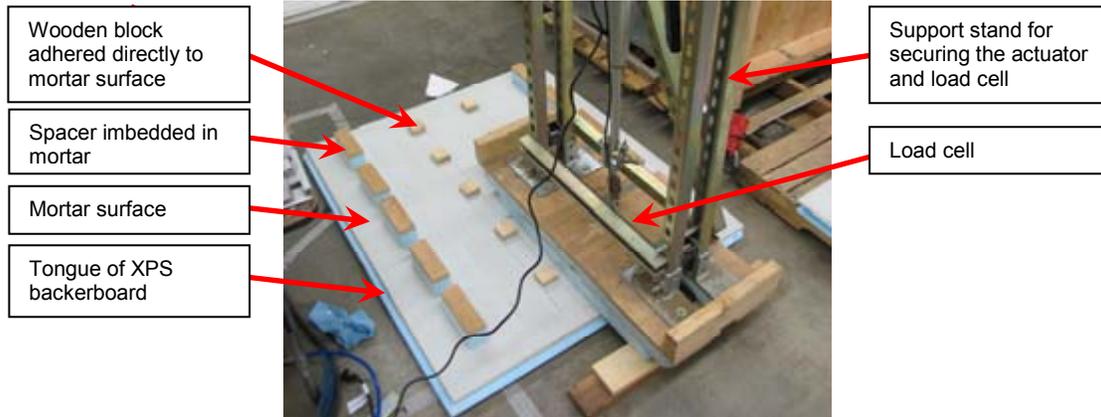
wooden block is adhered to the top of each spacer, and this block is in turn connected to the actuator and load cell. Figure 24 shows this test set-up.

Figure 24: Two methods of measuring the tensile bond strength of the mortar to the XPS.

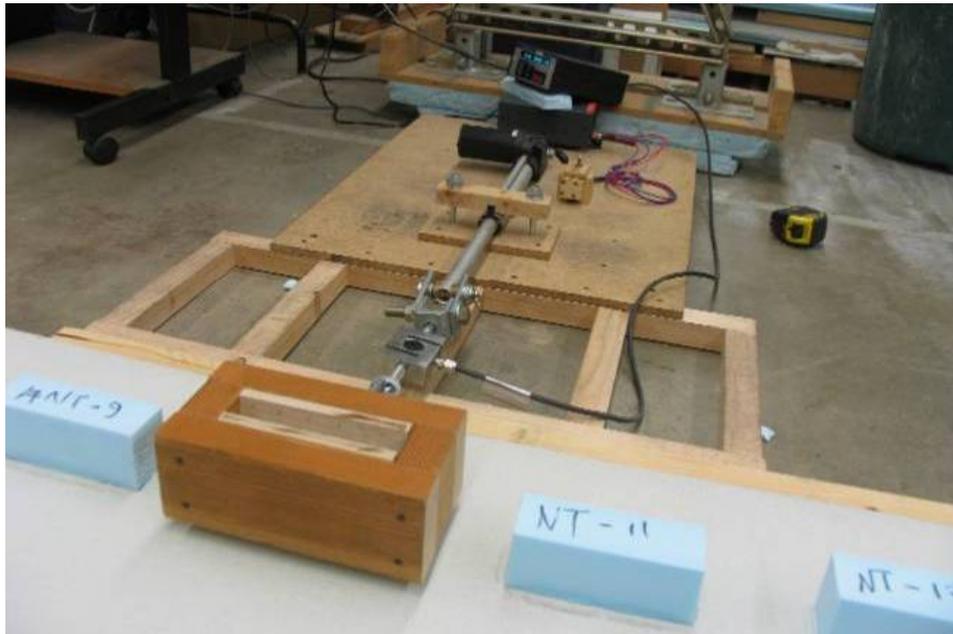
Although it is not expected that PowerGuard tiles will experience large shear loads, experience on our production line has shown that a poor bond between the XPS spacer and mortar may be more easily identified by a shear test than by a tensile test. PowerLight performed shear tests on three types of sample tiles: standard mortar formula and thickness; reduced latex formula; and reduced mortar thickness. The first type of samples served as the control group against which the results of the other two were compared. A photo of the test set up is shown in Figure 25.

Figure 25: Shear test on XPS spacer bonded to mortar.

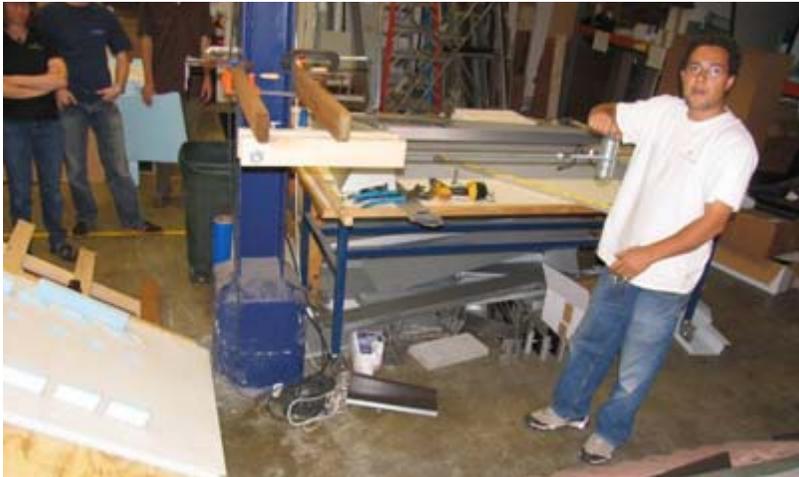
that a reduction in latex content or mortar thickness would not result in unsatisfactory impact resistance, PowerLight devised an impact test. The test consisted of a pendulum with a mass attached to the end. The pendulum was elevated at various heights to determine the energy required to cause impact damage to the edge of the tiles. A photo of the test is shown in Figure 26.

Figure 26: Impact test on mortar.

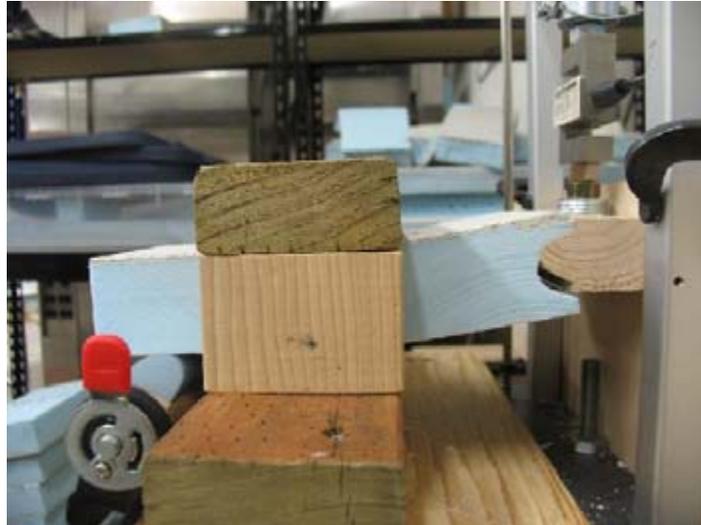
As discussed above, the mortar reinforces the XPS foam edges against horizontal impact loads. Similarly, the mortar also reinforces the top of the foam along the routed groove edges to resist uplift loads more effectively. PowerGuard wind design guidelines are based on wind tunnel tests in which the wind velocity that initiates tile uplift is used as the failure velocity. In a worst-case wind event, PowerGuard tiles may experience small vertical oscillations. The mortar along the groove edges adds considerable strength to the foam, so that foam breakage above the groove will not be a mode of failure. Reduced latex content or reduced mortar thickness may reduce the strength of this reinforcement. Therefore, PowerLight devised a test to measure the strength of the groove reinforcement. Small sections of the tile perimeter were cut and mounted in a tensile tester. A wooden fixture with the form of the XPS tongue was inserted into the groove edge of the test sample. The wooden fixture was lifted while the test sample was held in place. The load that caused failure was recorded for control samples and samples with reduced latex and reduced mortar thickness. A photo of the test set up is shown in Figure 27.

Figure 27: Strength of groove test.

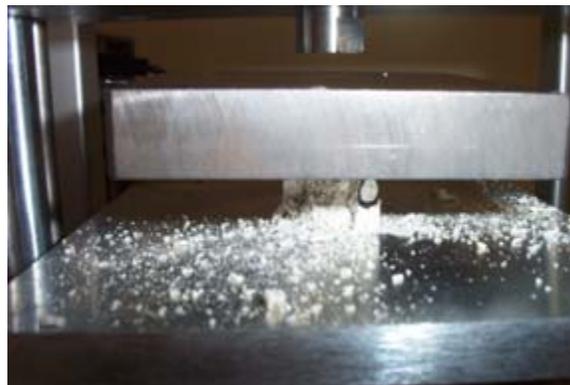
PowerGuard tiles are not subjected to large compressive loads, so in a sense the compressive strength of the mortar is not part of the design criteria. However, it is well known in the concrete industry that the compressive strength of concrete is an indicator of concrete quality and freeze-thaw resistance. In addition, the test is very easy to perform and requires minimal material for the test. The compressive strength test on the mortar is based on the ASTM test C597. In this test, 1" diameter x 1" height samples of mortar are fabricated and allowed to cure. The samples are then compressed until failure occurs, and the load causing failure is recorded. This test was conducted on samples with the standard amount of latex and with a reduced amount of latex. Freeze/thaw testing was planned to be done following a series of tests on unconditioned samples. A photo of the test set up is shown in Figure 28. The minimum compressive strength is 3500 psi.

Figure 28: Compressive strength test.

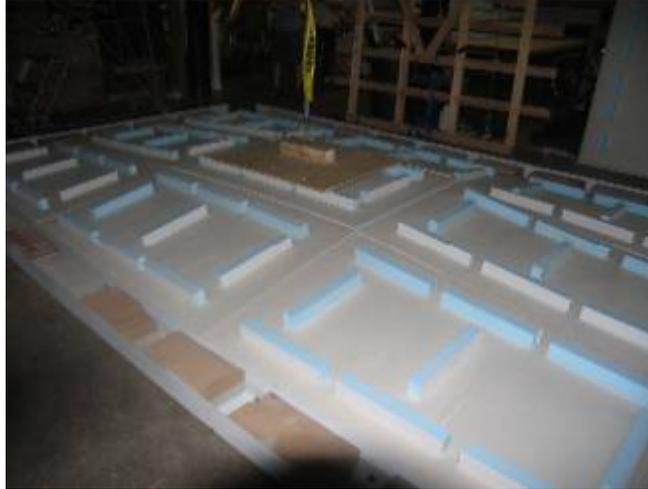
Full-scale testing was also conducted on samples with reduced latex and reduced mortar thickness. In this test, a 3x3 array of tiles was assembled on the shop floor. A perimeter curb was installed around the array of tiles. The center tile was connected to a load cell and cable and winch assembly. The center tile was lifted until failure occurred. A photo of this test set up is shown in Figure 29.

Figure 29: Tile uplift test.

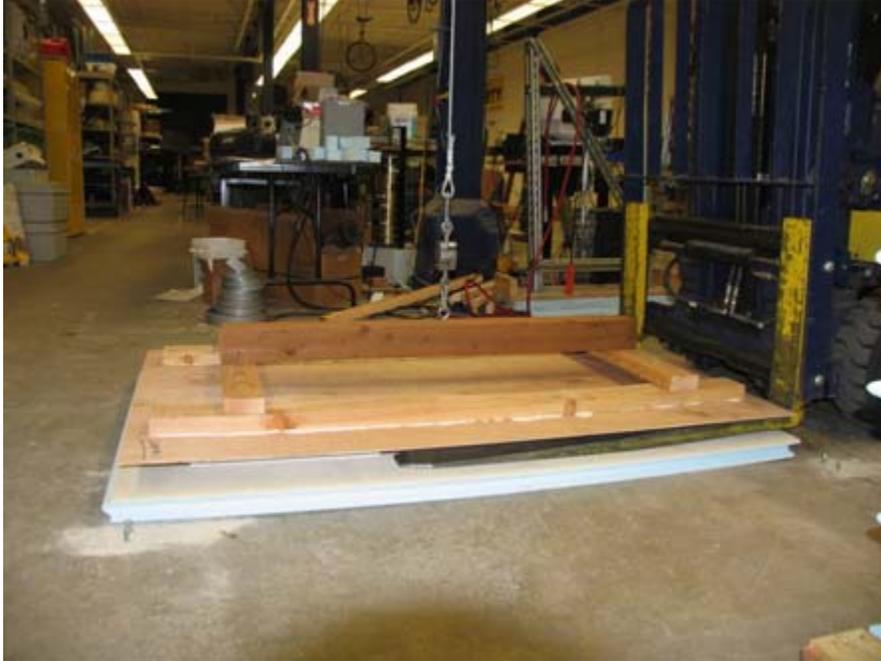
Testing consisted of a destructive tensile test on the tiles to ensure the tiles can meet an uplift requirement of 50 lbs. per square foot (psf). The test setup is shown in Figure 30.

Figure 30: Tensile test of PowerGuard tile made with continuous process

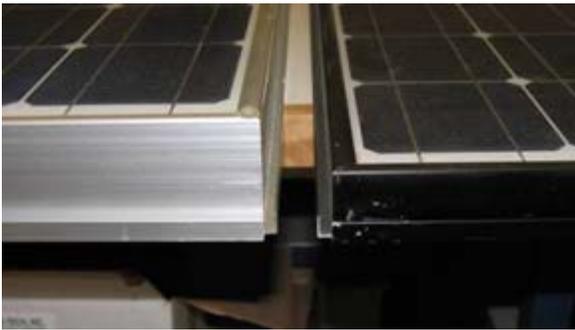
Each PV module manufacturer has a unique PV frame design. The frames can be categorized into two types: external flange frame (EFF) and internal flange frame (IFF). Photos of these two frame types are shown in Figure 31 and Figure 32.

Figure 31: Examples of external flange frames

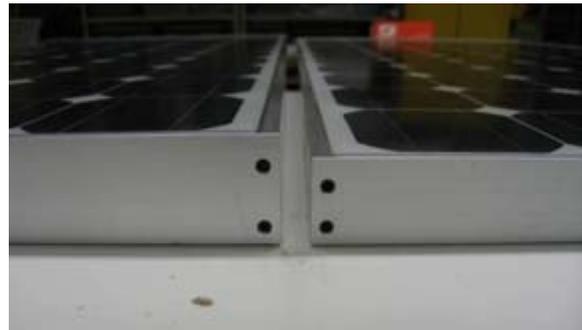
Figure 32: Examples of internal flange frames

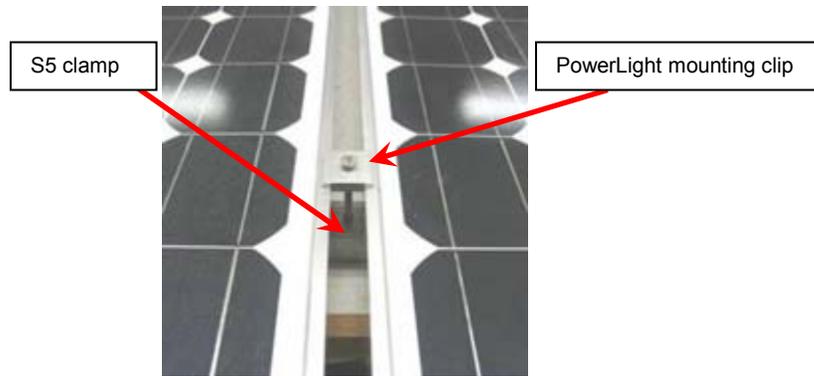
Standing seam and corrugated metal roofs can be used as a mounting structure for PV modules. PowerLight has developed standardized mounting clips to mount EFF and IFF PV frames to structural components, such as S5 clamps or Unistrut. These structural components are then attached to the metal roofing using standard industry practices. A photo of an S5 clamp is shown in Figure 33.

Figure 33: S5 clamp and PV mounting clip to secure two PV modules.

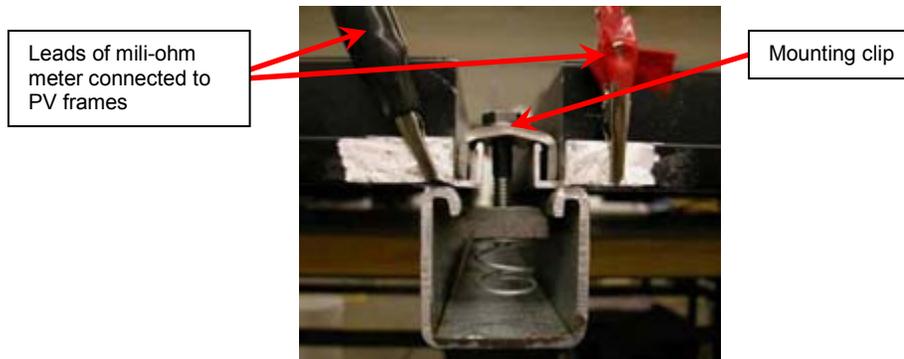
UL 1703 specifies that the resistance between accessible conductive components in a PV system cannot exceed 0.1 Ohms. PowerLight evaluated the IFF and EFF clip assemblies to ensure that the resistance was below this value. In this test, leads of a highly sensitive milli-ohmmeter are connected to two adjacent PV frames in order to measure the resistance across the clip assembly, as shown in Figure 34.

Figure 34: Ground testing of mounting clip and frames.

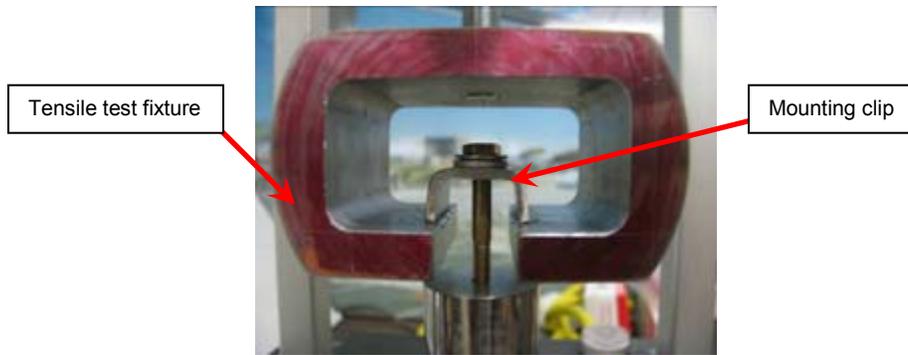
UL requires that PV modules pass a loading test where 45 psf is applied to the module surface. Permeable PV roofing systems typically have excellent pressure equalization, resulting in lower wind loads on the module. PowerLight tested the IFF and EFF clips in a tensile test, as shown in Figure 35. A vertical load was slowly applied until failure occurred, and the load causing failure was recorded and compared to the UL requirement.

Figure 35: Mounting clip uplift test.

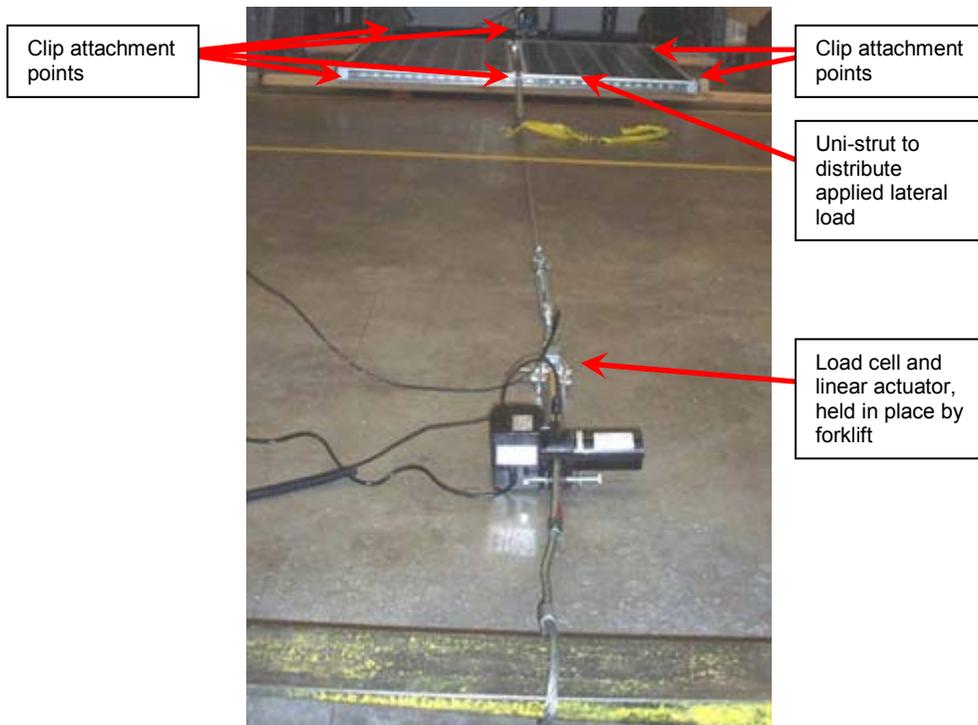
PowerLight used International Building Code (IBC) guidelines to calculate expected lateral loads on the PV array in a severe seismic event. Then a lateral loading test was conducted to determine if the assembly could withstand the predicted load. A photo of the test setup is shown in Figure 36.

Figure 36: Lateral load test on RMR mounting clip.

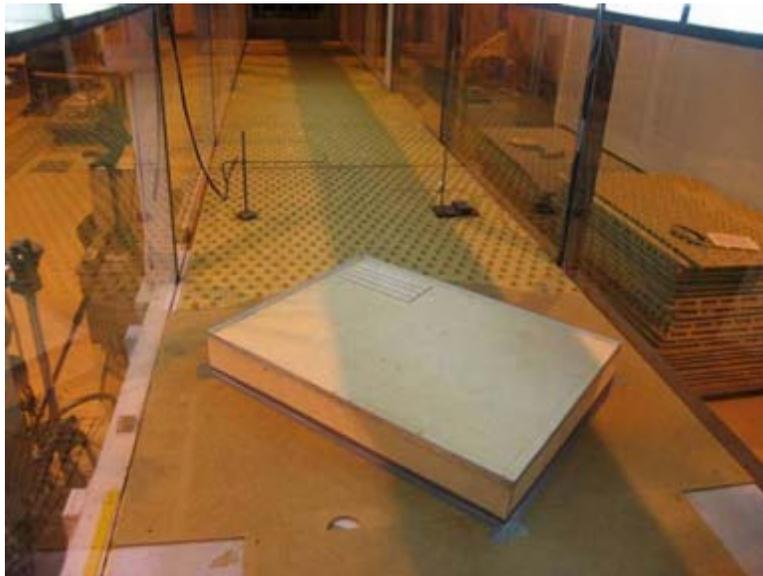
For each test configuration, the array was set up on the model building, and the wind speed in the tunnel was slowly increased until failure occurred. In some cases, failure occurred due to tile lifting around the edges of the array, and, in others, the entire model array slid on the roof surface. Figure 37 shows a typical test configuration.

Figure 37: Wind tunnel model for an RFT10 array installed on the edge of a building.

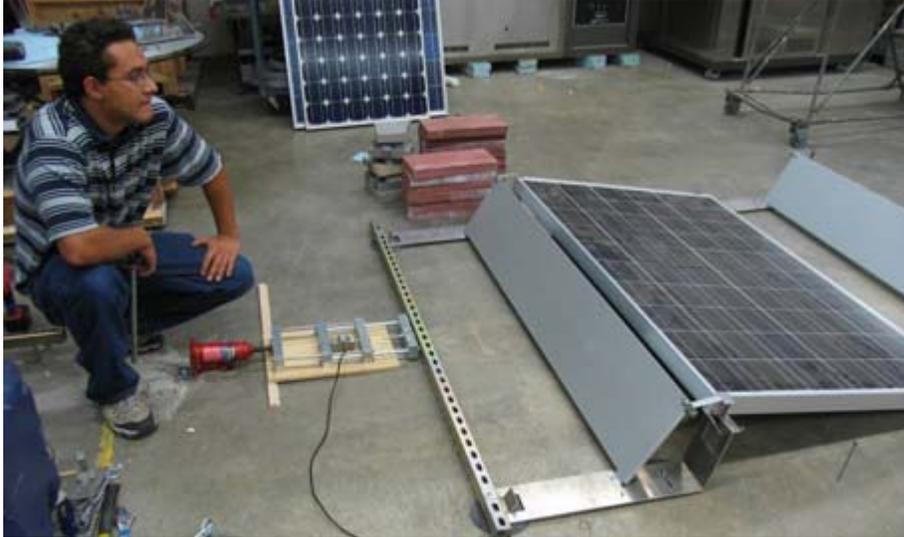
Four types of structural loading tests were done RFT10 assemblies. First, a lateral compressive load in the north-south direction was applied to a RFT10, as shown in Figure 38. The force was applied at the north end of the tile, while the south end was restrained. The purpose of the test was to simulate a strong wind hitting the north end of the array, causing the first row of tiles to be pushed into the interior sections of array. The force was increased until some part of the structure yielded. The force and displacement were then measured.

Figure 38: Lateral load test on RFT10 assembly. A compressive load is applied to the north side of the tile.

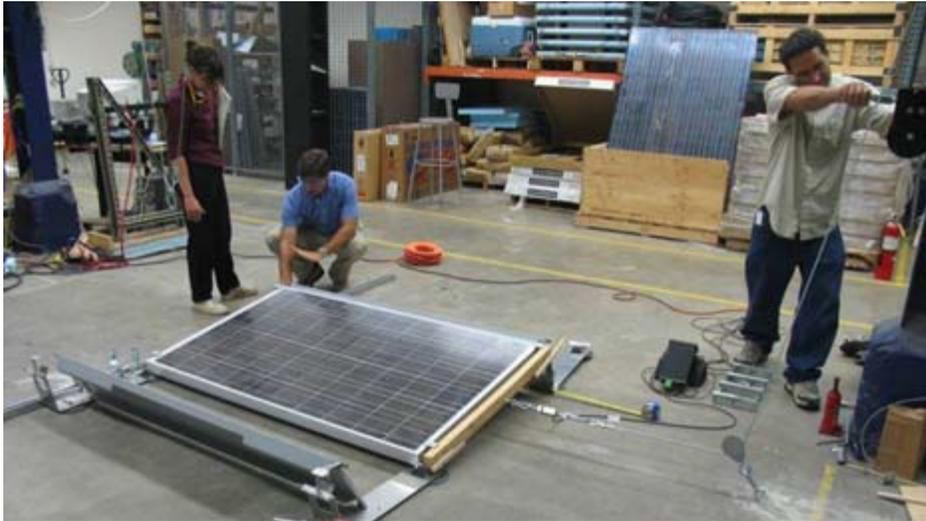
In a second test, a lateral compressive load was applied to the east side of a tile with the west side restrained. This configuration simulated a wind load hitting the outer eastern edge of the array. As before, the force was increased until some part of the structure yielded. The force and displacement were measured. A photo of the test set up is shown in Figure 39.

Figure 39: Lateral load test on an RFT10 assembly. A tensile load is applied to the east side of the assembly.
