Accelerating PV Cost Effectiveness Through Systems Design, Engineering, and Quality Assurance

Subcontract Report
NREL/SR-520-40335
July 2006

Phase I Annual Technical Report
4 November 2004 — 3 November 2005

J. Botkin
PowerLight Corporation
Berkeley, California

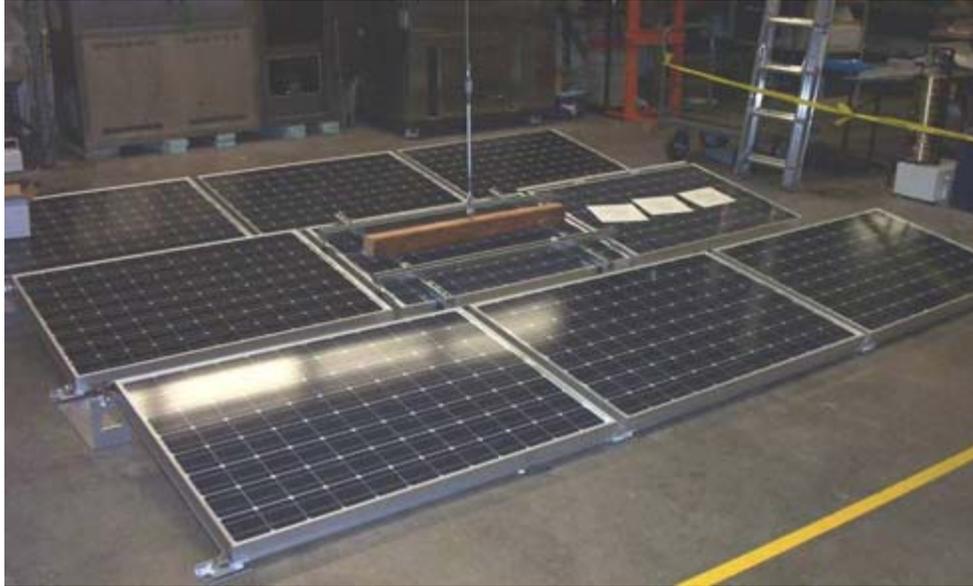
The third test simulated wind uplift failure. The purpose of this test was to ensure that the retaining clips were sufficiently strong to keep the PV module from being pulled loose under the most severe uplift loads that might be encountered. A photo of the test set up is shown in Figure 40.

Figure 40: Uplift test on an array of RFT10 tiles. A vertical force is applied to the center tile.

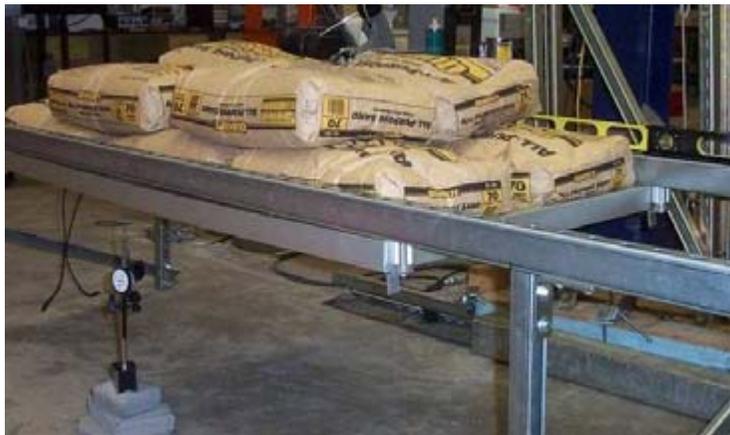
The strength of the PV mounting clips in the RFT10 assembly was evaluated in a loading test based on UL1703 and IEC 61215. In this test, 50 psf was applied to the module and clips. A photo of this test is shown in Figure 41.

Figure 41: Loading test on a PV module supported with RFT10 mounting clips.

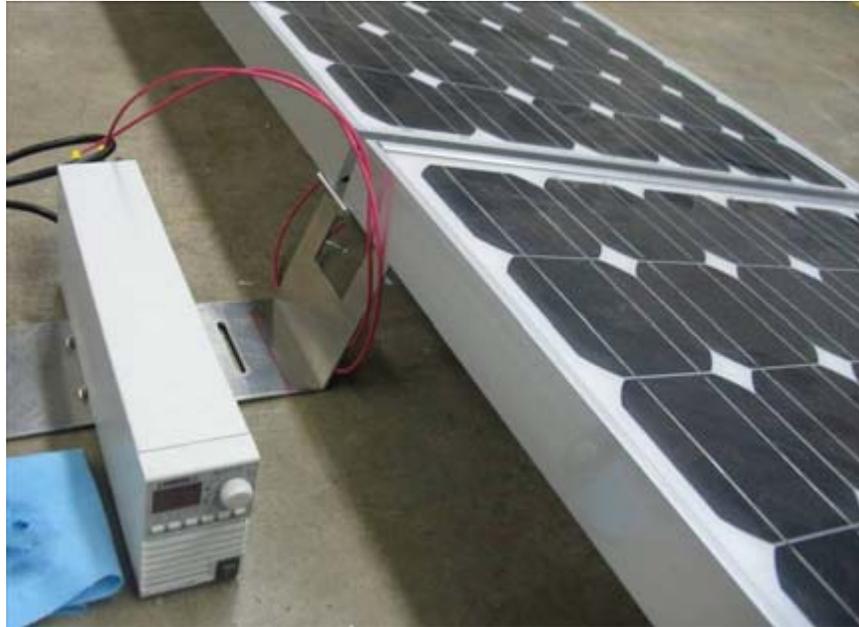
The RFT10 assembly has many accessible conductive components that must all be electrically connected together to create a reliable bond to earth ground. A test was conducted to verify that the resistance across the assembly was below an industry-established maximum of 0.1 Ohms. A photo of the test set up is shown in Figure 42.

Figure 42: Grounding test on an RFT10 assembly.

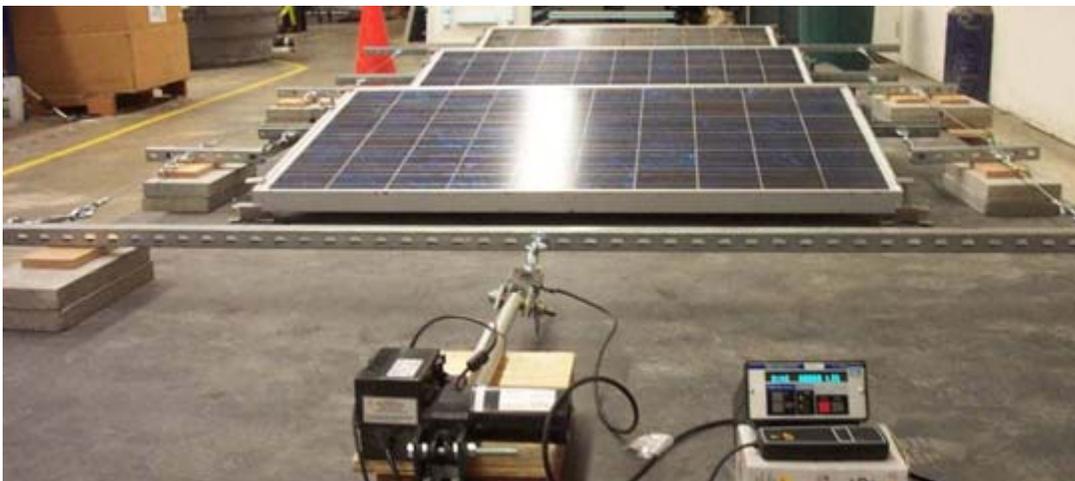
First, friction coefficients between the assembly and various roofing surfaces were measured. A horizontal load was applied evenly to the sides of three tiles until motion occurred. The load causing motion was automatically captured by the data collection system and used to calculate the friction coefficient on a membrane roof. A photo of the test set up is shown in Figure 43. A typical low value was chosen for further evaluation of system performance in a seismic event.

Figure 43: Friction test on an RFT10 assembly.

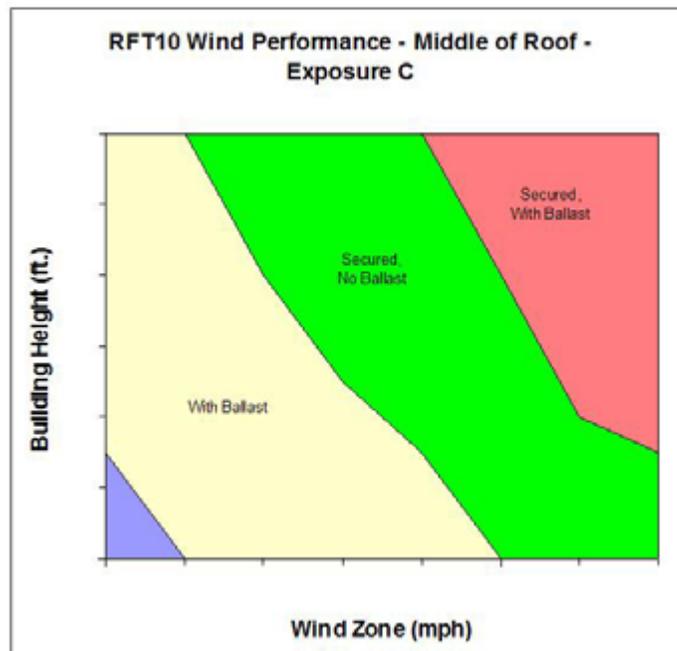
The wind tunnel test results provided a failure velocity and failure mode for each configuration that was tested. A safety factor was applied to all failure velocities. PowerLight reviewed the results extensively to identify worst-case conditions and to identify the dominant trends in the data. The results were then incorporated into a series of charts to be used as guidelines for array design.

Figure 44: Wind design chart for RFT10 arrays in the middle of the roof in Exposure C.

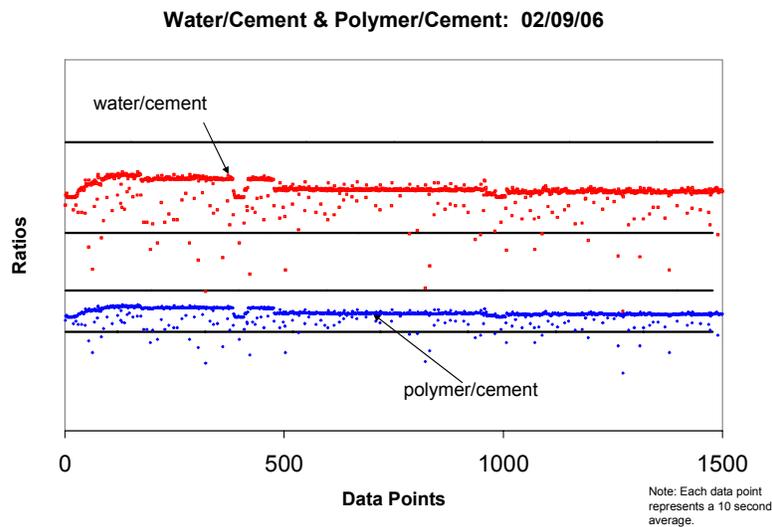
The greatest impact on the measured yield of PowerGuard tiles was achieved through the implementation of the error-proofed mixing system for the liquid and dry ingredients of the coating. This new pumping station was combined with an improved data monitoring system. Two parameters are monitored as primary indicators of coating quality: the polymer-to-cement ratio and the water-to-cement ratio. The new monitoring system collects data on material flow and calculates these parameters in real time. A plot of these parameters is then stored for each day of production, providing traceable information for each lot of PowerGuard backerboards made. Figure 45 shows a typical plot from one production run. A solid line is displayed above and below each parameter plot showing the acceptable range for that parameter. The system is programmed to start collecting data when the flow rate exceeds a threshold level. This produces the slight scatter of outlying points each time the system starts and stops.

Figure 45: Typical plot from coating monitoring station

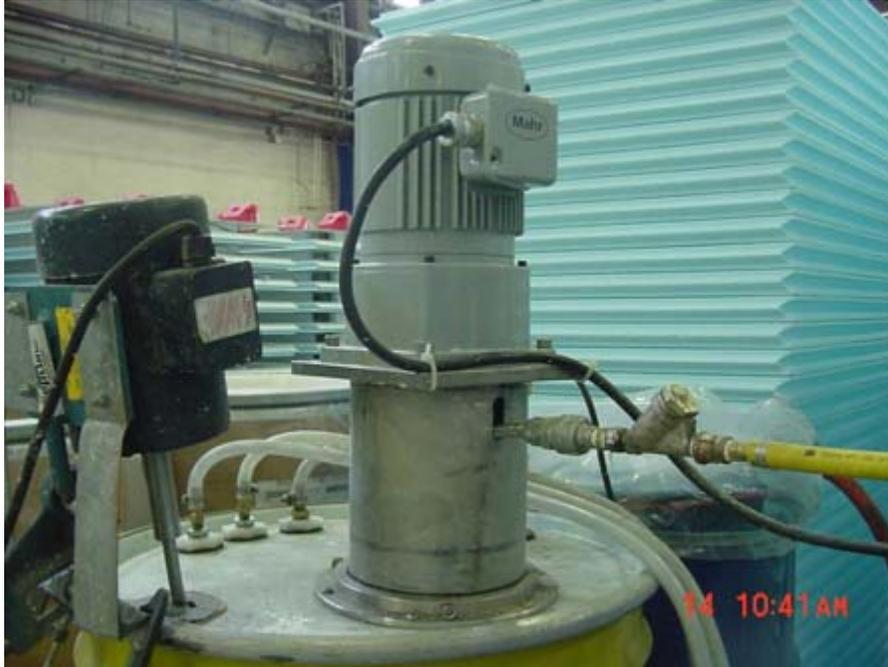
The implementation of the new pumping station improved the control of the mixing process and reduced labor required at the same time. Prior to the implementation of this new station, the mixture was controlled by an operator based on an analog flow meter. The mixture could vary widely depending on the skill and attentiveness of the operator. Figure 45 shows that the two critical parameters are now being maintained very tightly. An operator checks the function of the mixing system at the start of the coating run; after this initial check, it requires no attention. Figure 46 and Figure 47 show the new pumping station.

Figure 46: New pumping station for mixed liquids

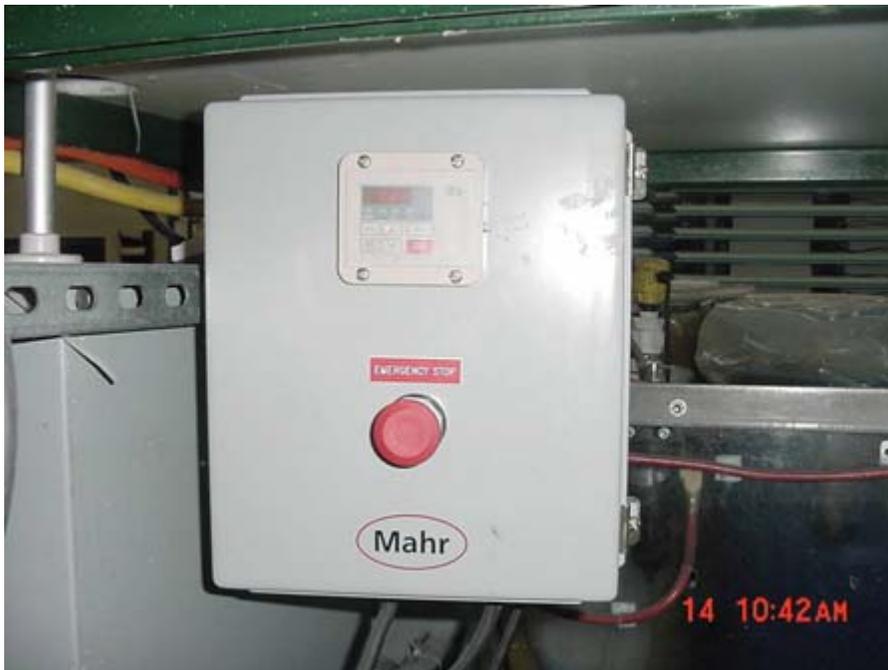
Figure 47: Control panel for pumping station

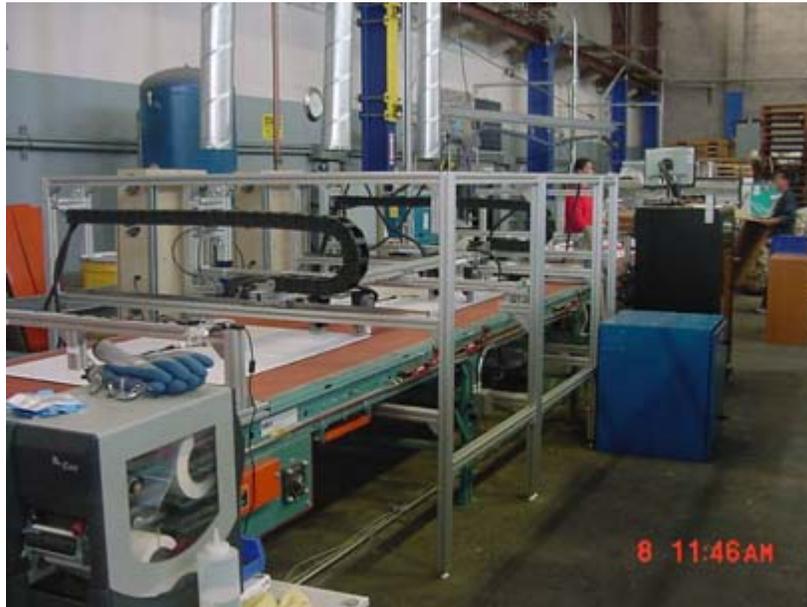
Figure 48: PV prep line

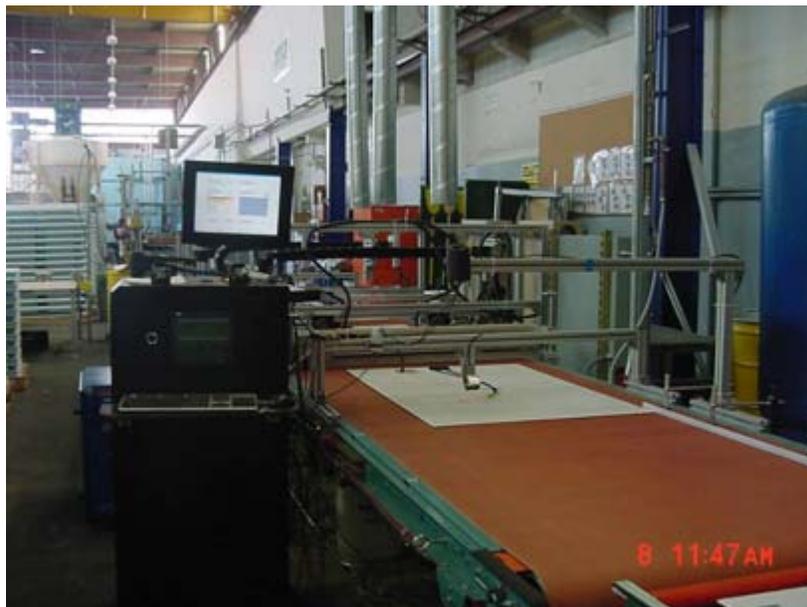
Figure 49: PV prep line

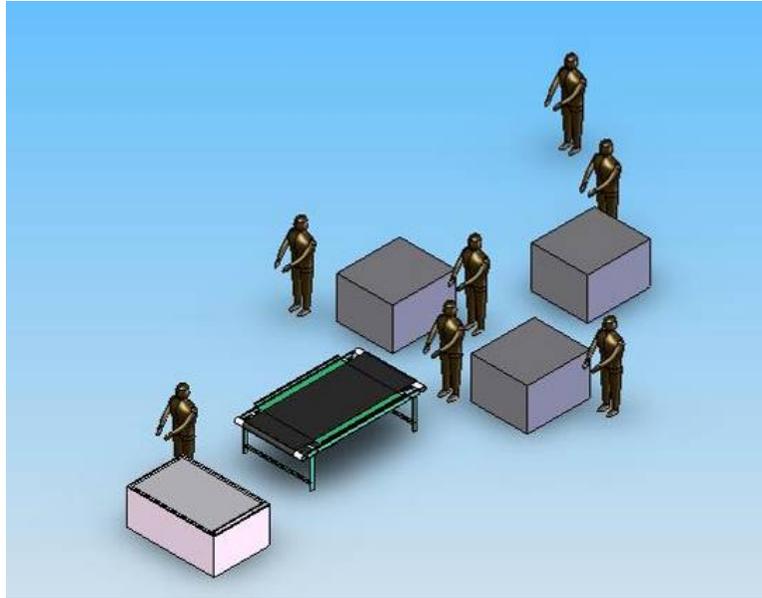
Figure 50: Existing Process

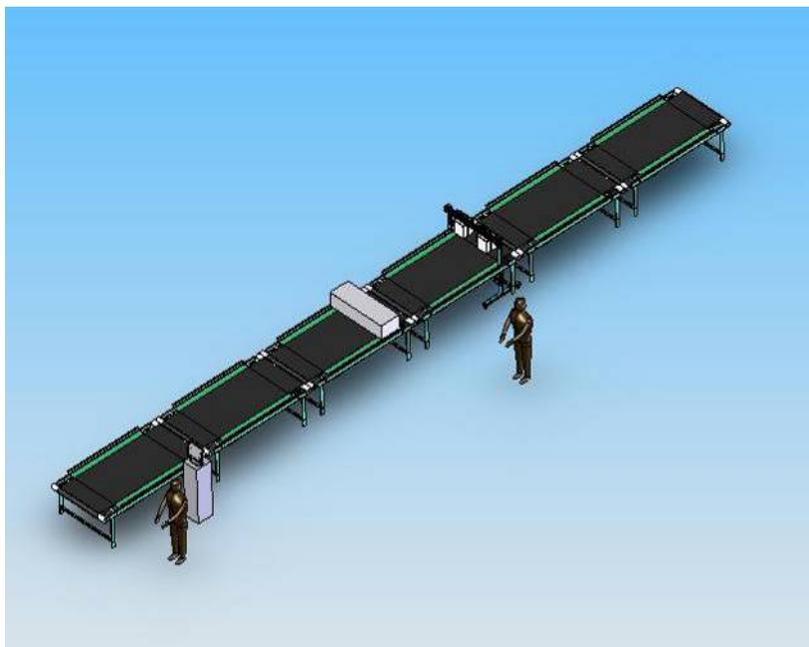
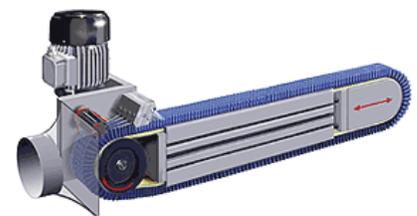
Panel Cleaning Machine

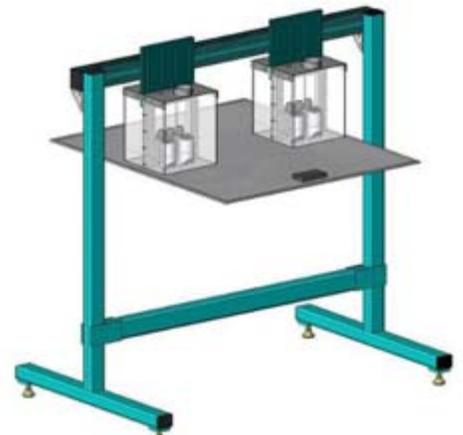
Surface Treatment Machine

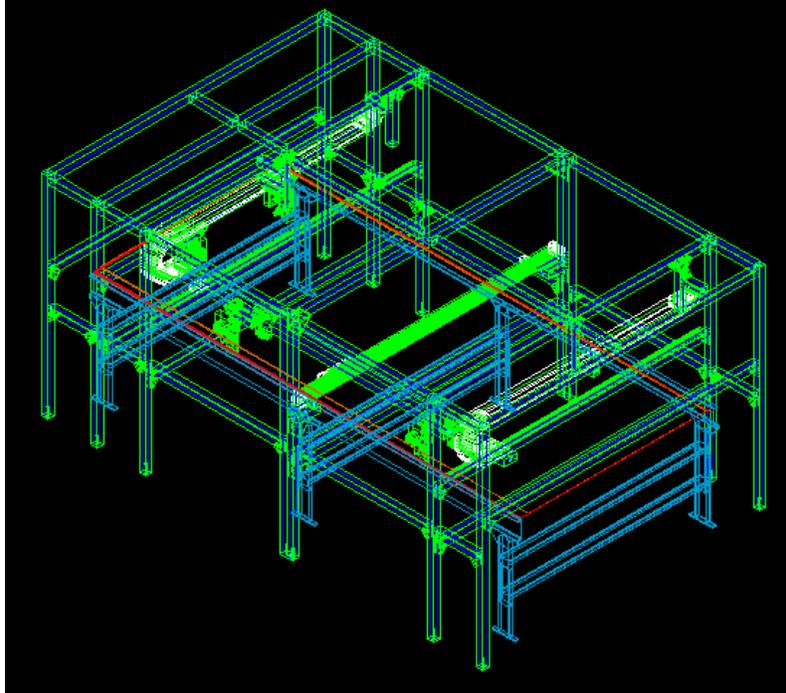
Figure 52. Layout of the Surface Treatment Section of the Equipment

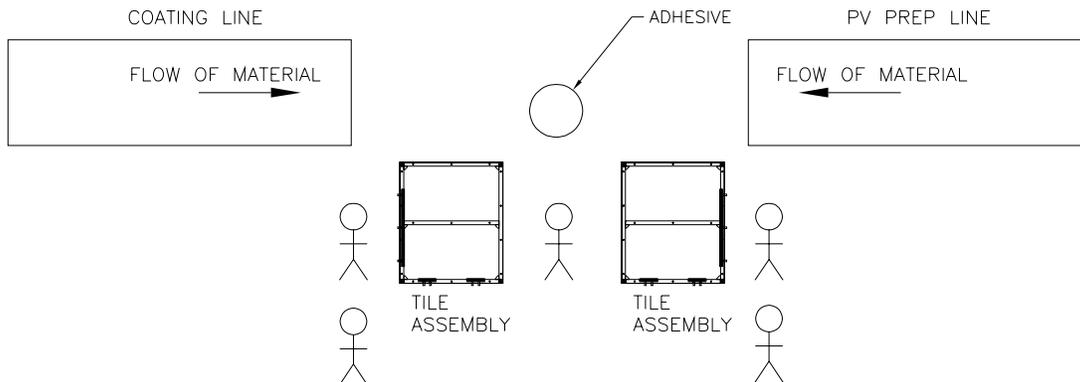
Figure 53: Tile Assembly Layout after Kaizen Event

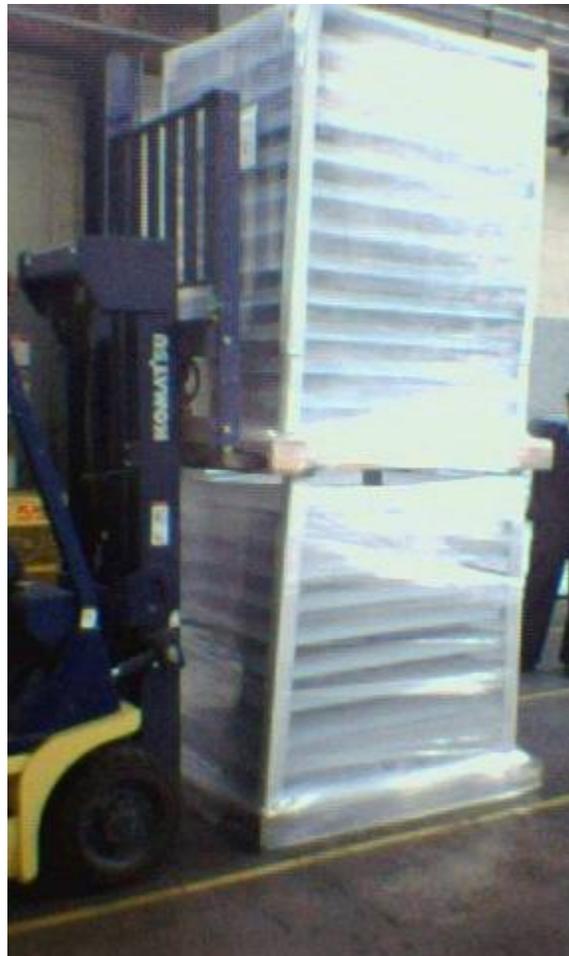
Figure 54: Test of corner supports in double stacked pallets

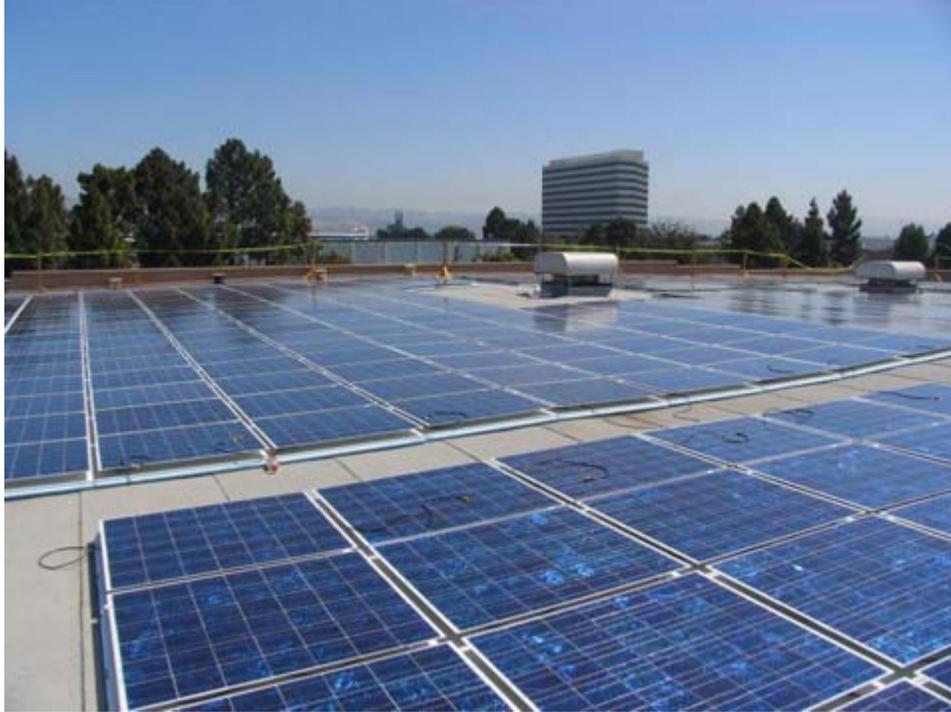
Figure 55: Demonstration array with reduced coating thickness during installation

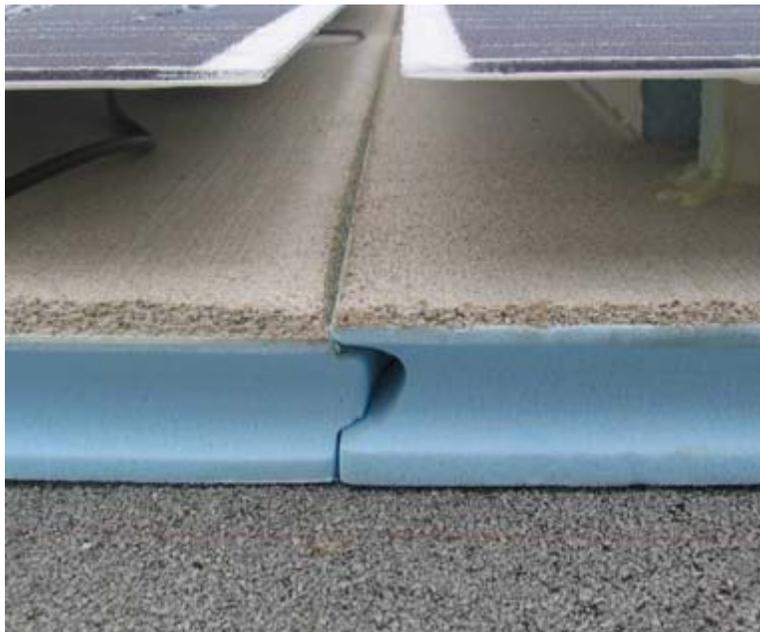
Figure 56: PowerGuard tile with reduced coating thickness (on right)

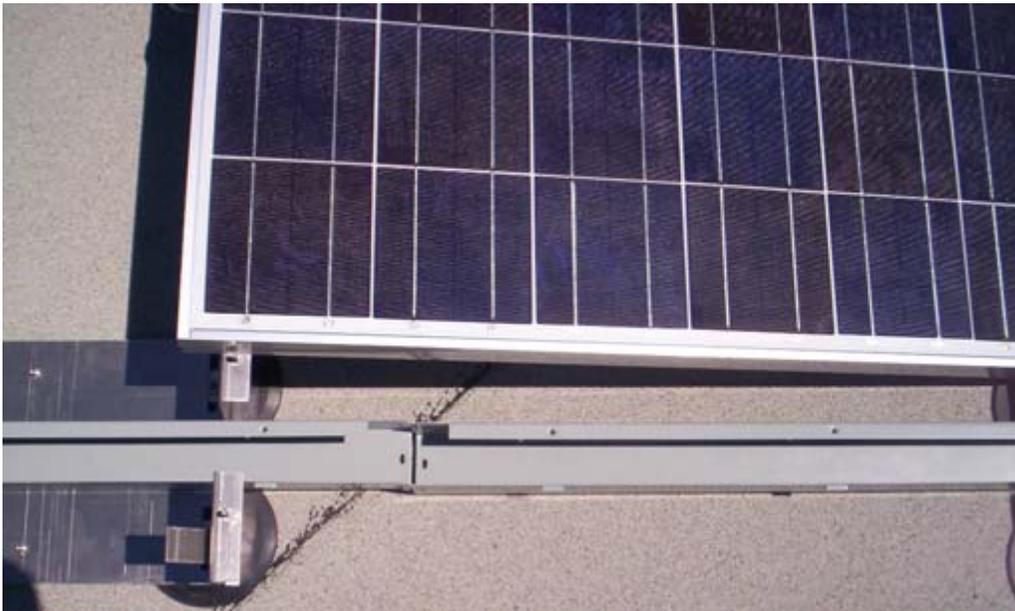
Figure 57: Wiring gutter during installation (designed changed after this installation)

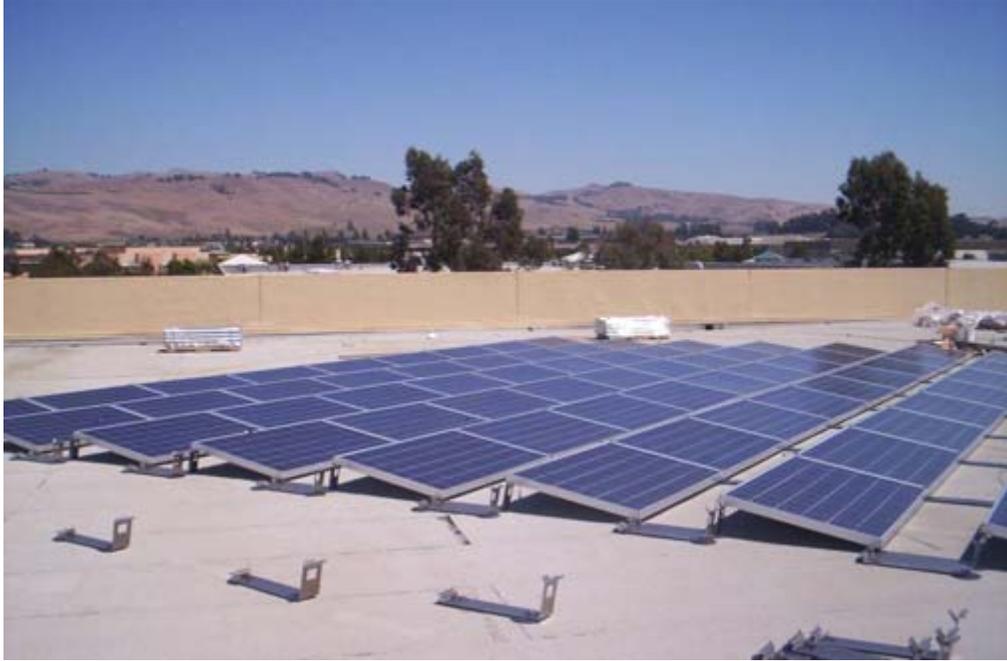
Figure 58: RFT10 system during installation

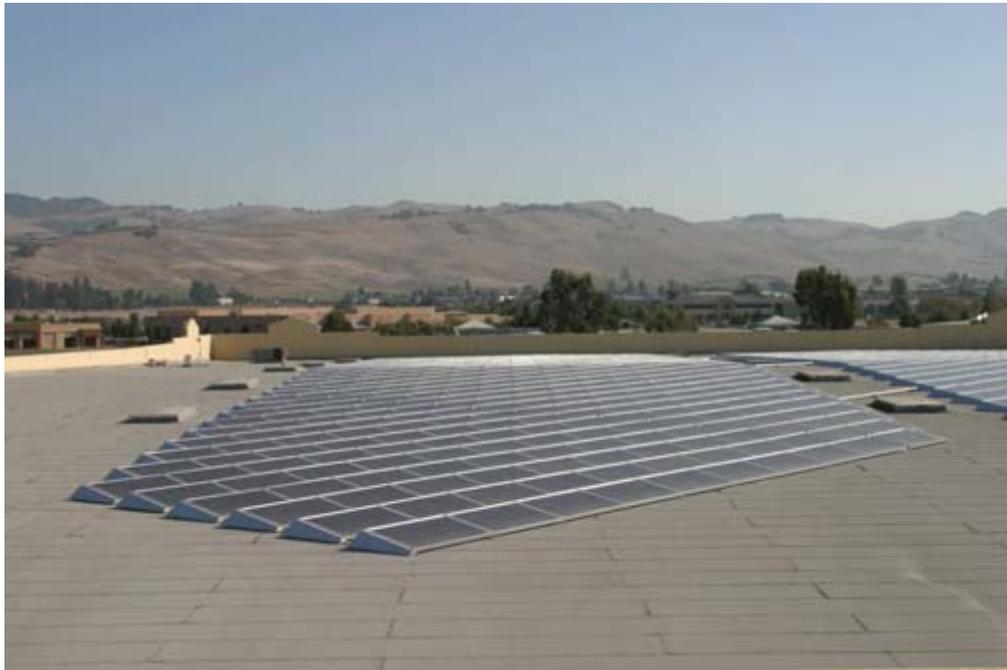
Figure 59: Completed array from Southeast

The installation of these systems took less labor than was anticipated, with the exception of the North-South wiring. After the crews had one or two days' of experience, they were able to assemble the array pieces very quickly. It took some experimentation to learn that the array alignment was easier to maintain if the modules were installed in North-South columns rather than working from East to West in rows. Figure 58 shows an array during installation. Figure 59 and Figure 60 show a completed array.

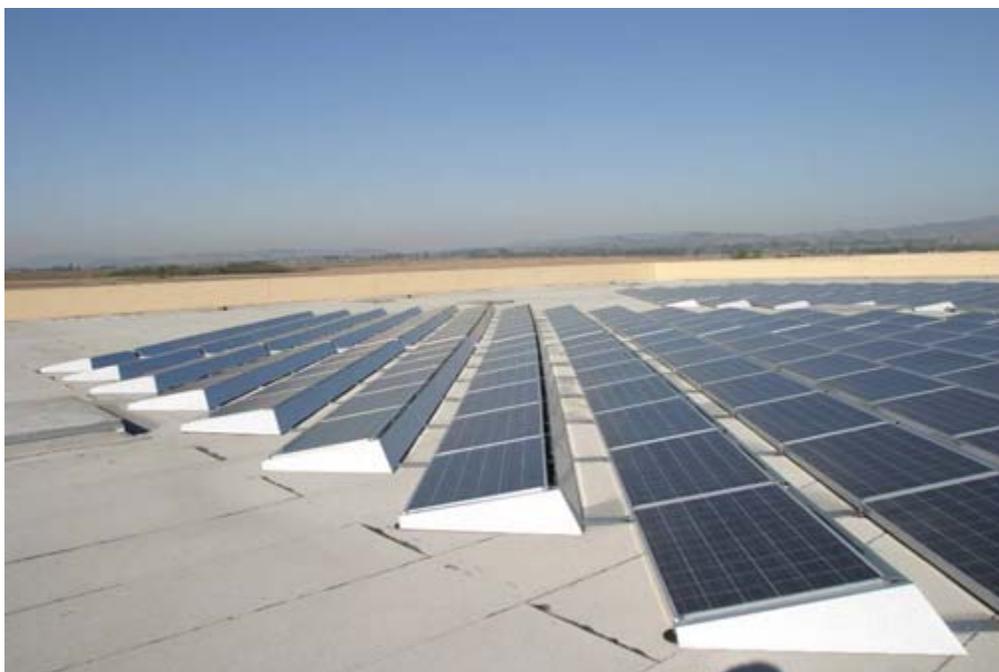
Figure 60: Completed array from East
