**Motorcoach Median
Crossover and Collision
With Sport Utility Vehicle
Hewitt, Texas
February 14, 2003**

NTSB/HAR-05/02

**NTSB/HAR-05/02
PB2005-916202
Notation 7727A
Adopted July 12, 2005**

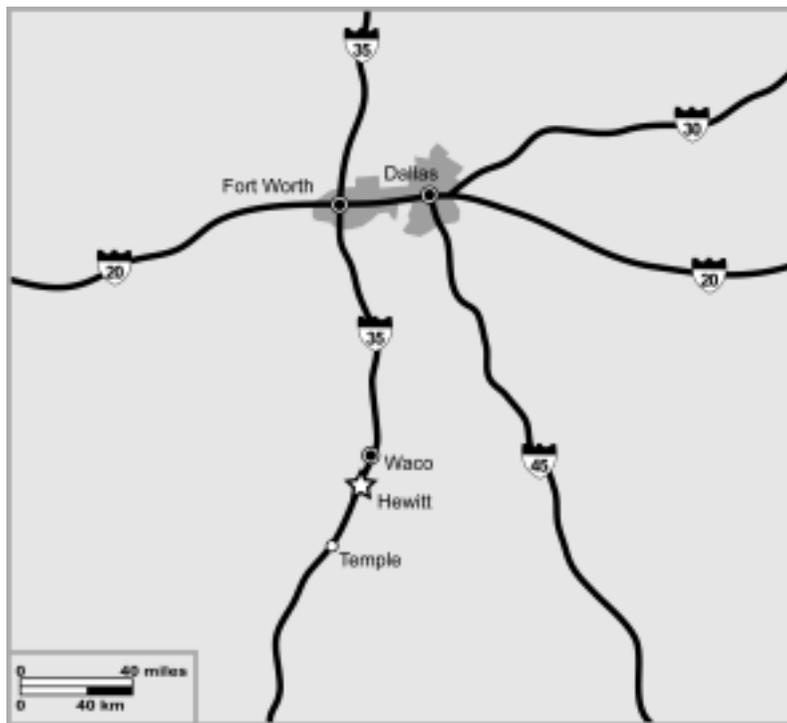
Figure 3. Accident location.

About 9:30 a.m., an accident had occurred on northbound I-35 at mile marker 328, causing traffic to back up on I-35. The backup extended to mile marker 326.3, where the 9:59 a.m. accident subsequently occurred.

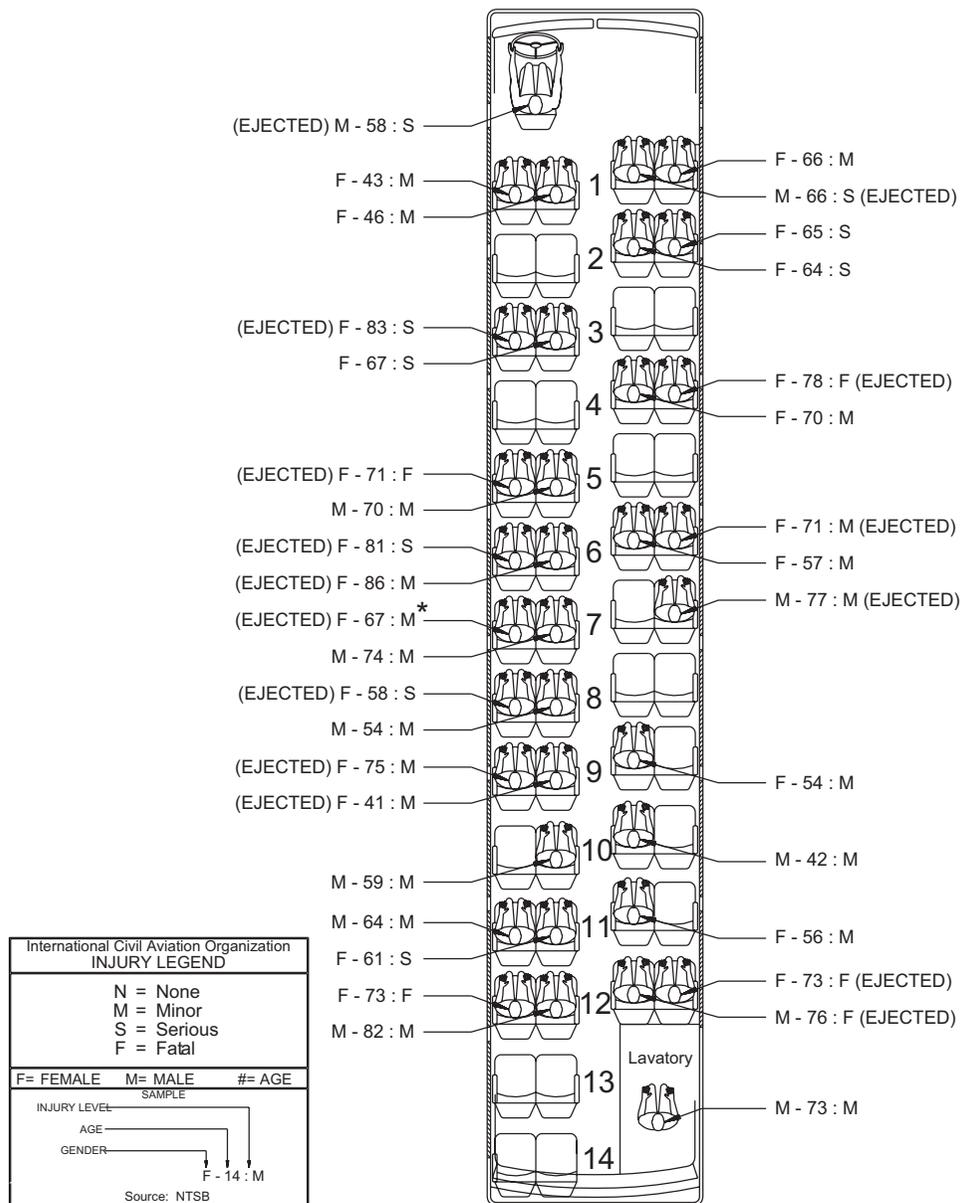
Figure 4. Seating diagram.

The driver of the motorcoach was ejected during the rollover and sustained serious injuries. He was not wearing the available lap/shoulder belt. Fourteen passengers in the motorcoach were either fully or partially ejected; one was ejected out of the front window, and the rest were ejected or fell through the broken windows on the right side of the motorcoach as it rolled over. Four of the ejected passengers sustained fatal injuries, and four sustained serious injuries. (See figure 4.) None of the passenger seats had restraints.

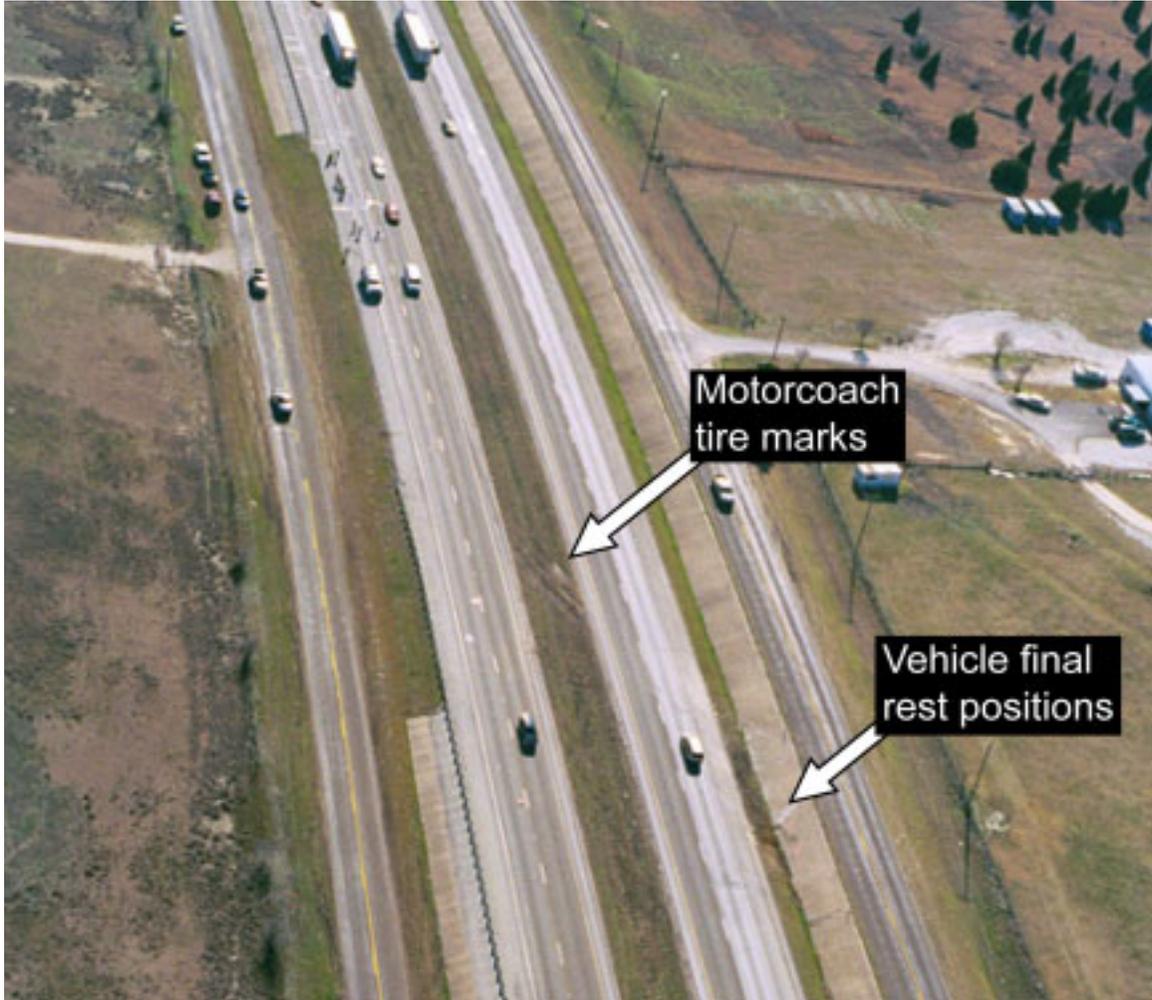
Figure 12. Accident location. (Source: Texas DPS)

The accident occurred on I-35 at mile marker 326.3 in McLennan County, Texas, approximately 5 miles south of the Waco city limit line. I-35 is a divided, two-way, four-lane urban principal arterial paved asphalt roadway bordered on either side by a two-way frontage road. A sloped Portland cement concrete wall separates the southbound lanes from the frontage road. The paved portion of both the north- and southbound roadways consists of one 10-foot-wide right (outside) shoulder, two 12-foot-wide travel lanes, and one 6-foot-wide left (inside) shoulder. The north- and southbound lanes are divided by a 28-foot-wide depressed earthen median, which did not contain a temporary or permanent barrier at the time of the accident. (See figure 12.) A crest vertical curve¹⁷ consisting of a 1.965 percent foreslope (uphill) and a -3.826 percent downslope (downhill) is located south of the accident site. The crest of the curve occurs about 158 feet before the motorcoach's first skid mark.
