Cape Lookout National Seashore
O'BOYLE - BRYANT HOUSE
**HISTORIC STRUCTURE
REPORT**

2004
Historic Structure Report
O'Boyle- Bryant House
CAPE LOOKOUT NATIONAL SEASHORE
Cape Lookout Village
LCS#: 271581

Historic Structure Report

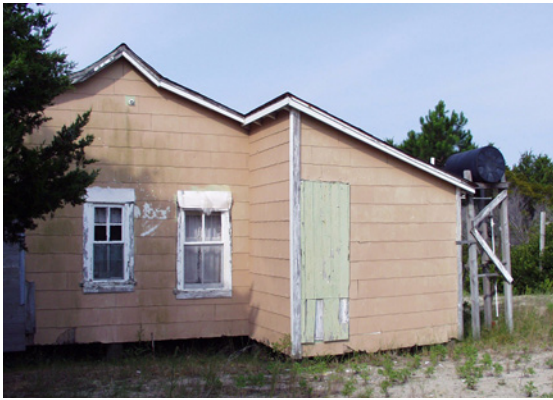
Figure 26 View of house from northeast showing bathroom addition. (NPS-SERO-CRS, 2002)

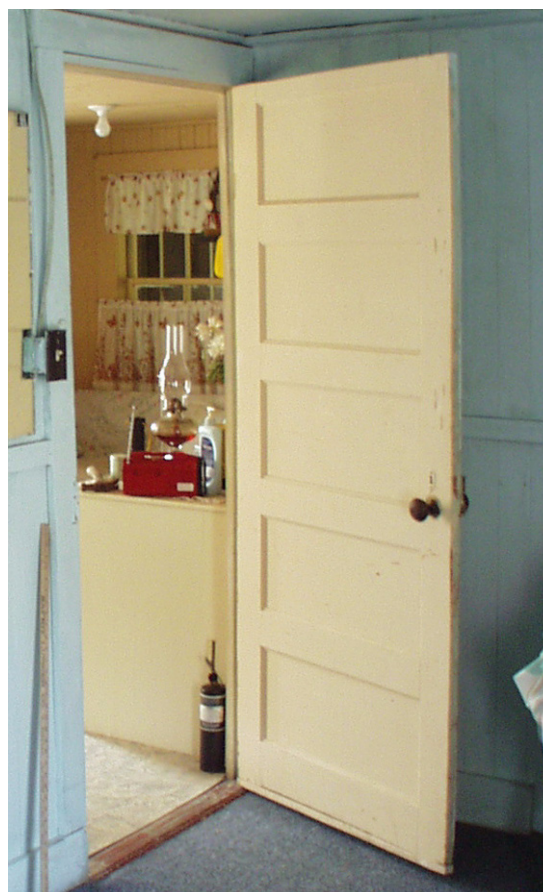
Figure 30 Five-panel door at Room 103. (NPS-SERO-CR, 2002)

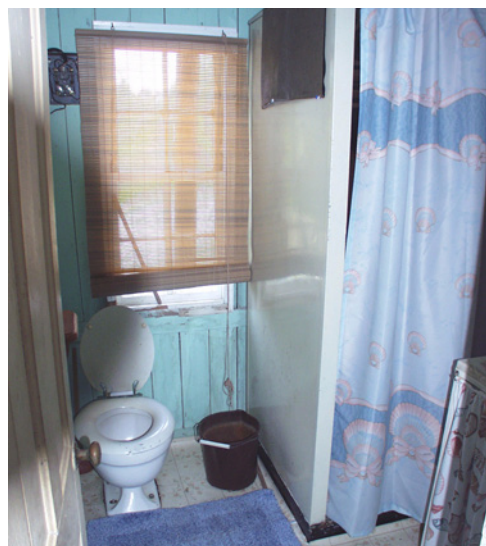
Figure 38 View of bathroom.
(NPS-SERO-CR, 2002)

Fixtures: In the north corner of the room is a metal shower enclosure, 32" by 32", apparently installed when the room was constructed. The toilet, which also appears to date to the room's original construction, is missing its tank and appears to be flushed using water from the metal water tank mounted on the wooden frame just outside the window. The original sink (if there was one) has been replaced by the present wooden cabinet with a modern, imitation marble sink.

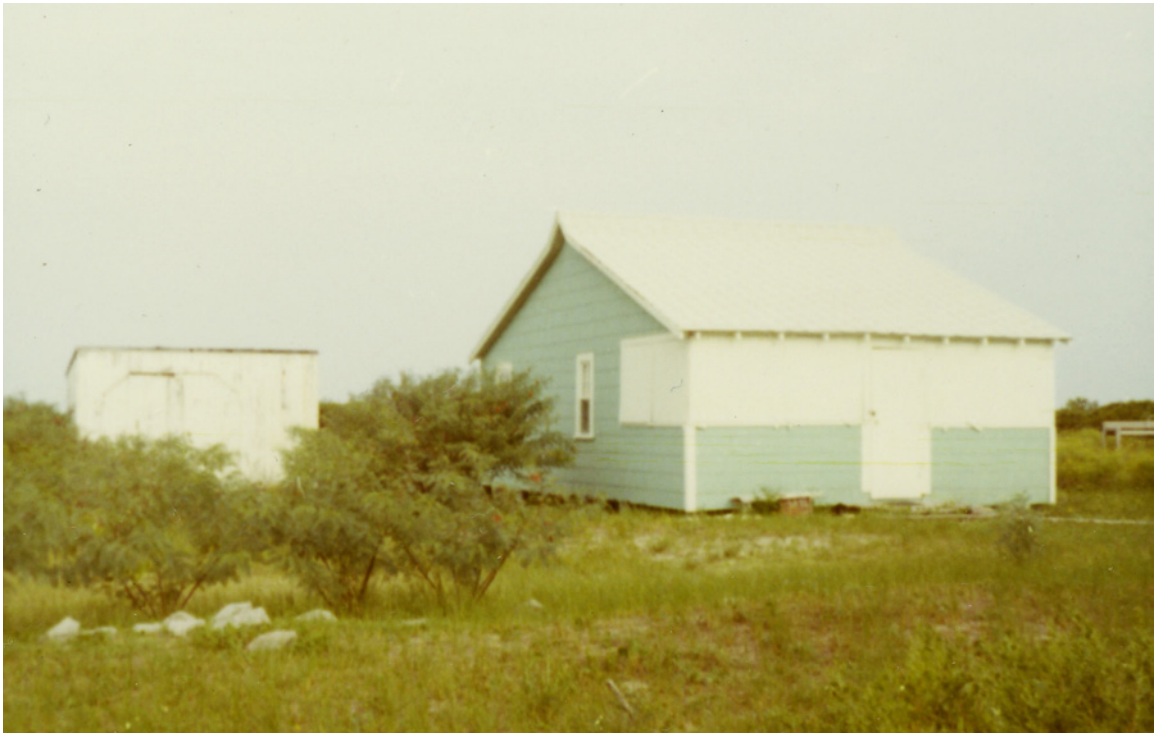
Figure 40 The goal of the proposed plan is a return of the house to its general appearance in this image, c. 1970, minus the asbestos siding. (CALO Coll., Phelps#6)

In many cases, sizing and spacing of historic and modern framing members do not meet modern code requirements, but the historic framing can be augmented without total replacement. In raising the building to replace foundation piles, additional beams can be installed to strengthen the floor system. Set on wooden piles, these should be run perpendicular to the joists in a manner similar to the support beam that already exists at mid-span of the original joists. Temporarily raising the building would also allow easier access for necessary repairs to termite or water damaged sills and, as noted above, to raise the grade

beneath the building to insure good drainage. It may also make possible improvements to the connection of the wall framing to the perimeter sills. Augmentation of the wall framing is not recommended since that would necessitate total removal of interior and/or exterior finishes, something which cannot be accomplished without significant damage to and loss of historic materials.
