# Failure Analysis of Sapphire Refractive Secondary Concentrators

Failure analysis was performed on two sapphire, refractive secondary concentrators(RSC) that failed during elevated temperature testing. Both concentrators failed from machining/handling damage on the lens face. The first concentrator, which failed during testing to 1300 °C, exhibited a large *r*-plane twin extending from the lens through much of the cone. The second concentrator, which was an attempt to reduce temperature gradients and failed during testing to 649 °C, exhibited a few small twins on the lens face. The twins were not located at the origin, but represent another mode of failure that needs to be considered in the design of sapphire components. In order to estimate the fracture stress from fractographic evidence, branching constants were measured on sapphire strength specimens. The fractographic analysis indicated radial tensile stresses of 44 to 65 MPa on the lens faces near the origins. Finite element analysis indicated similar stresses for the first RSC, but lower stresses for the second RSC. Better machining and handling might have prevented the fractures, however, temperature gradients and resultan

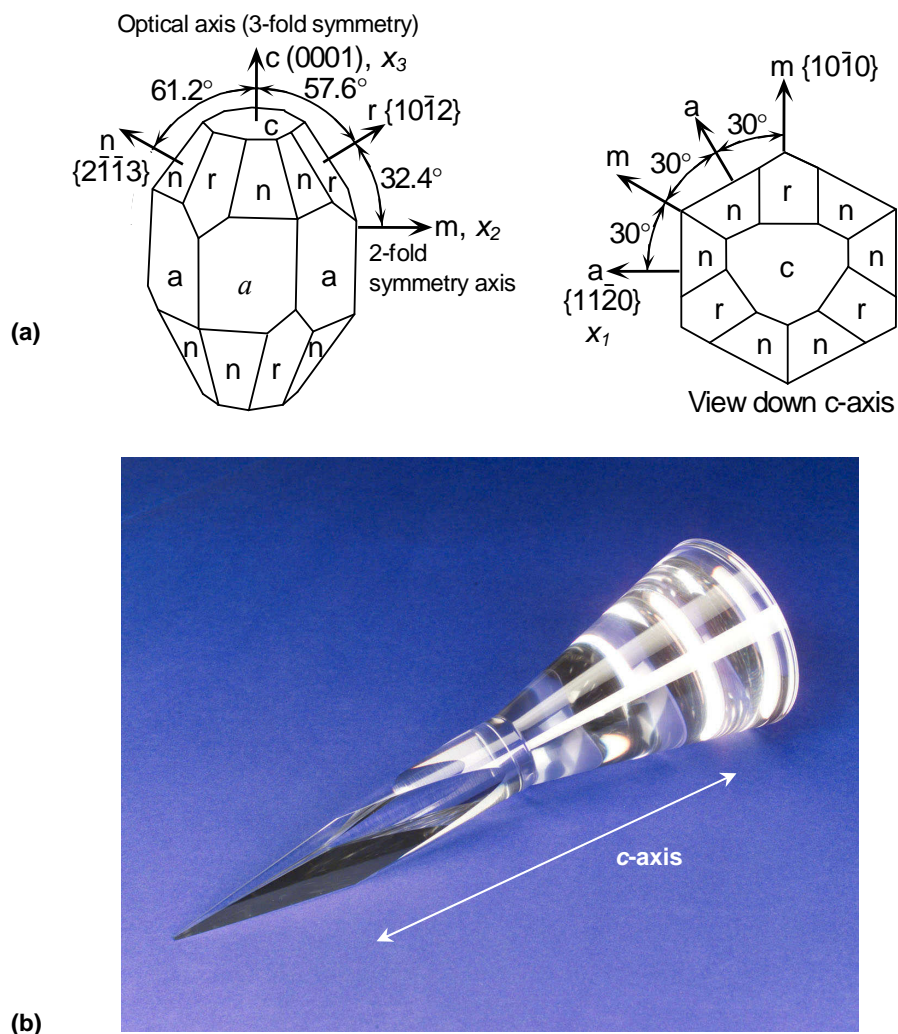
Figure 1.—(a) Sapphire crystal showing mineralogical and Miller index notation. The  $c$ -axis is a 3-fold symmetry axis, but sapphire is indexed as a hexagonal unit cell with  $c/a = 2.730$ ; and (b) sapphire concentrator prior to testing.

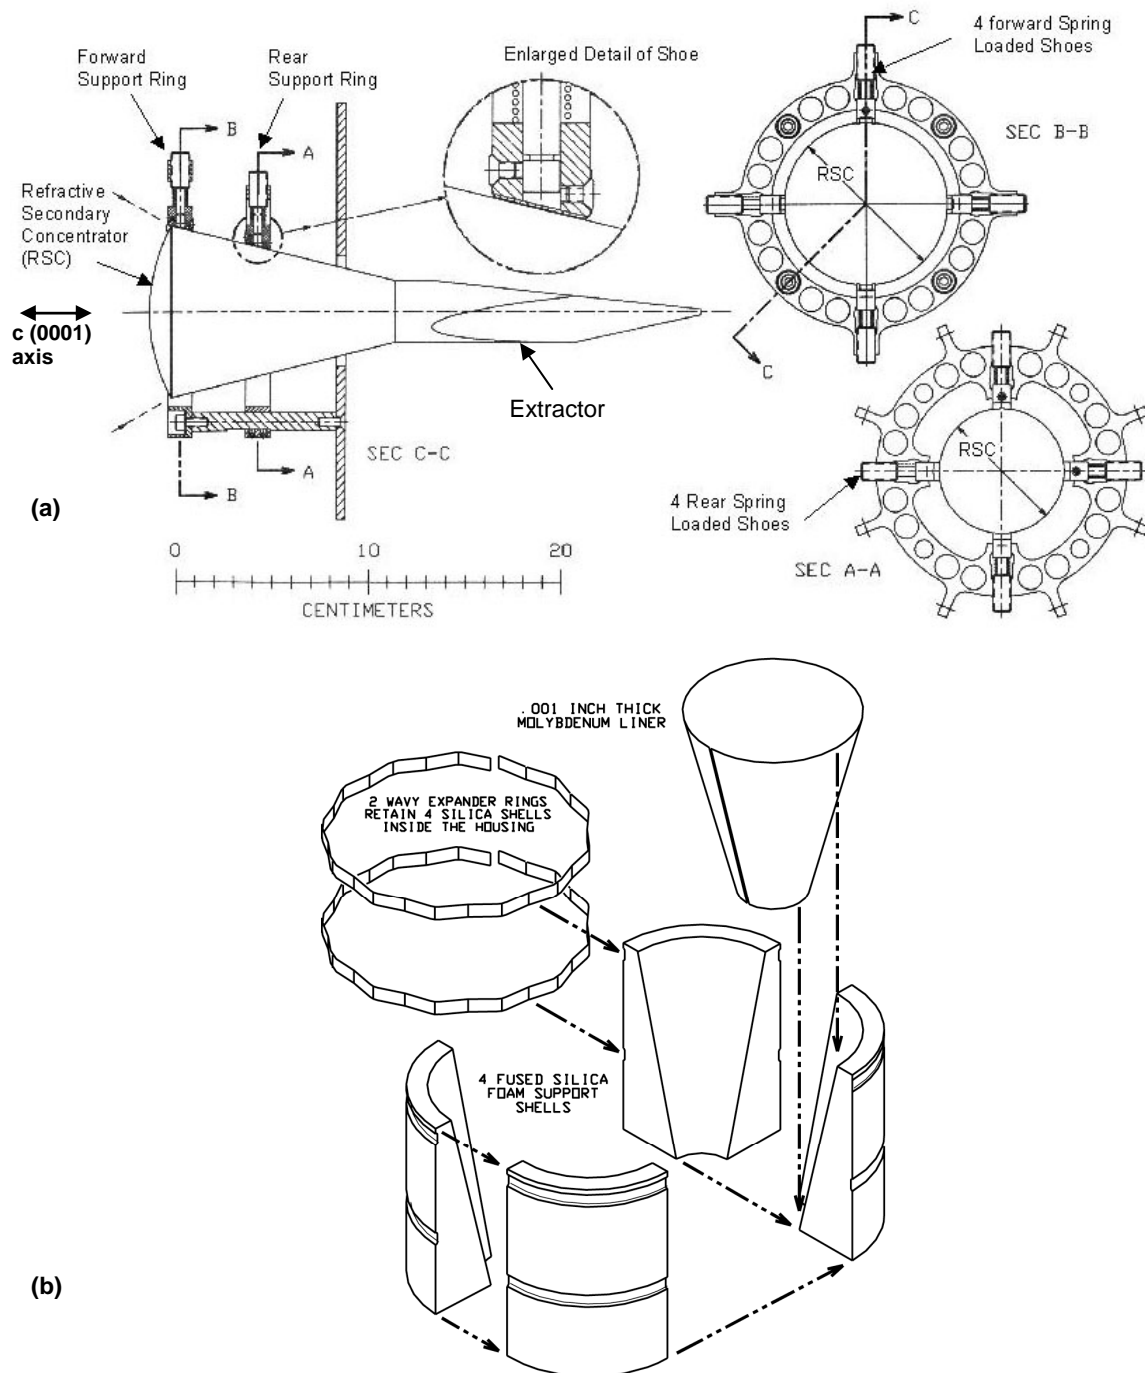
Figure 2.—Test assembly for (a) the first (exposed cone) and (b) the second (covered cone) RSCs.

On March 31, 2004, tests were performed with a new concentrator and holder that were designed to lower thermal gradients and minimize contact stresses. The new holder was made from a ceramic insulation fabricated to fit in a glove-like fashion around the RSC, with a molybdenum sheet between, as shown in Figure 2(b). In 2004 two tests were run—one test with an inflatable primary concentrator at a lower temperature and one at mid-temperature with the rigid primary concentrator and Re receiver. For the mid-temperature exposure the maximum receiver temperature was approximately 649 °C (922 °K) and the front shoe temperature was approximately 438 °C (711 °K). The crystal again failed. The temperature at failure was one-half of that in the first test, despite the use of more insulation and a lower temperature gradient. Figure 6 shows RSC no. 2 after removal from the test rig.

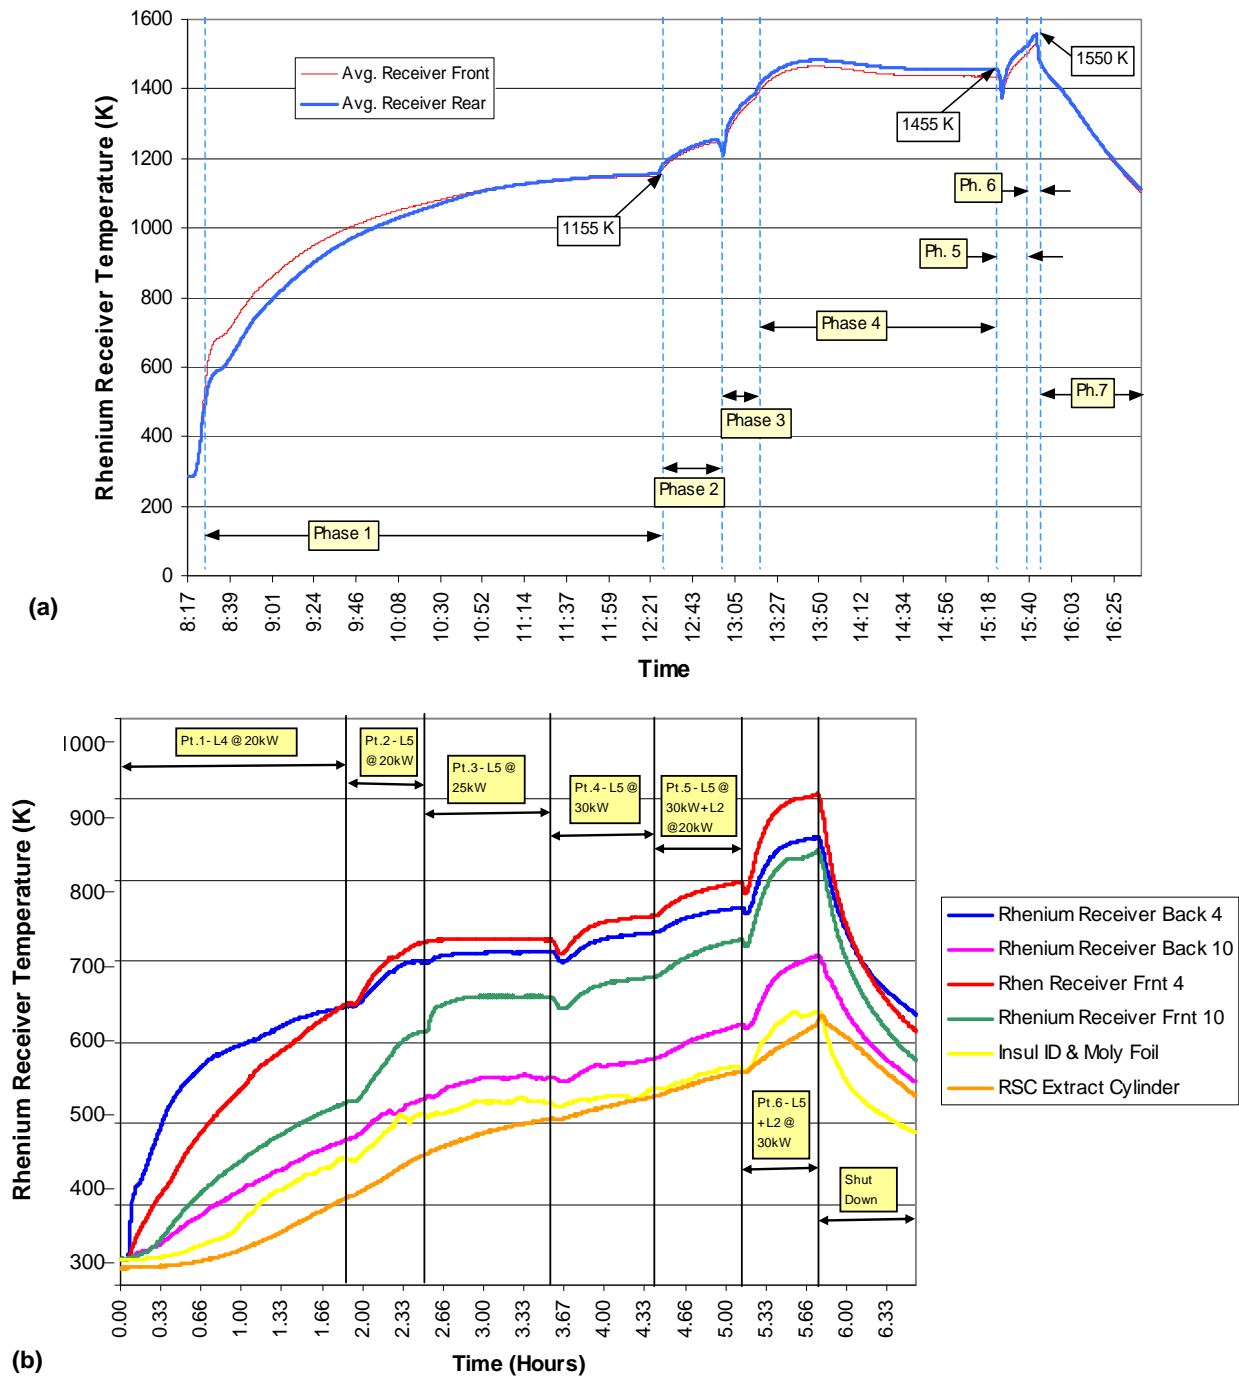
Figure 4.—Average temperature profiles of (a) the first RSC and (b) the second RSC. The dips at the start of phases 3 and 5 are due to short periods in which the solar simulator shutter was closed to allow ignition of additional lamps.

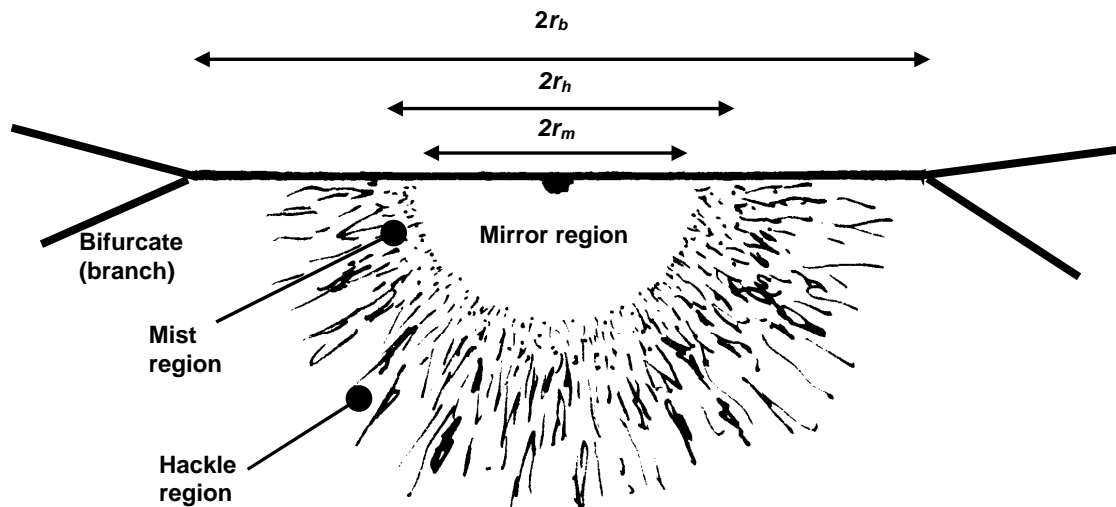
where  $\sigma_f$  is the remote fracture stress and  $A_j$  is a particular constant corresponding to a particular boundary with radius  $r_j$ , where  $j$  is  $m$ ,  $h$ , or  $b$  for mirror, hackle or branching as shown in Figure 29, which shows an idealized schematic for a surface flaw. Equation 1 is valid for uniform steady state stress fields.

Figure 29.—Idealized regions and boundaries formed around a failure origin on the surface of a part that was exposed to uniform tension stress. The distance  $r_m$  is the radius of the boundary for the onset of mist, the distance  $r_h$  is the radius of the boundary for the onset of hackle, and the distance  $r_b$  is the radius of the boundary for the onset of branching. Problems in interpreting single crystal fracture mirror markings often force one to use the branching distance for quantitative stress estimates.

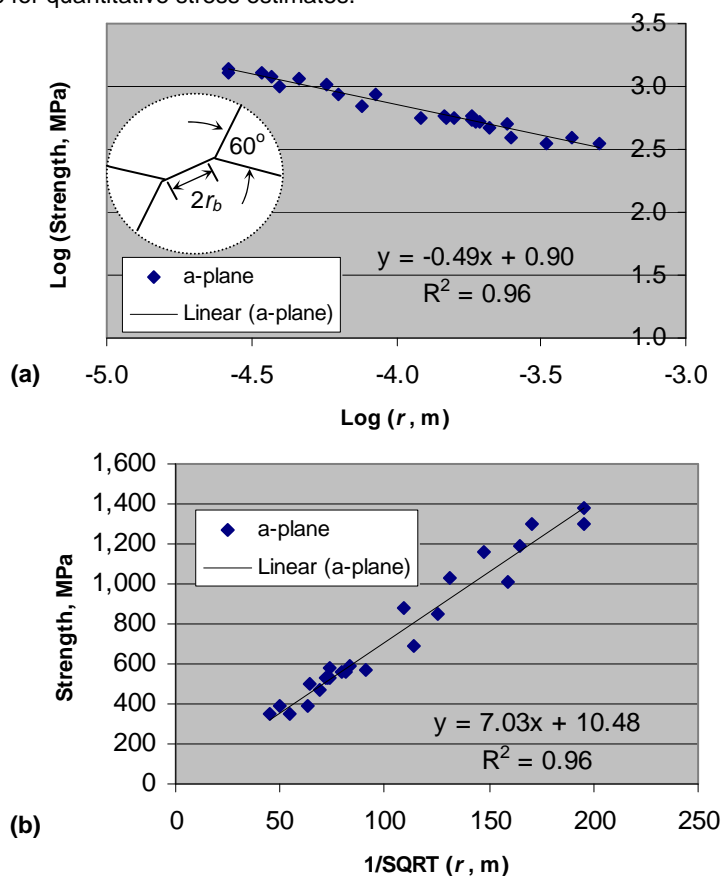
where  $\sigma_{th}$  is interpreted as either a threshold stress for branching or a residual stress (Refs. 7 and 13). Equations 1 to 3 yield  $A_b$  of  $7.2 \pm 0.6$ ,  $7.9 \pm 1.5$ , and  $7.0 \pm 0.3 \text{ MPa}\sqrt{\text{m}}$  for the sapphire respectively, with  $M = -0.49$  and  $\sigma_{th} = 11 \text{ MPa}$ , as shown in Figure 30. These results compare well with those in (Ref. 7), implying a relatively constant value for alumina. The presence of a slight residual stress is not surprising, considering the grinding damage observed on the specimens via X-ray topography (Ref. 8), but this would be very shallow. During measurement of the branch lengths, several specimens were observed to exhibit fracture on the  $r$ -plane and bifurcation onto another  $r$ -plane. When the principal stresses were resolved on the  $r$ -plane, similar  $A_b$  resulted.

Figure 30.—Room temperature fracture strength as a function of branching length for the a-plane of sapphire tested in four-point flexure: (a) fit to Equation (2) and (b) fit to Equation (3). Strength data from Reference 8.

Assuming that the room temperature fracture constants are applicable, the 44 mm bifurcation distance used with Equation (3) implies a stress of only ~44 MPa. This is much less than the 250 MPa or larger strengths exhibited by well polished sapphire tested at low temperatures (Ref. 8). This very low stress estimate is consistent with the observation that the contact crack origin was moderately large. Large cracks require very little stress to trigger fracture.

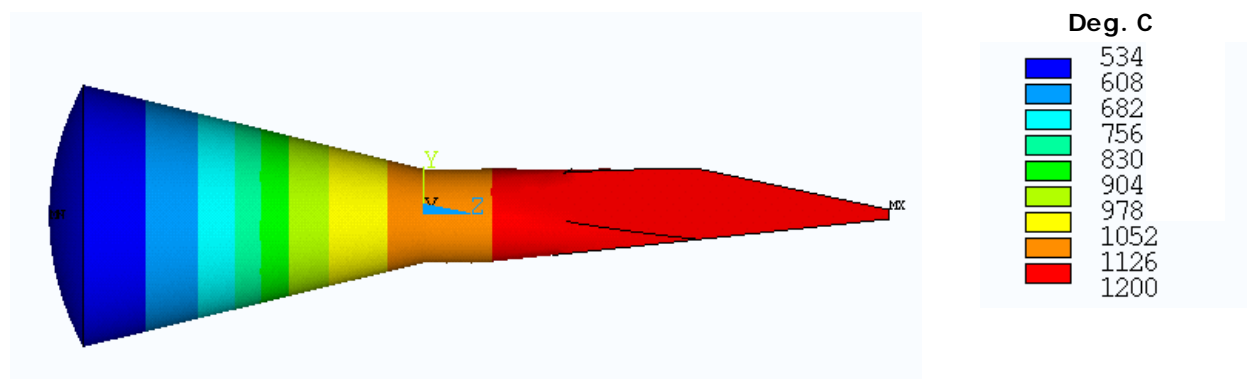
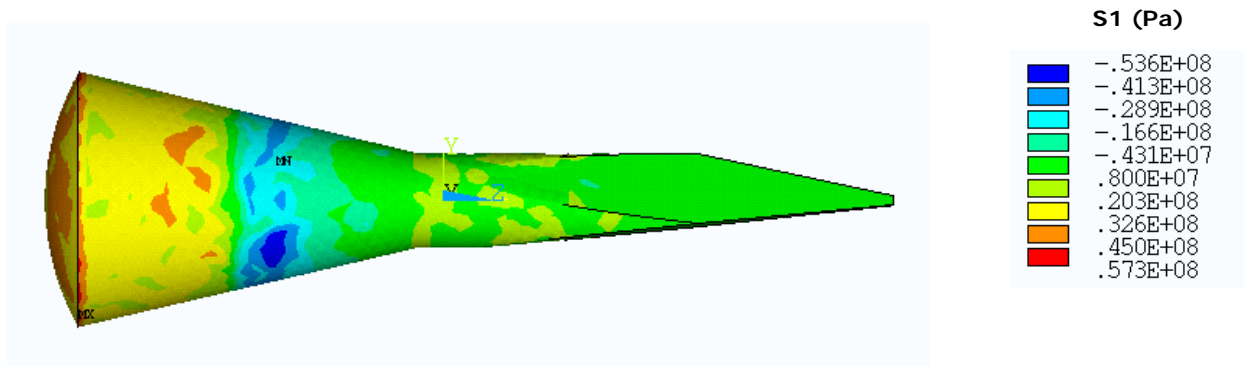
In order to understand the stress state in the RSC and design better RSC systems, finite element analyses were performed by using the single crystal thermal and elastic constants (Ref. 14). The resulting thermal and stress profiles are shown in Figures 31 and 32 for the first concentrator and indicate a maximum principal tensile stress of 57 MPa at the rim of the front lens face of the concentrator where the  $a$ - and  $m$ -axes exit, near the actual failure. This is in reasonable agreement with the value of 44 MPa based on fractographic measurement.

As noted previously, the radial cracking suggests that tensile hoop stresses at the rim caused fracture in both concentrators. The origins were also located near the rims, where shielding and clamping may alter the temperature profiles relative to those estimated by the FEA analyses based upon the assumed boundary conditions. Better modeling with more realistic boundary conditions may give improved stress estimates in the front face rim regions.

Figure 31.—Temperature distribution in sapphire crystal for receiver temperature of 1200 °C with exposed cone design.

Figure 32.—First principal stress distribution in sapphire crystal for receiver temperature of 1200 °C with exposed cone design. Stress results are in Pa.

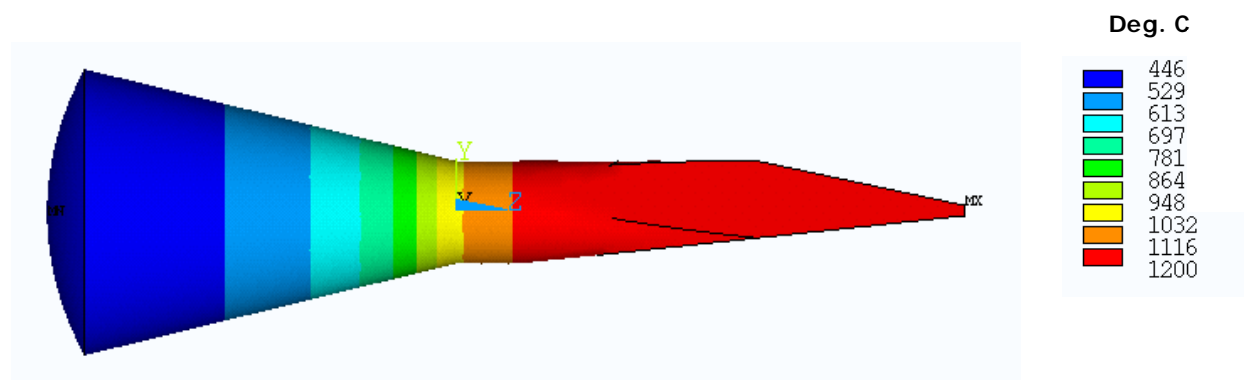
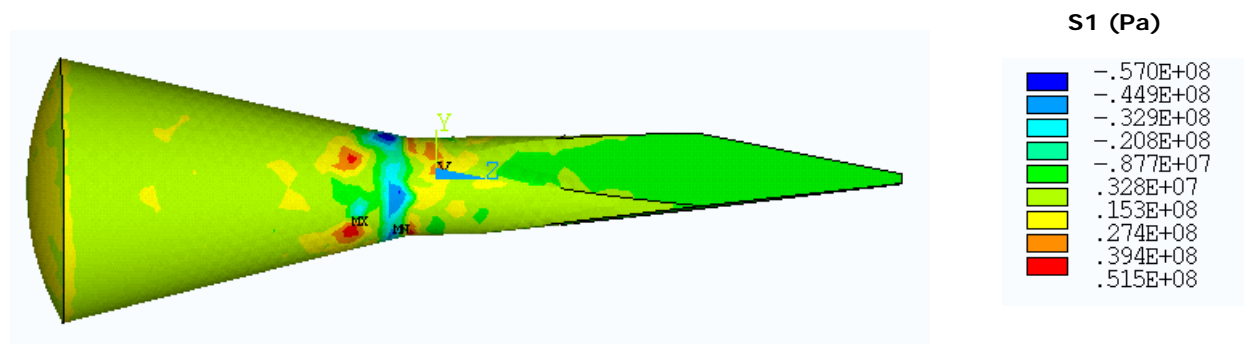
For the second concentrator, FEA modeling (covered cone design, 1200 °C) shown in Figures 33 and 34 indicates somewhat lower tensile stress of about 20 to 25 MPa on the lens face. Peak stresses up to 52 MPa occur just before the transition from the lens cone to the extractor rod.

Figure 33.—Temperature distribution in sapphire crystal for covered cone design with a receiver temperature of 1200 °C.

Figure 34.—First principal stress distribution in sapphire crystal for receiver temperature of 1200 °C with covered cone design. Stress results are in Pa.

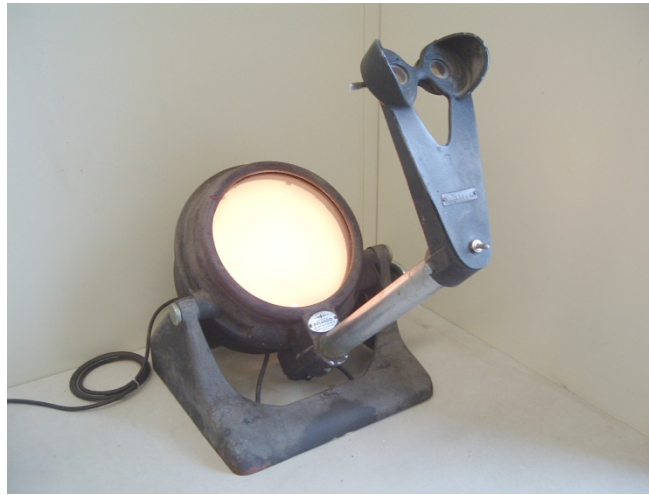
Figure A1.—Classic style Polariscope. (a) The component is placed between the polarizer eyepieces and the illuminated polarizing screen. (b) is a picture of piece 1 of concentrator 1. The photo was taken by a digital camera focused through one eyepiece. The very large twin appears as a light colored band running diagonally through the piece (white arrows). It is not a fracture plane.

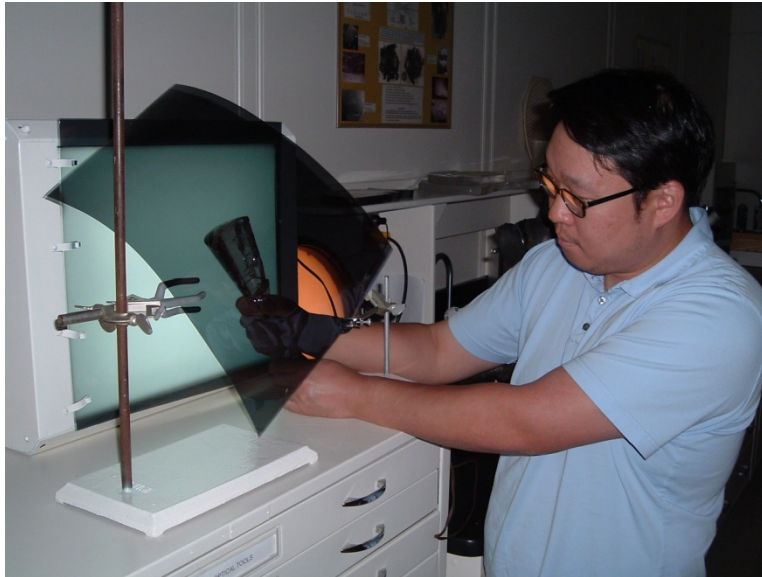
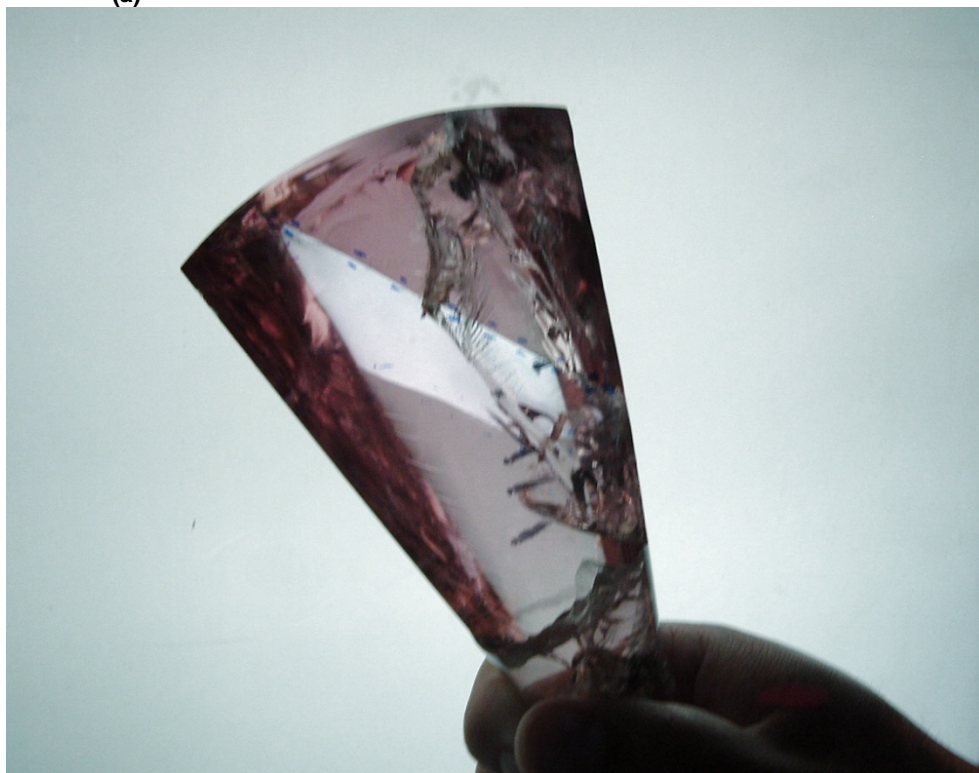
Figure A2.—An improvised Polariscope examination device. (a) shows a common light box is with two polymer polarizing sheets. One is clipped to the light box, the other is held by a clamp on the post in the foreground. Piece 1 of concentrator 1 is placed in between and rotated about. (b) shows a photo of the twin.
