NATIONAL TRANSPORTATION SAFETY BOARD

HAZARDOUS MATERIALS ACCIDENT REPORT

RUPTURE OF A RAILROAD TANK CAR
CONTAINING HAZARDOUS WASTE
NEAR CLYMERS, INDIANA
FEBRUARY 18, 1999

**NTSB/HZM-01/01
DCA99MZ004
PB2001-917002
Notation 7329
Adopted March 5, 2001**

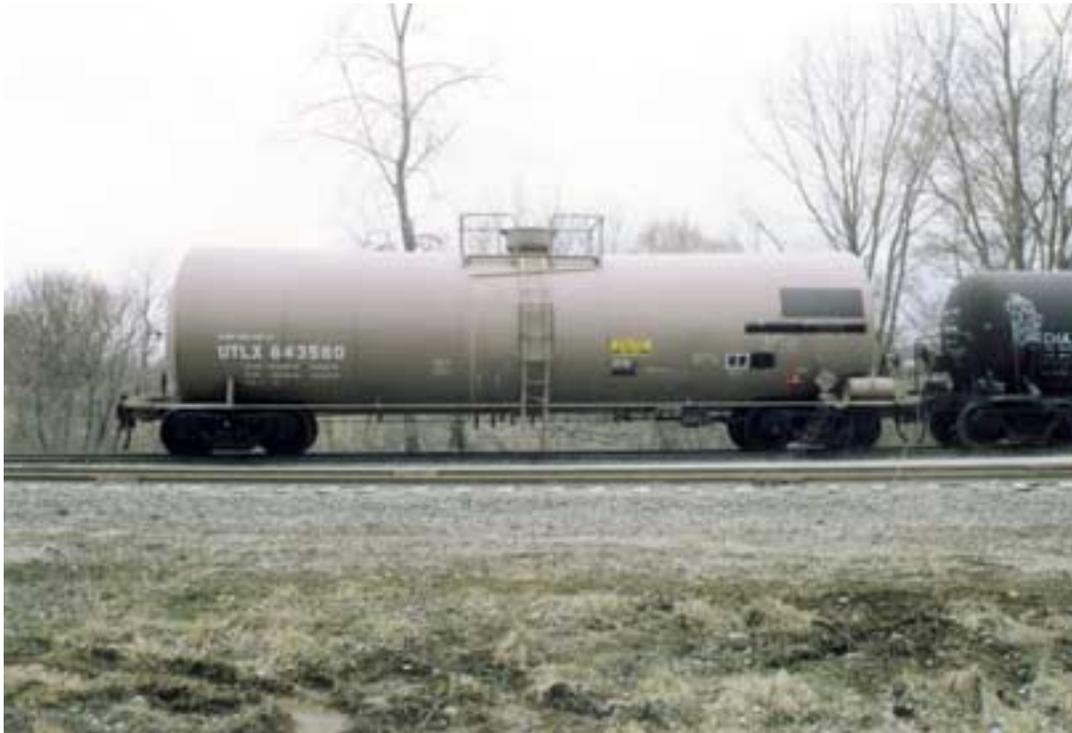
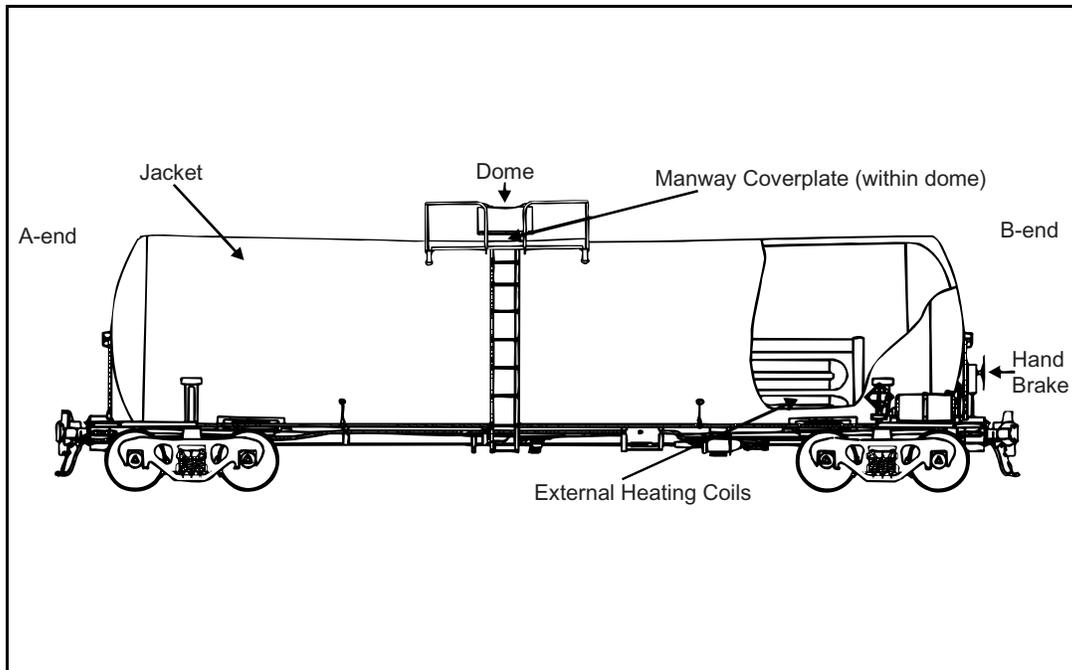
Figure 3. Photo and diagram showing tank cars of same design as UTLX 643593. (NTSB)

Railroad tank car UTLX 643593 (see figure 3) was loaded on October 1, 1993, with approximately 161,700 pounds (14,185 gallons) of a TDI mixture designated as "TDI matter waste" at the then-Olin Corporation (Olin) plant in Lake Charles, Louisiana. The loaded tank car remained in storage at the Lake Charles plant until March 31 or April 1, 1998, when it was shipped to the Essroc cement plant, near the towns of Clymers and Logansport in north-central Indiana.³ At Essroc, the TDI matter waste was to be used as a fuel for the plant's kilns. UTLX 643593 was interchanged at the rail yard in Logansport on April 20, 1998.

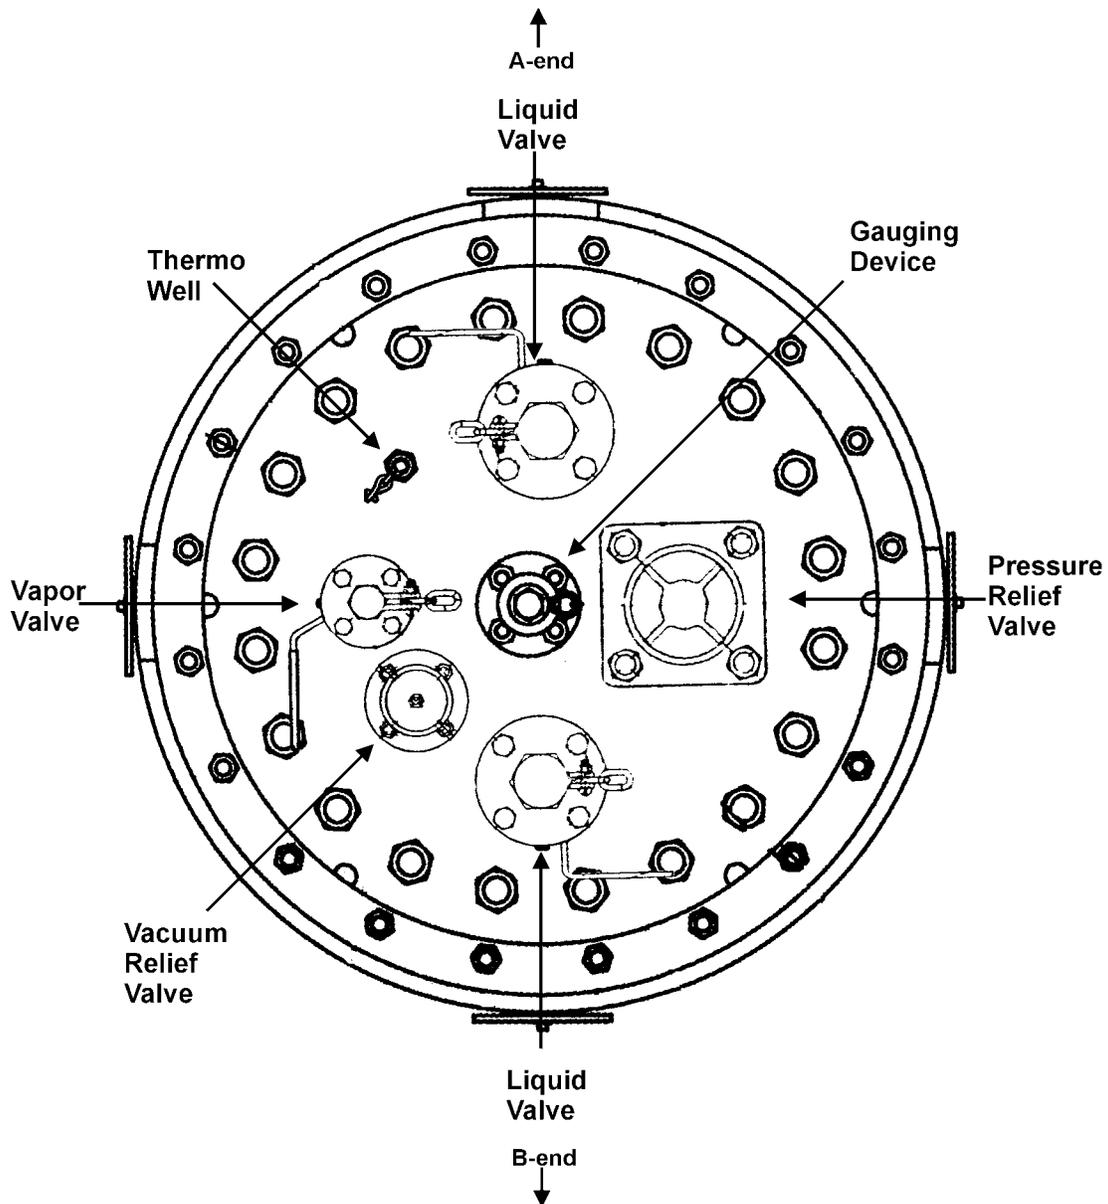
Figure 8. Fittings on UTLX 643593 manway coverplate. (NTSB)

All seven valves/fittings on the top of the tank car were mounted on a pressure manway plate, which was bolted to the tank and enclosed in the type of housing used on pressure tank cars that transport liquefied compressed gases. The seven fittings mounted on the manway plate comprised a valve for each of the two liquid loading/offloading lines, the valve to the tank's vapor space, the pressure relief valve, the vacuum relief valve, the gauging device, and the thermometer well. (See figure 8.)

The pressure relief valve had been made by the Midland Manufacturing Corporation (Midland). The Midland model A-1479 pressure relief valve had a start-to-discharge pressure of 75 psig. The rated flow capacity of the pressure relief valve was 2,027 cubic feet per minute (cfm). (The DOT minimum flow capacity for this design of tank car was 166 cfm.) The O-rings and gaskets for the pressure relief valve were of ethylene propylene rubber and Teflon, respectively.
