UNITED STATES
DEPARTMENT OF LABOR
MINE SAFETY AND HEALTH ADMINISTRATION
COAL MINE SAFETY AND HEALTH

REPORT OF INVESTIGATION
Underground Coal Mine
Nonfatal Entrapment
July 24, 2002

Quecreek #1 Mine, ID No. 36-08746
Black Wolf Coal Company, Inc.
Quecreek, Somerset County, Pennsylvania

RELEASE DATE: August 12, 2003

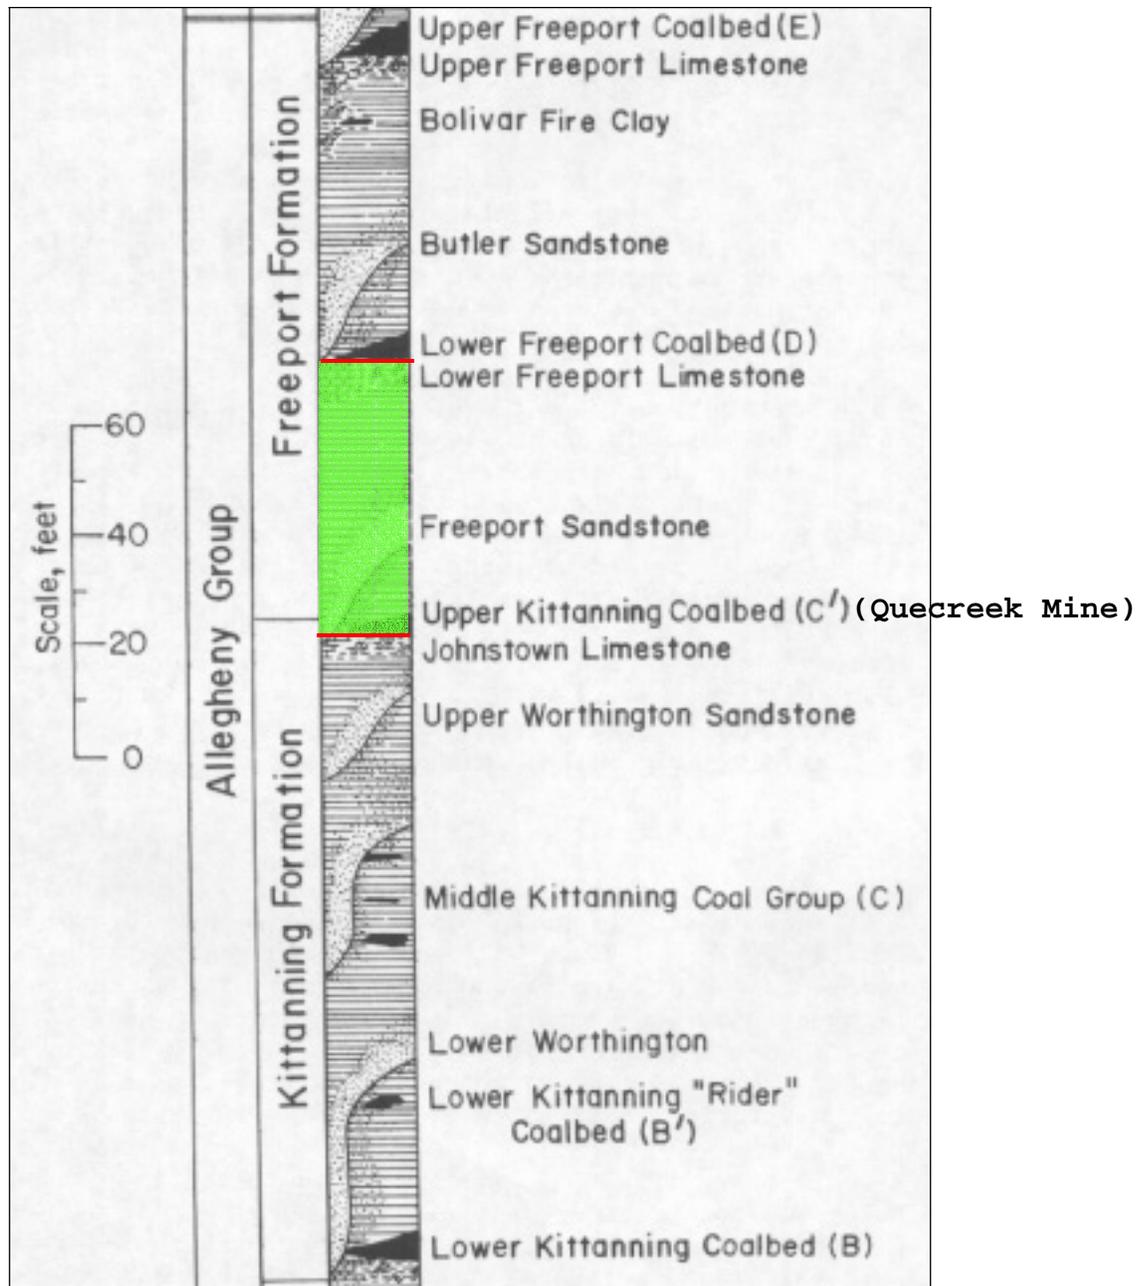
Figure 1. Stratigraphic column of the Middle Pennsylvanian-aged Allegheny Group, showing thickness of rock units in the Kittanning and Freeport Formations. Shaded area represents interburden between the Upper Kittanning coal seam, where Queecreek #1 mine is developed, and the overlying Lower Freeport coal seam. Modified From Iannacchione, A.T., Ulery, J.P., Hyman, D.M., and Chase, F.E., 1981, Geologic Factors in Predicting Coal Mine Roof-Rock Stability in the Upper Kittanning Coal bed, Somerset County, PA: U.S. Bureau of Mines, RI 8575.

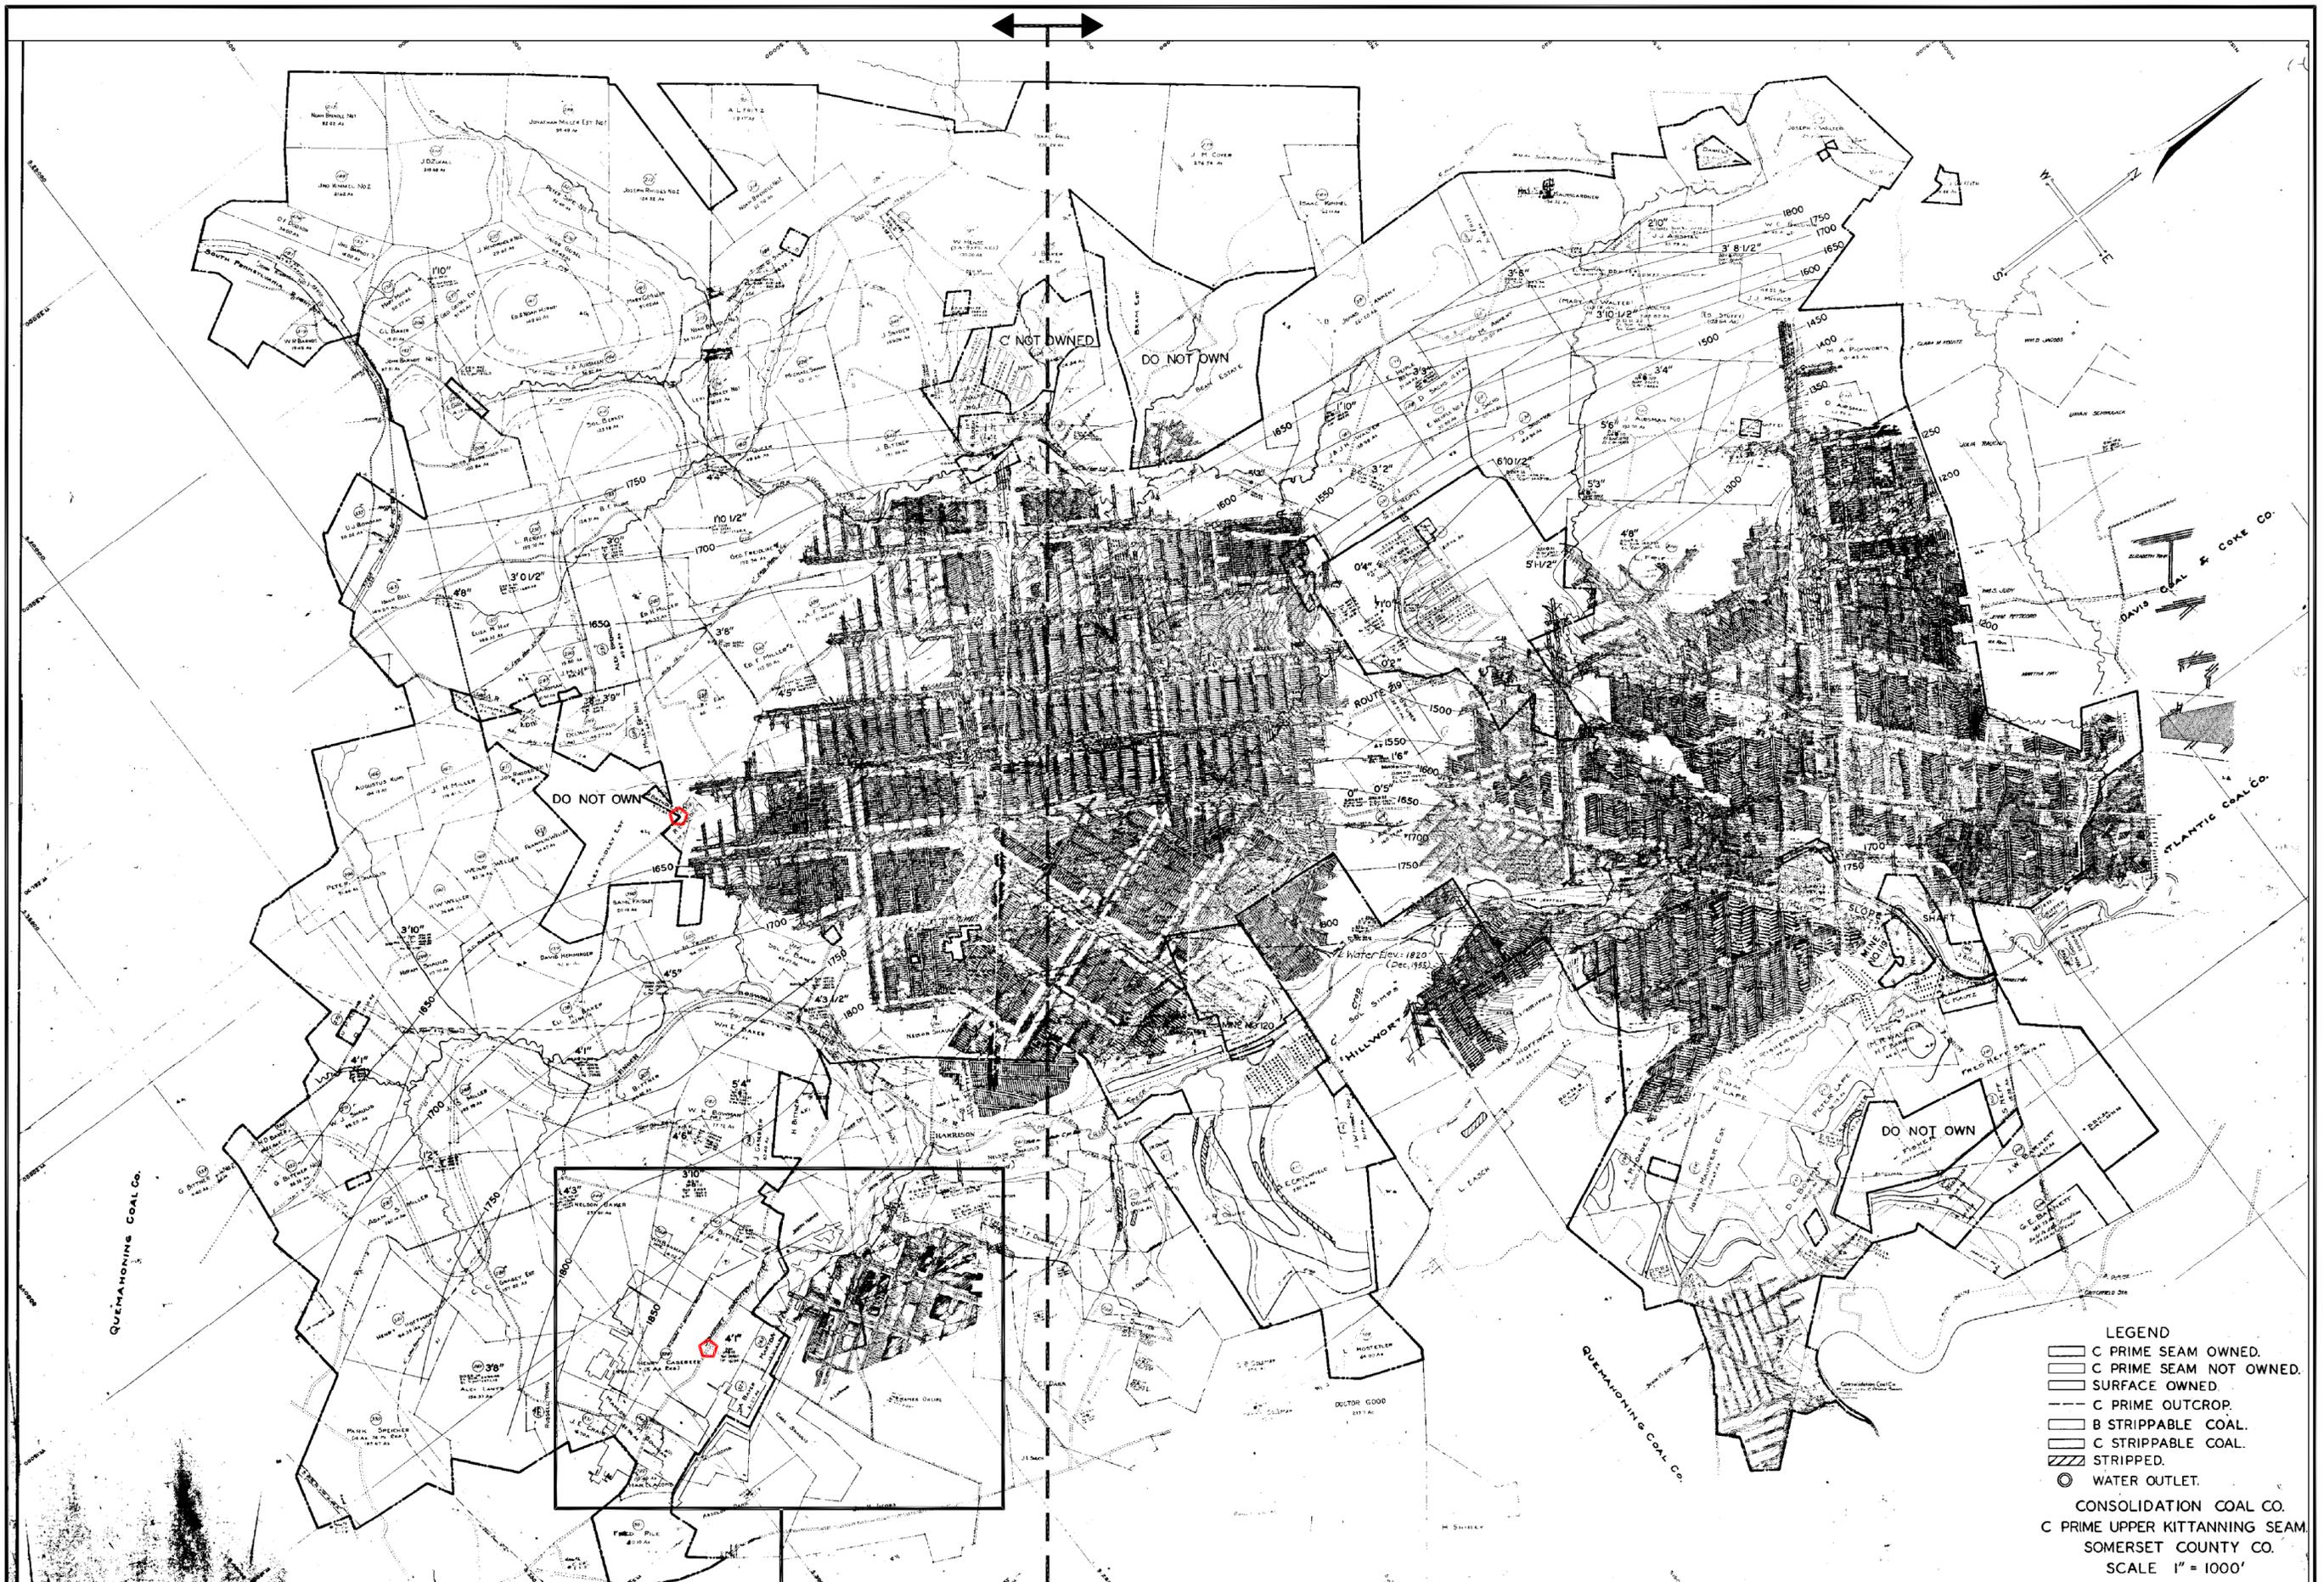
Map 14
Consolidation Coal Company
Property Map
 Map Reproduced From Scanned Image. Not to scale.

Area of Harrison No.2 Mine
(See Appendix G, Map 15)
