Intensity Distribution and Iseismal Maps for the Nisqually, Washington, Earthquake of 28 February 2001

Open-File Report 02-346

2002

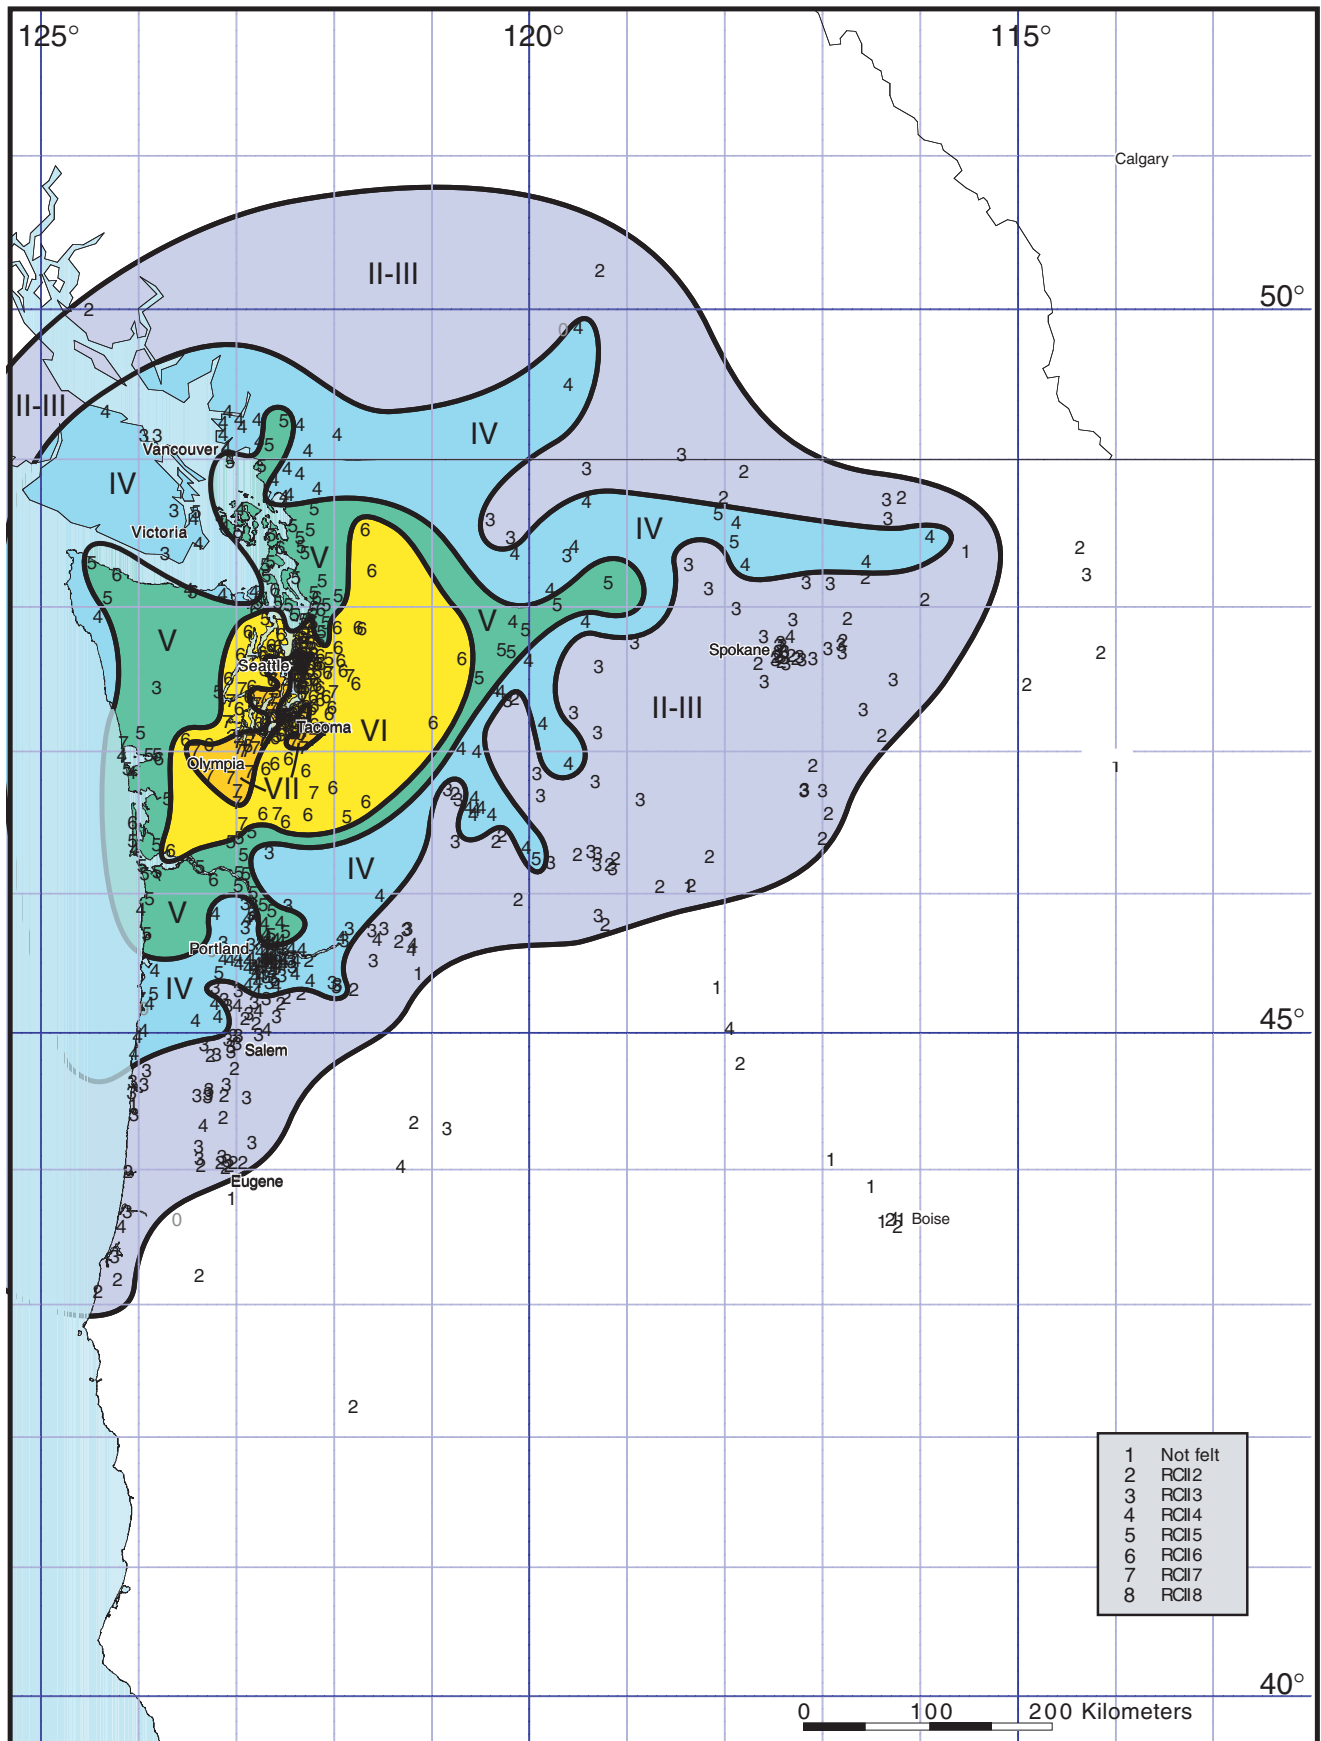
Figure 1. Far-field isoseismal map and Reviewed Community Internet Intensities (RCII) for the Nisqually earthquake.

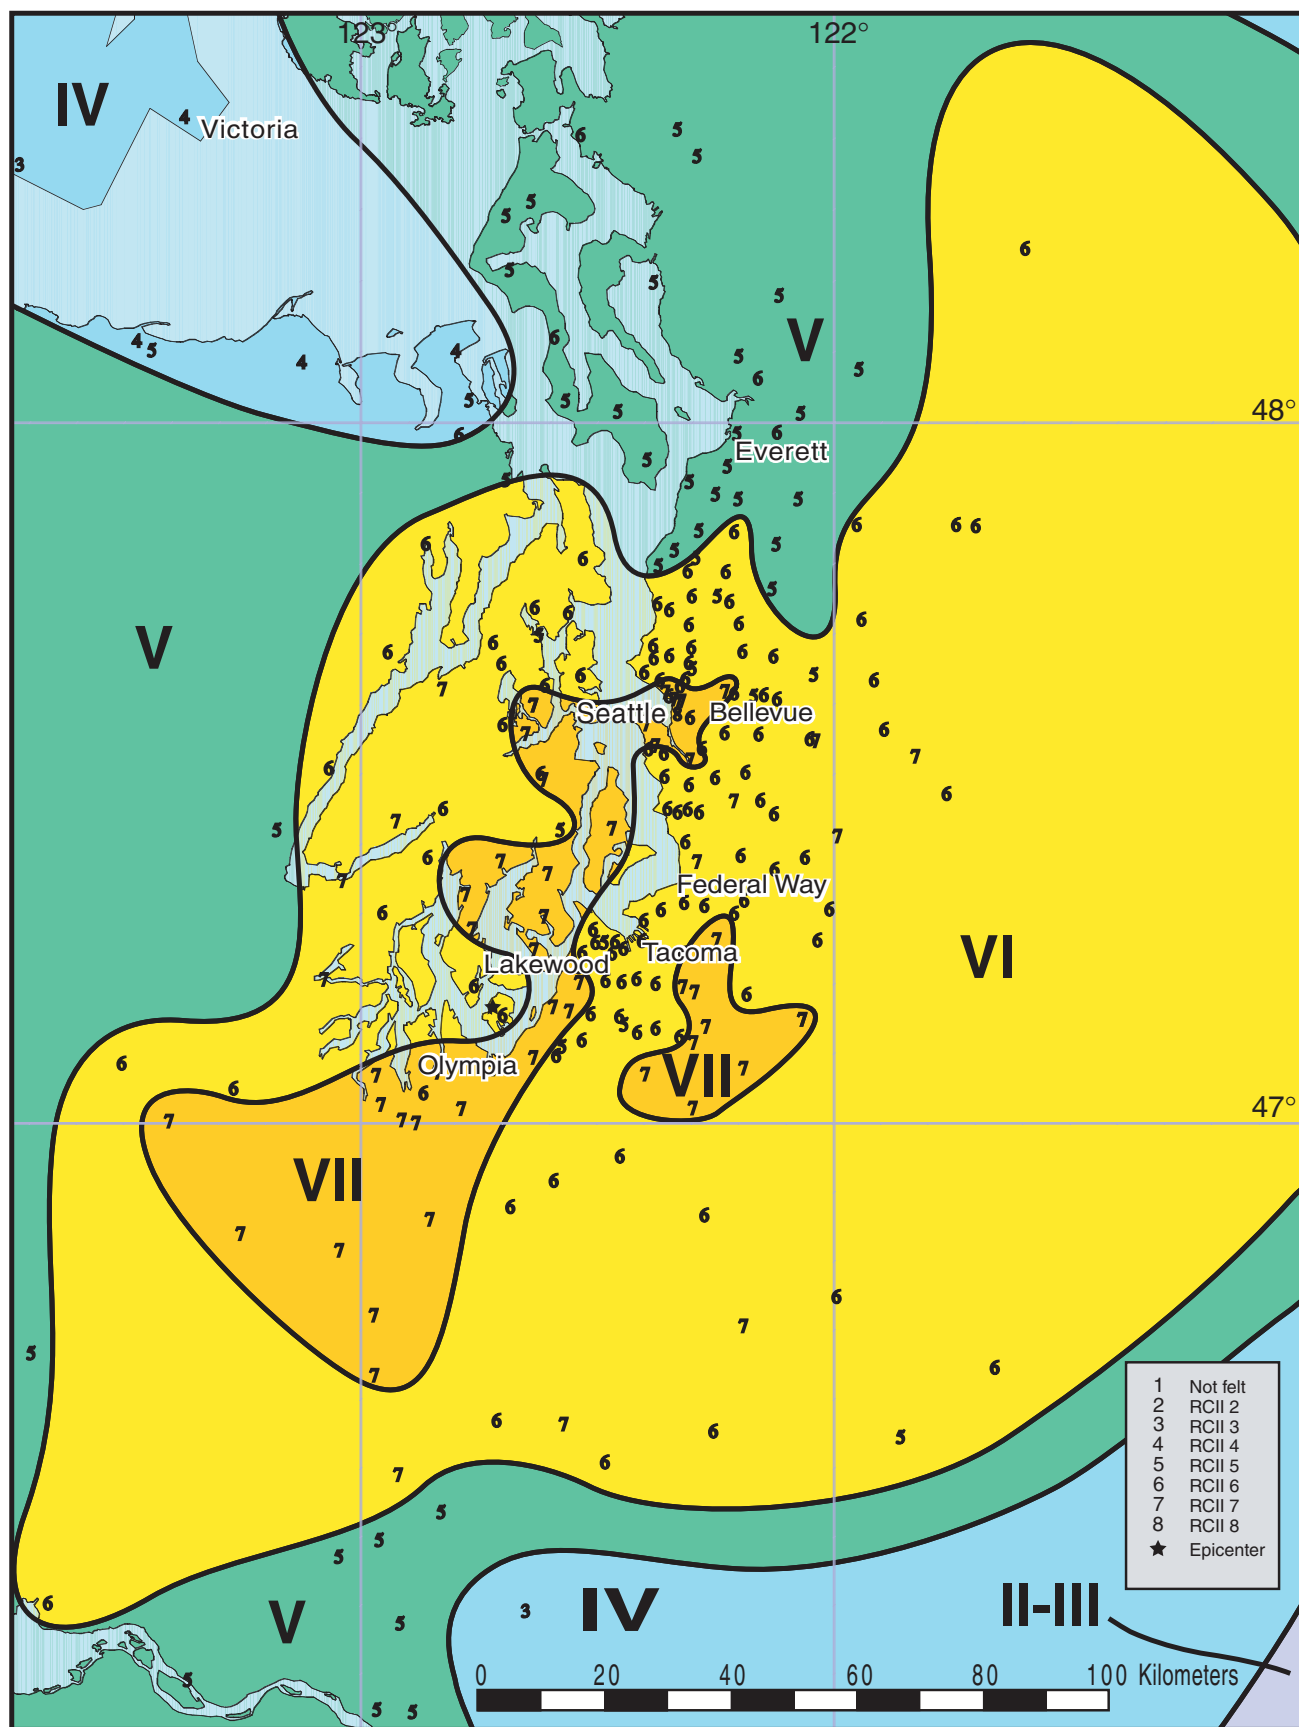
Figure 2. Isoseismals and distribution of Reviewed Community Internet Intensities (RCII) in the Puget Sound region for the Nisqually earthquake.
