**NASA Technical Memorandum 102679**

# **Unique Failure Behavior of Metal/Composite Aircraft Structural Components Under Crash Type Loads**

**Huey D. Carden**

**May 1990**

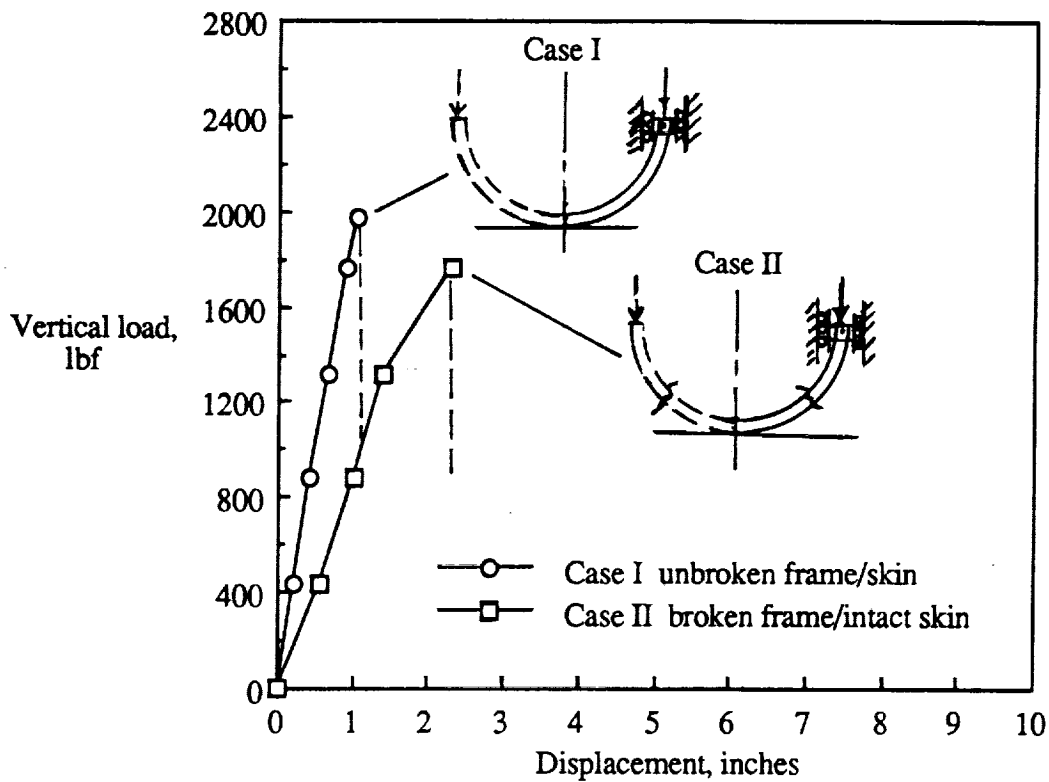
(a) Load-displacement.

Static analytical studies.- To demonstrate analytically the apparent behavior of the frames under load (exclusive of the local buckling which actually initiated the failure in the static case), a DYCAST finite element model was constructed. For ease of analysis, an I-section was modeled from the specimens described in the "Single Frame Studies" section. The frame was loaded at the top and a simulated ground plane (ground contact springs) resisted the vertical movement of the frame during load application. Boundary conditions were imposed at the bottom node of the model to account for the symmetrical situation thus only half the frame had to be modeled. The top node was constrained to allow only vertical displacement thus simulating the effect of a very stiff floor across the frame diameter. The static load was slowly increased until an input failure strain for the material (0.0086) was exceeded at the point of loading and failure was indicated. The curve labeled *unbroken frame* in figure 12(a) is the load-deflection plot for this case I.

Furthermore, a comparison of the analytical cases (figure 12(a)) with the actual static load-deflection of the Z-section (figure 11(b)) indicates very similar load-

Figure 12. - Typical analytical results for composite frame skin using I-section for ease of analysis.

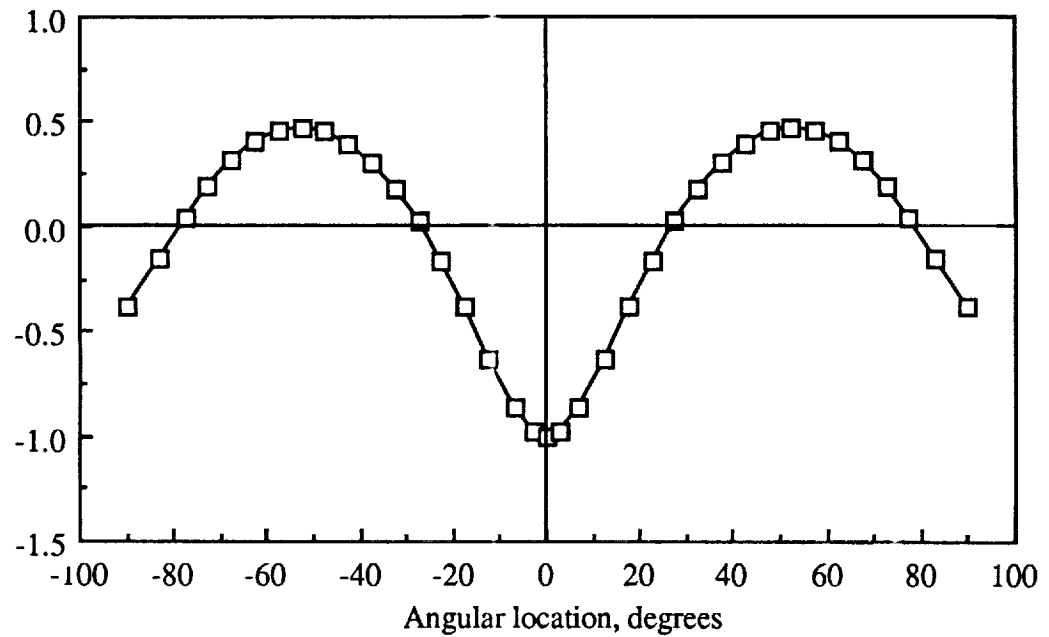
(b) Case I---Normalized moment (Prior to failure).

An examination of the normalized distribution of the bending moment on the frame shown in figure 12(b) provides insight and a better understanding of the failure/behavior. Maximum moments are indicated (just prior to failure) to be at the 0 degree location and between 50-60 degrees from the bottom contact area. The locations correlate well with the failure

deflection behavior patterns as discussed above. Although the Z-frame had no skin, if the ends jam together (as they did in several cases), the boundary is effectively between the skin stiffened case and a guided boundary. Thus, the predicted failure location in the simple beam-frame model at about 50 degrees (See figure 12(b)) agrees well with the 54 and 58 degree failure locations in the experiment with the Z-section frame.

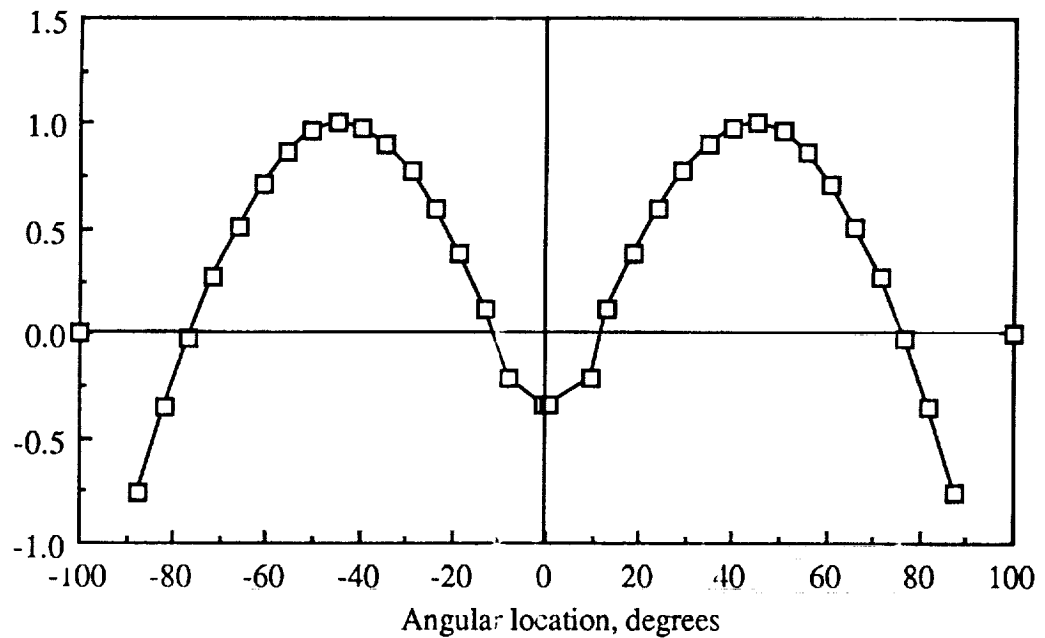
(c) Case II---Normalized moment (Broken frame-intact skin).

Figure 12(c) presents the normalized bending moment distribution on the broken frame. As may be noted, the distribution is quite similar to the initial model results in figure 12(b). The failure location is at the maximum bending moment location predicted to be about 45 degrees which is somewhat lower than the same location shown in the initial model of the unbroken frame. The agreement between the two models, however, is still considered good. The effect of diameter on the moment distribution of the frame was assessed with a model having a 75 inch diameter (twice the initial diameter). The distribution was identical to the smaller diameter results, however, the loads producing the moments differed between the two models (as expected).

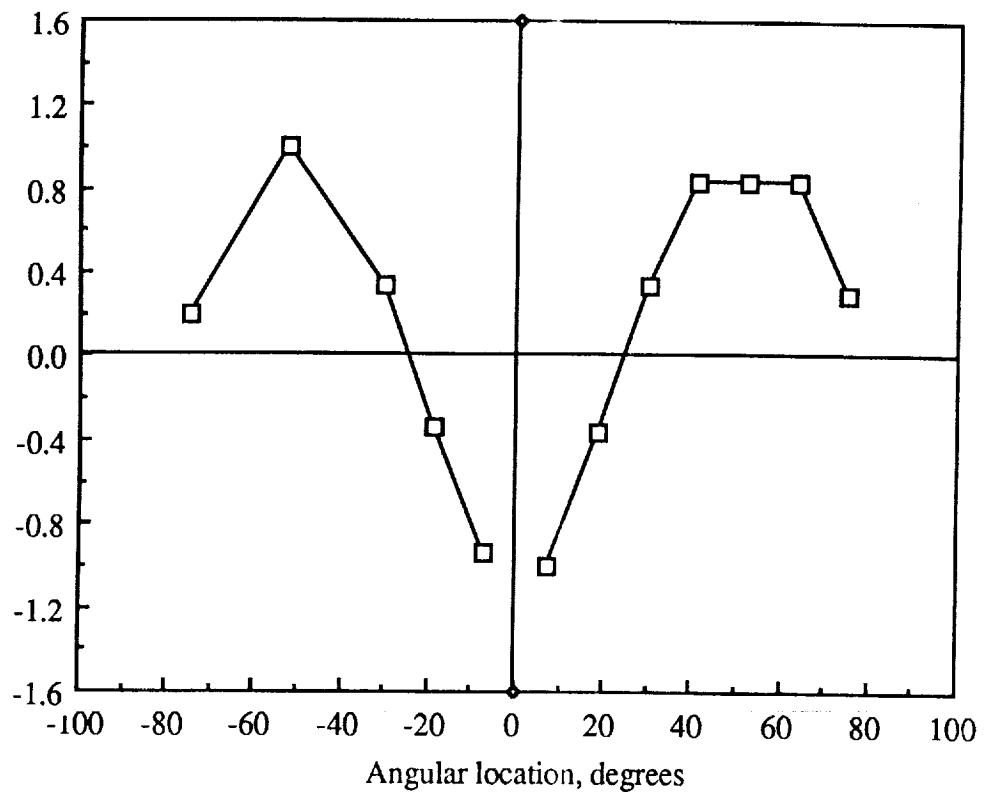
(c) Normalized strain distribution.

Dynamic tests.- Figure 15 shows the skeleton subfloor after an impact test onto a concrete surface at 20 feet per second. In the dynamic test of the skeleton subfloor fractures were produced at notches in the frames (Figure 15(a)). The locations, shown in figure 15(b), were also near the point of impact (about 14 degrees because of the splice plate) and at three other locations up the circumference of the frames (55 degrees and 85 degrees) and involve all three frames for a total of 15 fractures. The impact energy exceeded the energy absorbed by the local fractures and the floor bottomed out in the impact. Figure 15(c) is a normalized strain distribution measured on the first (end) frame during the dynamic test just before first failure. A comparison of the distribution to the moment distribution of Figure 12(b) and (c) shows essentially identical shape between the single frame and skeleton frame distributions. Maximums at 0 degrees and at approximately 50 to 55 degrees agree well with the analytically predicted locations on the frame.

Figure 15. - Behavior of skeleton composite subfloor under dynamic loading tests.

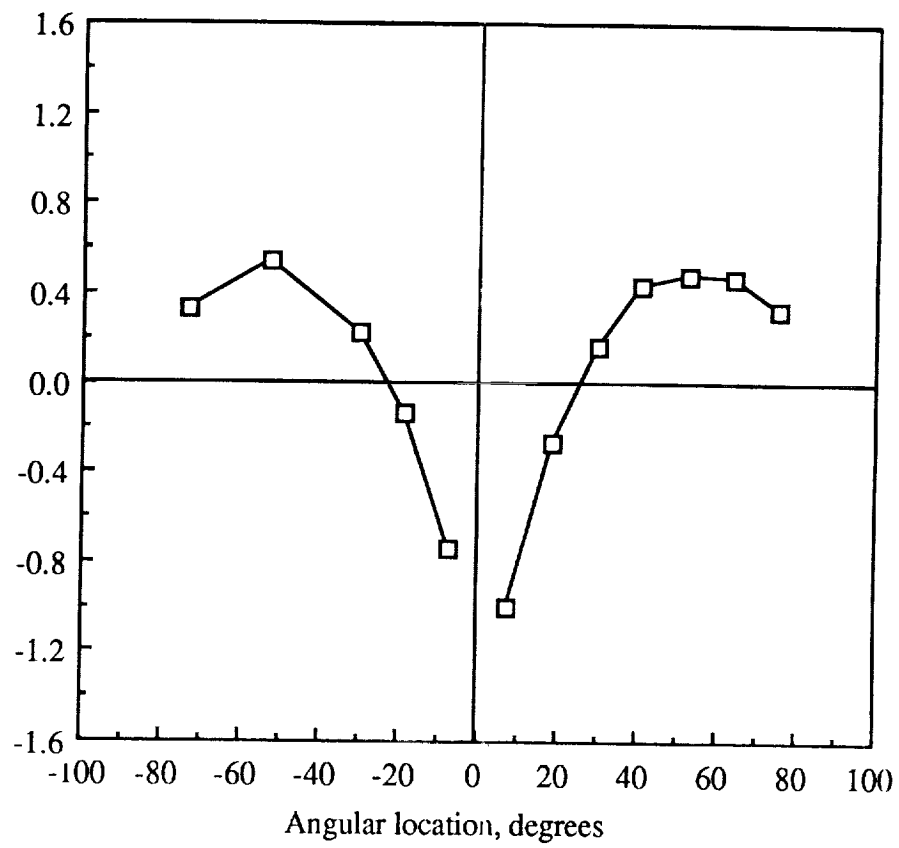
(c) Normalized strain distribution.

subfloor specimen after the test. Points of failure of the frames in this specimen are indicated in figure 16(b). Again the points of failure are at/near the impact point (within 12 degrees) and circumferentially at about 56 degrees up both sides of the frame on the middle and back frame and 45, 12 and 22.5 degrees on the front frame. It was observed that the subfloor impacted first on the front area which possibly explains the 12 and 22.5 degree fractures being different from the other locations. Again all three frames were involved in the failures. Some delamination of the frames from the skin was evident but the skin remained intact. Figure 16(c) is a normalized strain distribution (just prior to first failure) measured on the first (end) frame during the dynamic test. A comparison of the distribution to the moment distribution of Figure 12(b) and (c) and the strain distribution in Figure 16(c) shows essentially identical shape as the single frame and skeleton frame distributions. As was the case for the skeleton subfloor maximums at 0 degrees and at approximately 50 to 55 degrees agree well with the analytically predicted locations on the frame.

Figure 16. - Behavior of skinned composite subfloor under dynamic loading tests.

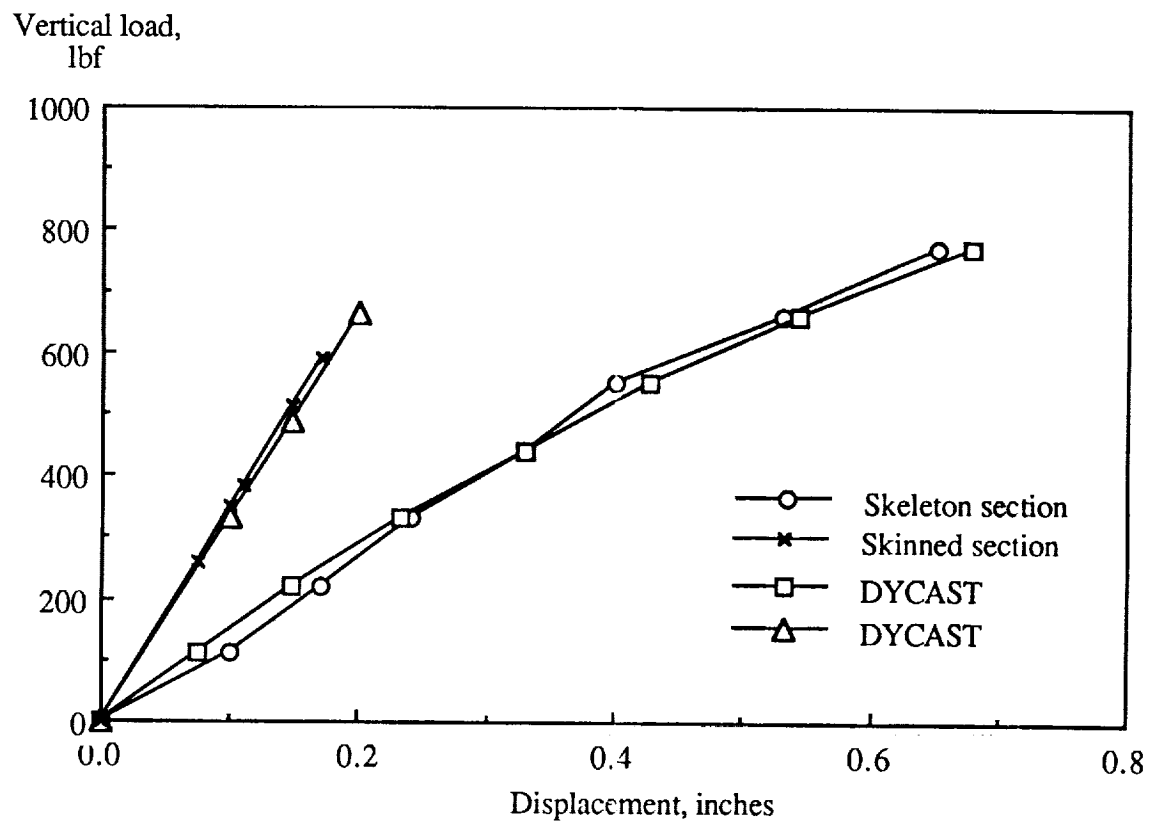
nonsymmetrical frames is illustrated in figure 17. Static load-deflection data for the unskinned subfloor and the skinned subfloor along with the DYCAST predictions are shown in the figure. It can be noted that the subfloor stiffness (with skin) is approximately three times the stiffness of the skeleton subfloor, thus the skin's contribution to the structure is to maintain in-plane deflections of the nonsymmetrical Z-section and prevent any substantial twisting of the frames. Out-of-plane bending and twist were allowed in the skeleton subfloor predictions. As a further note of interest, if for the skeleton subfloor, load in the load-deflection results (with three frames) is reduced by a factor of three, good correlation with single frame data is evident.

Figure 17. - Comparison of experimental and analytical stiffness of skeleton and skinned composite subfloors.
