U.S. Fire Administration/Technical Report Series

10 Million Dollar Marina Fire

Bohemia Bay, Maryland

USFA-TR-026/January 1989

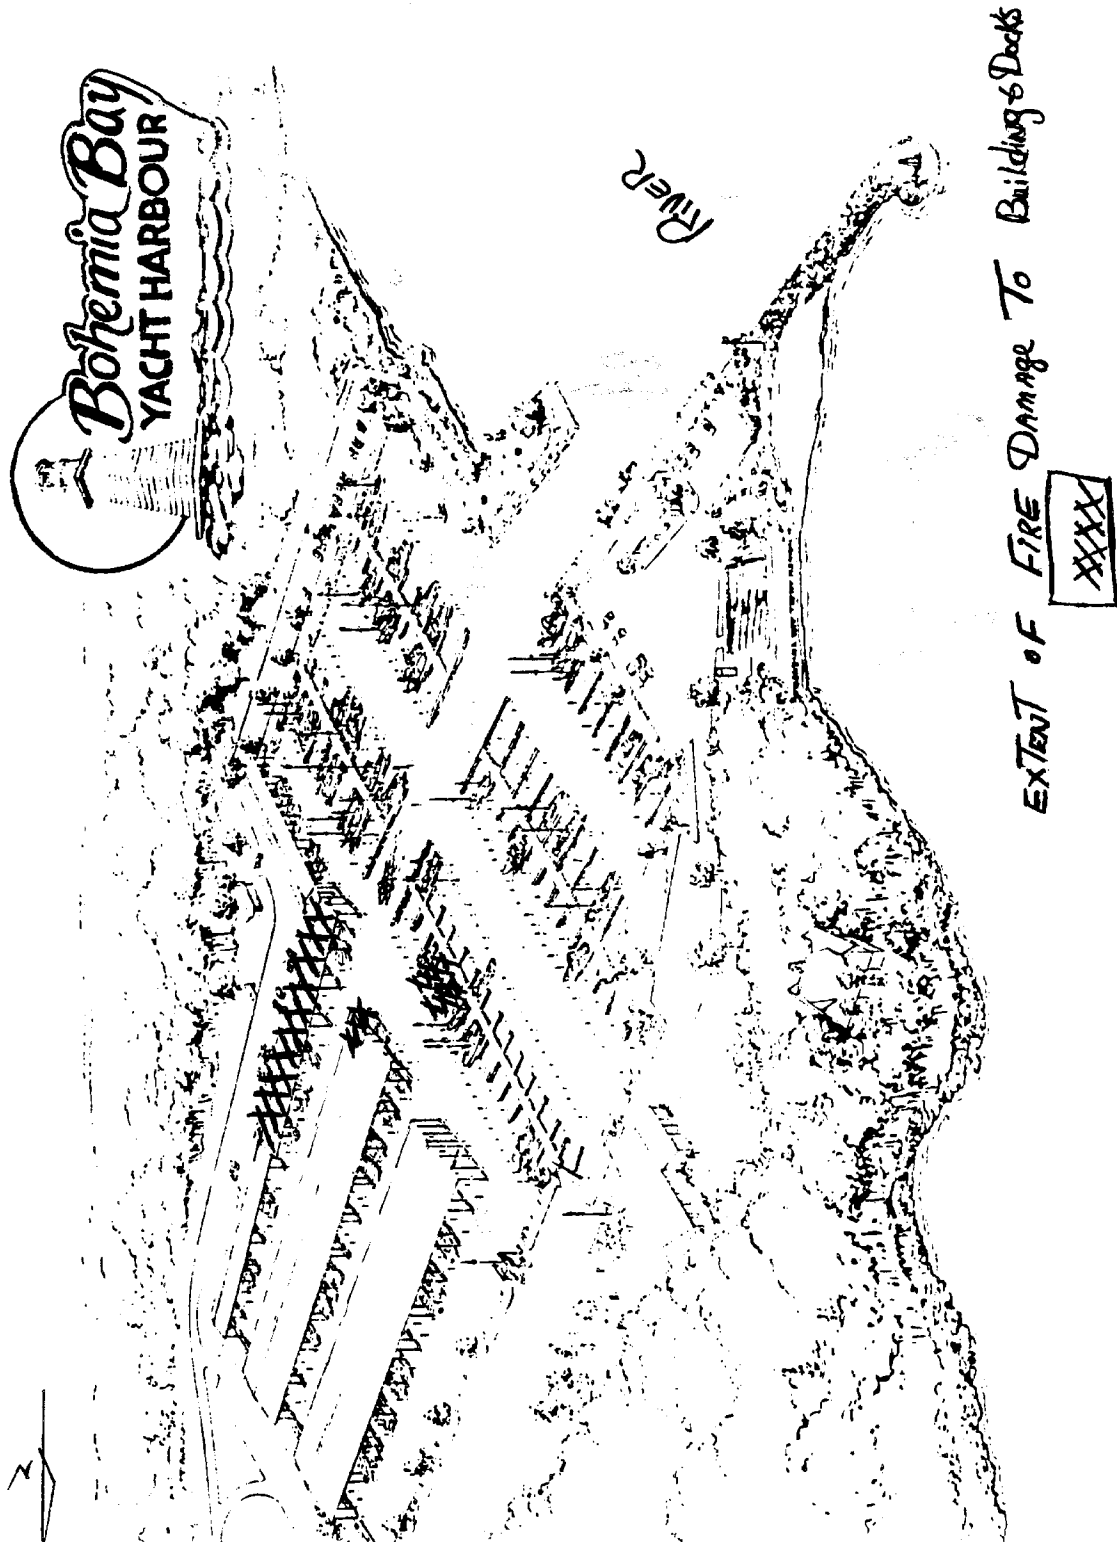
APPENDIX F

Most of the finger piers, pilings, and walkways between slips 9 and 23 on 'F' dock were destroyed. Sixteen vessels were sunk. One vessel located at 'F' dock received heavy damage and two at 'C' dock received substantial damage as a result of fuel burning on the water. Approximately 100 boats received light damage from soot and burning embers. Their cleaning proved much more difficult and expensive than first thought.
