# Schomburg Plaza Fire

New York City (Harlem)

USFA-TR-004/March 1987

**BOARD OF INQUIRY  
INTO THE MARCH 22, 1987  
SCHOMBURG PLAZA FIRE  
PRELIMINARY REPORT  
June 11, 1987**

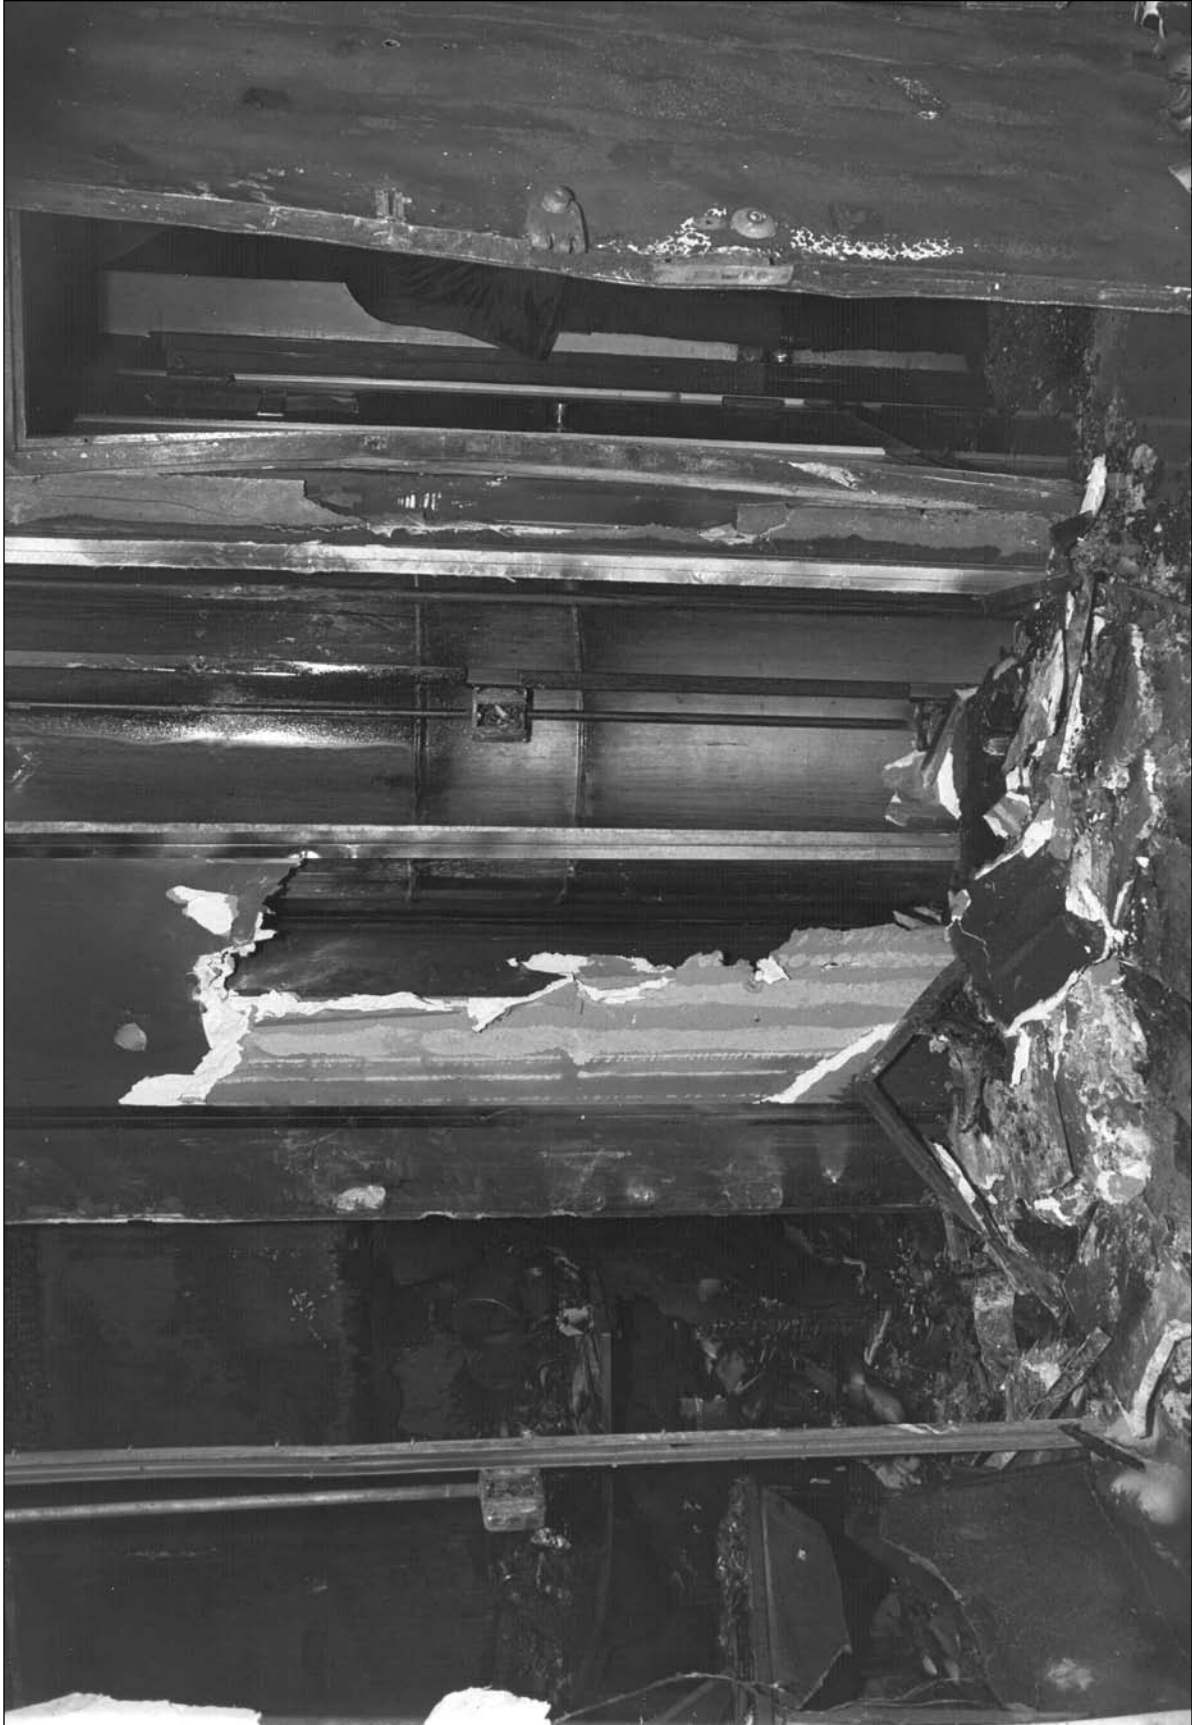
Photo 3

1. Exterior of fire building with water and burn patterns.
2. Compactor unit in the fire building (morning of fire).
3. Kitchen area, Apartment 23, adjoining compactor and pipe chase.
