U.S. Fire Administration/Technical Report Series

Sprinklers Control Arson Fires in Rack-Storage Warehouse

Mt. Prospect, Illinois

USFA-TR-030/October 1988

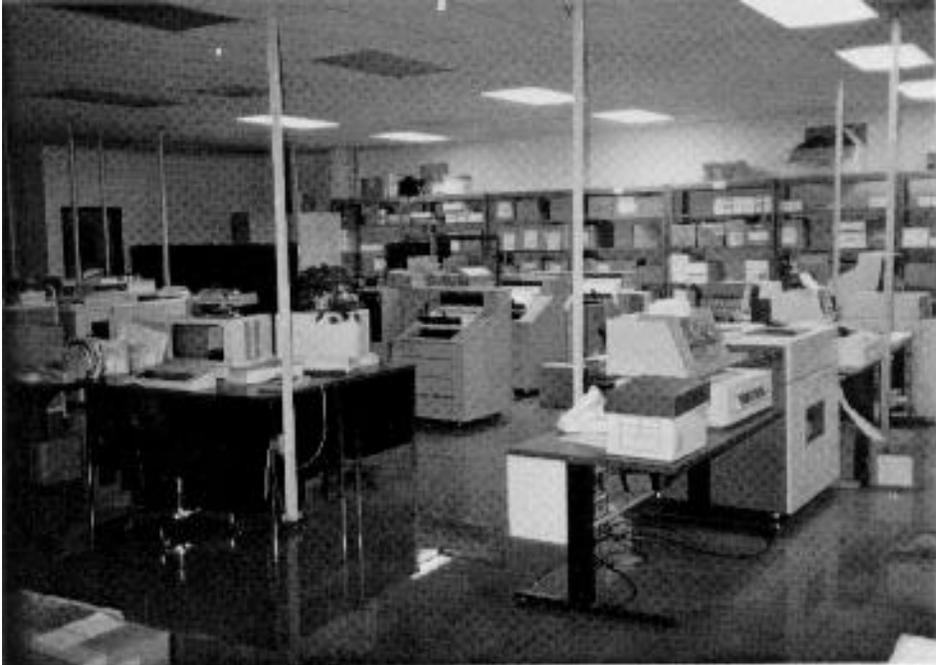
7

- *7. Typical damage to goods on upper level of racks
8. Looking due south at door leading to warehouse section. Shows extent of water penetration due to fire
