# **NATIONAL TRANSPORTATION SAFETY BOARD**

## **PIPELINE SPECIAL INVESTIGATION REPORT**

**EVALUATION OF ACCIDENT DATA AND FEDERAL  
OVERSIGHT OF PETROLEUM PRODUCT PIPELINES**

**Abstract:** Between December 1991 and March 1993, the Colonial Pipeline Company had two petroleum product pipeline ruptures. Because the accidents raised safety issues applicable to the entire pipeline system, the National Transportation Safety Board conducted a special investigation on petroleum product pipelines. This report reviews the efforts of the U.S. Department of Transportation's Research and Special Programs Administration (RSPA) to implement Safety Board recommendations concerning the safety of petroleum product pipelines. The report also examines RSPA accident data for such pipelines. The safety issues examined are: RSPA's responsiveness to implement previous safety recommendations addressing the prevention of excavation damage, the control of corrosion damage, the inspection and testing of pipelines, and methods to more rapidly detect, locate, and shut down failed sections of a pipeline; RSPA's collection and analysis of accident data for petroleum product pipelines to identify accident trend

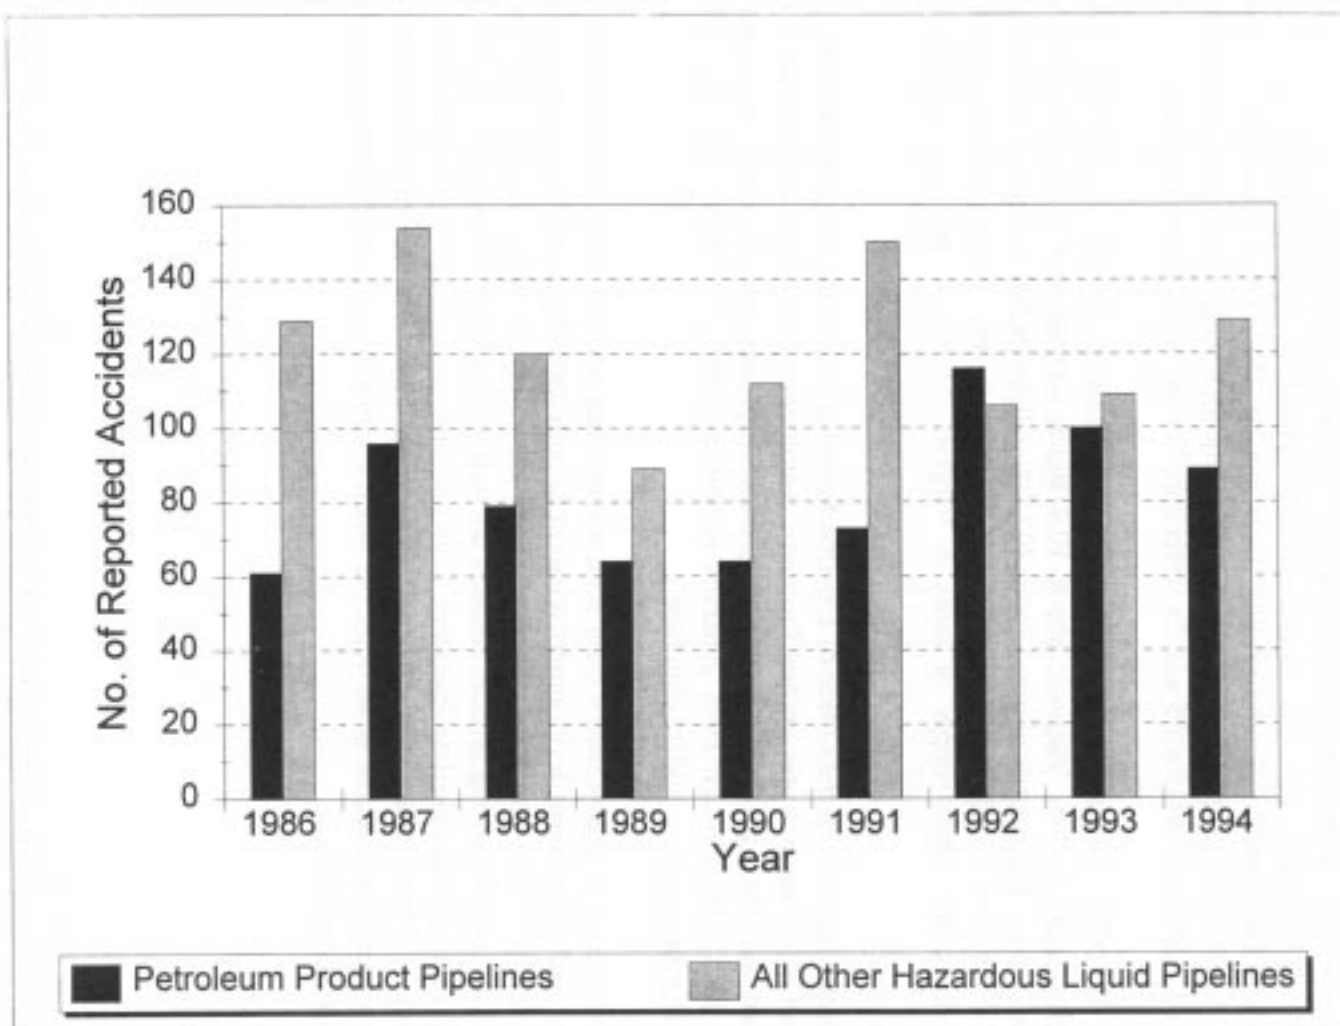
Figure 1. -- Petroleum product accidents versus other liquid pipeline accidents, for 1986-1994

Accident data compiled by the Office of Pipeline Safety (OPS) in the U.S. Department of Transportation's (DOT's) Research and Special Programs Administration (RSPA) indicate that the number of reported accidents involving petroleum product pipelines and all other hazardous liquids<sup>3</sup> pipelines from 1986 through 1994 generally remained stable. (See figure 1.) (Accident rates are not available through the accident data base.)
