# **A Damage Resistance Comparison Between Candidate Polymer Matrix Composite Feedline Materials**

*A. T. Nettles*

*Marshall Space Flight Center, Marshall Space Flight Center, Alabama*

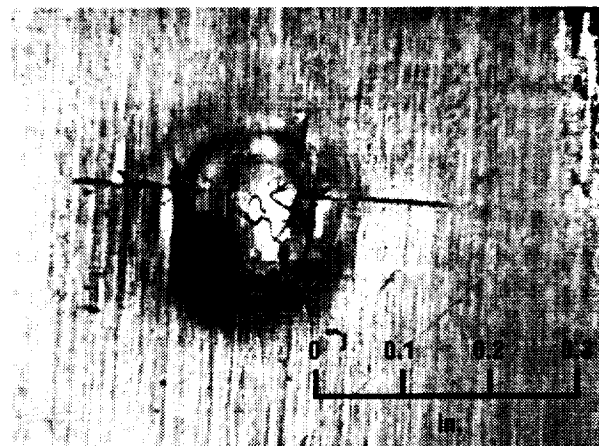
Figure 1. Typical damage to impacted side of specimens at 2.5 ft-lb.

Figure 1 shows the impacted side of each specimen tested at the high-energy level. In all cases, except the 977-6 resin, a distinct dent is seen in each of the specimens. Fiber breakage is observed in all of the specimens. The 977-6 resin possesses a relatively long crack across the outer warp fibers that spans the distance of the impacted zone. The PR 520 has short cracks at or near the indentation formed, as does the PEEK. The remaining three have fiber breakage within the indentation.

Figure 3 shows x rays of each type of resin system tested at the high-impact energy level. These x rays correspond to the visual observations of figure 1 and figure 2. The 977-6 resin system has noticeably less damage than the others. The Cycom 823 and RS-E3 systems appear as dark round circles indicating massive damage directly under the impact zone. Delaminations emanating from the impact can be seen in the Cycom 823, and RS-E3 and PEEK resin systems.

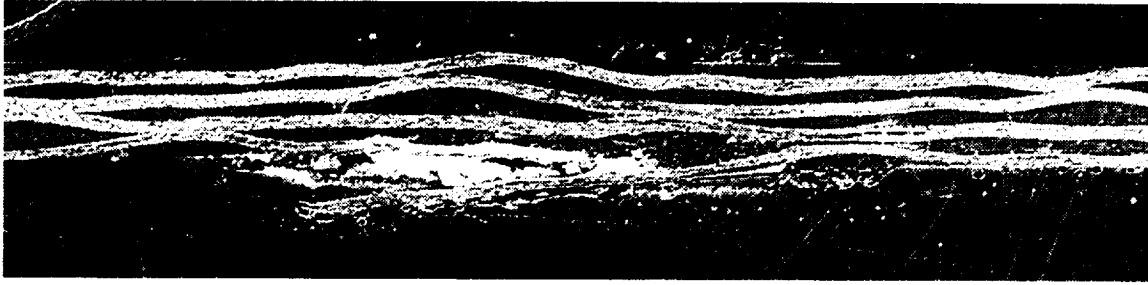
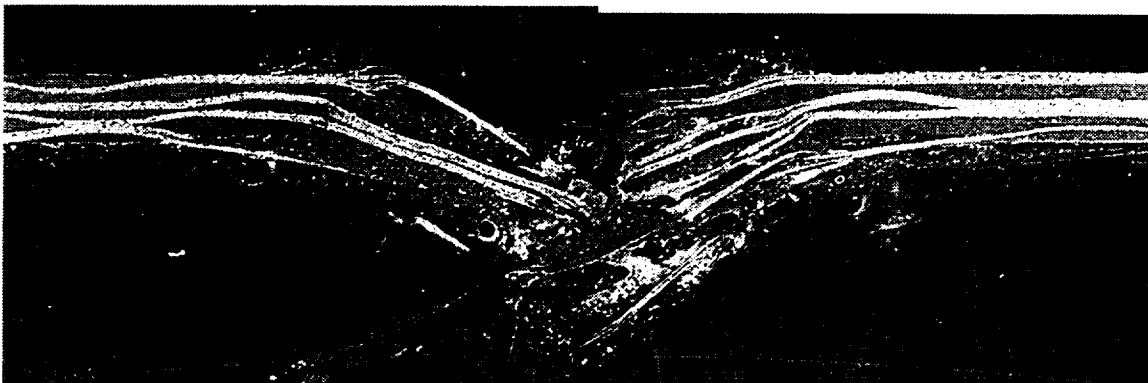
Figure 4. Cross-sectional photomicrographs of specimens impacted at 2.5 ft-lb.

Figure 4. Cross-sectional photomicrographs of specimens impacted at 2.5 ft-lb (continued).

Figure 4 shows photomicrographs of the cross section of each type of resin system tested at the high-impact energy level. The 977-6 and PEEK resins appear to have far less damage than the others tested. The Cycom 823 and RS-E3 resins show near penetration.
