Flight Motor Set 360L007 (STS-33R) Final Report

June 1990

Flight Motor Set 360L007 (STS-33R) **Final Report**

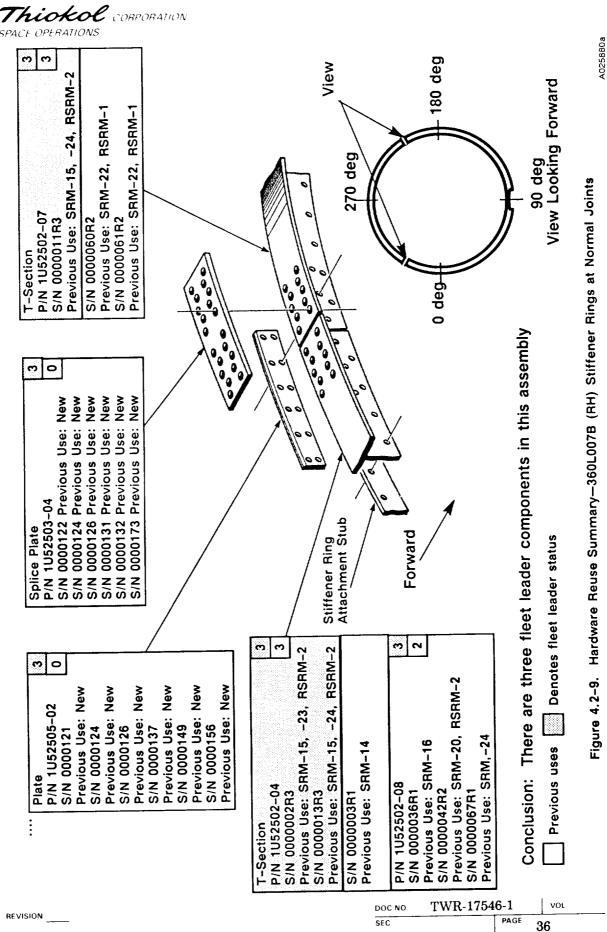
Figure 4.2-10. Hardware Reuse Summary-360L007B (RH) Stiffener Rings at Systems Tunnel Joint

180 deg View 270 deg 90 deg T-Section 1U52502-07 0 deg Forward Conclusion: There are no fleet leader components in this assembly °°° 0000 0000 ••• 0000 00 T-Section 1U52502-08 Denotes fleet leader status 2 0 Splice Plate P/N 1U52503-05 S/N 0000042 Previous Use: New S/N 0000043 Previous Use: New S/N 0000045 **Previous Use: New** 0 4 Stiffener Ring — Attachment Stub Adapter Plate P/N 1U52504-05 S/N 0000173 Previous Use: New S/N 0000175 Previous Use: New S/N 0000176 Previous Use: New S/N 0000165 Previous uses Previous Use: New S/N 0000167 **Previous Use: New** Previous Use: New S/N 0000170

The case segment reuse history for flight motors 360L007A and 360L007B is shown in Figures 4.2-1 and 4.2-2, respectively. Figures 4.2-3 through 4.2-6 show the LH and RH igniter and nozzle parts reuse, respectively. Nozzle snubber segments were new. Stiffener ring reuse is shown in Figures 4.2-7 through 4.2-10.

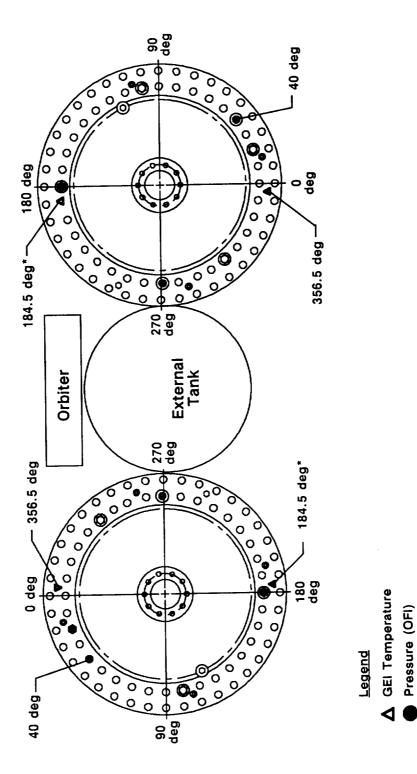
Figure 4.8-6. Forward Dome GEI

*One of two required for LCC compliance

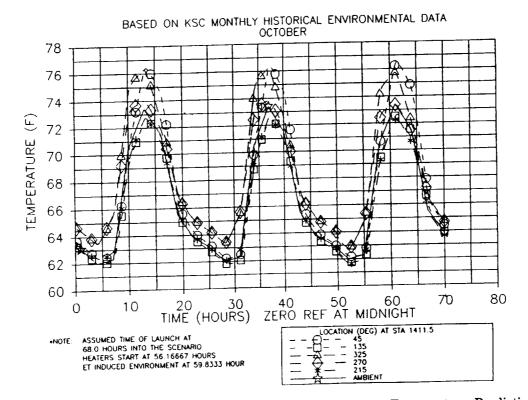
Figure 4.8-34. LH SRM Aft Case Acreage--GEI Sensor Temperature Prediction

BASED ON KSC MONTHLY HISTORICAL ENVIRONMENTAL DATA OCTOBER 78 76 AI 74 Ø, Ē ī//ì 5 72 TEMPERATURE 70 68 66 64 62 60 40 50 60 ZERO REF AT MIDNIGHT 70 80 20 30 TIME (HOURS) 10 0 •NOTE: ASSUMED TIME OF LAUNCH AT 68.0 HOURS INTO THE SCENARIO HEATERS START AT 56.16667 HOURS ET INDUCED ENVIRONMENT AT 59.8333 HOUR 215 AMBIENT

Postflight reconstructed predictions of GEI and igniter/field joint heater response were performed using the actual environmental data from the 24 hr prior to launch. A few examples of the predictions, compared with actual measured sensor data, are found in Figures 4.8-98 through 4.8-113. Reasonable agreement is apparent in all areas except the ET attach ring, the left SRB systems tunnel, and the case-to-nozzle

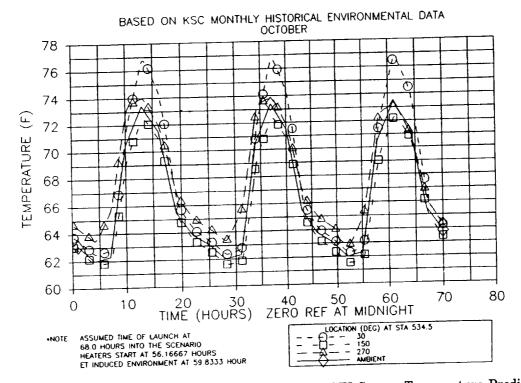
Figure 4.8-35. LH SRM Forward Dome Factory Joint--GEI Sensor Temperature Prediction

BASED ON KSC MONTHLY HISTORICAL ENVIRONMENTAL DATA OCTOBER

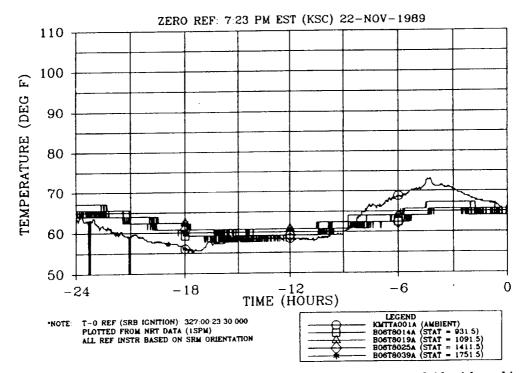
Figure 4.8-74. RH SRM Case Acreage Temperature at 325 Deg (overlaid with ambient)

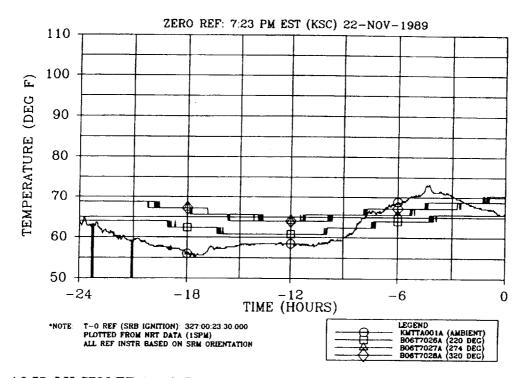
Figure 4.8-75. LH SRM ET Attach Region Temperature at Station 1511.0 (overlaid with ambient)

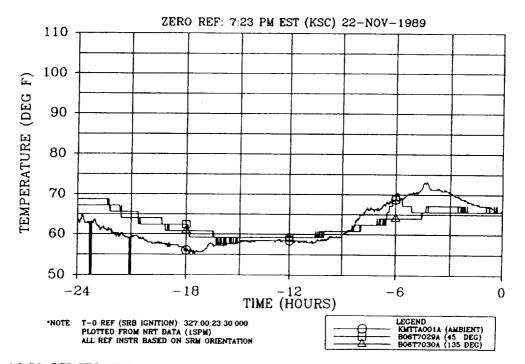
Figure 4.8-76. LH SRM ET Attach Region Temperature at Station 1535.0 (overlaid with ambient)

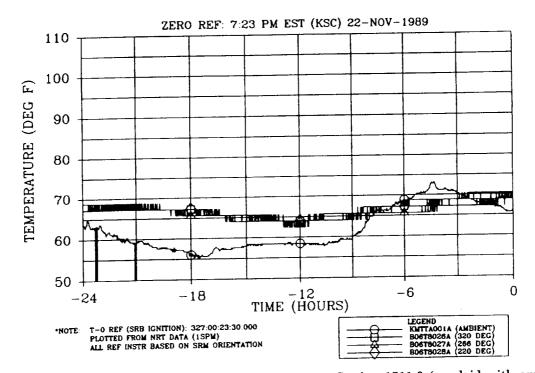
Figure 4.8-77. RH SRM ET Attach Region Temperature at Station 1511.0 (overlaid with ambient)

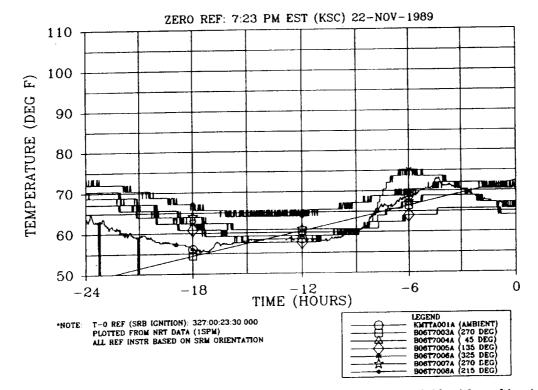
Figure 4.8-79. LH SRM Forward Factory Joint Temperature (overlaid with ambient)

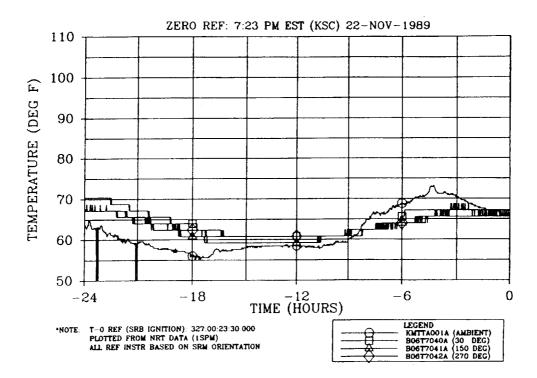
Figure 4.8-81. LH SRM Aft Factory Joint Temperature at Station 1821.0 (overlaid with ambient)

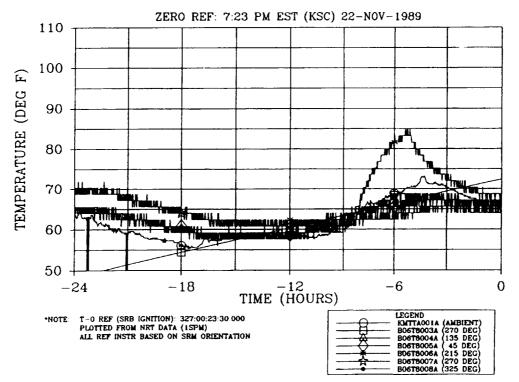
Figure 4.8-82. RH SRM Forward Factory Joint Temperature (overlaid with ambient)

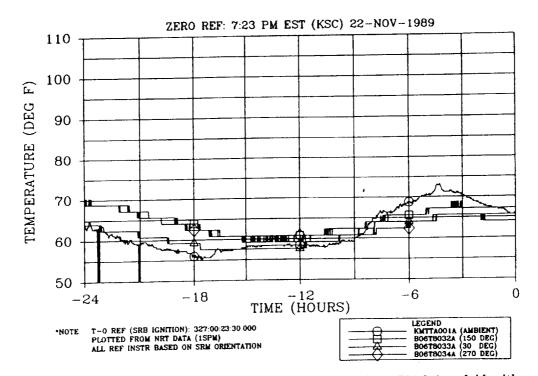
Figure 4.8-83. RH SRM Aft Factory Joint Temperature at Station 1701.9 (overlaid with ambient)

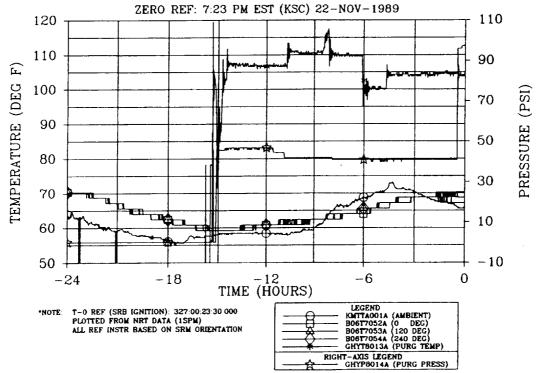
Figure 4.8-86. LH SRM Nozzle Region Temperature at Station 1950.0 (overlaid with ambient)

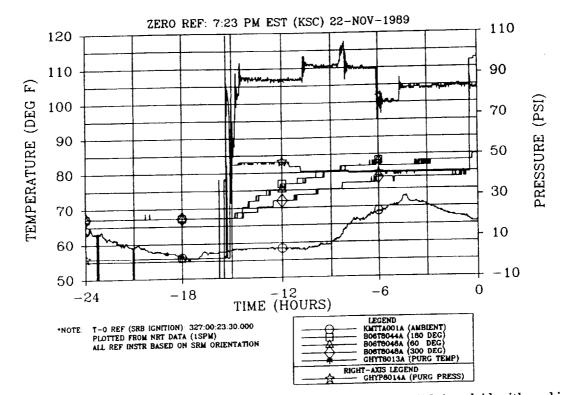
Figure 4.8-87. RH SRM Nozzle Region Temperature at Station 1845.0 (overlaid with ambient)

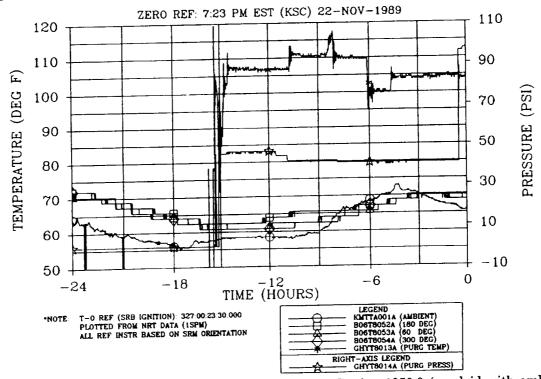
Figure 4.8-88. RH SRM Nozzle Region Temperature at Station 1950.0 (overlaid with ambient)

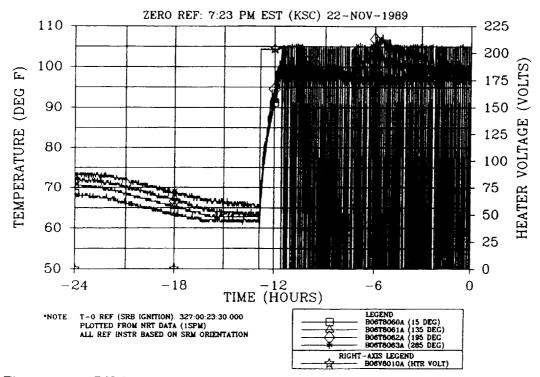
Figure 4.8-90. RH SRM Forward Field Joint Temperature (overlaid with heater voltage)

The six field joint heaters performed adequately and as expected with a 17° F sensor temperature range of 90° to 107° F during the LCC timeframe. All 24 field joint sensors recorded temperatures in the expected range. Prior to launch, an LCC contingency was created to lower the minimum redline temperature at any field joint from 85° to 69°F in the event of a complete heater failure. An IPR was written against the LH aft field joint heater voltage, which read 290 V instead of the nominal 209 V. This IPR was dispositioned when it was determined that the voltage must have been nominal because the current reading was nominal. In addition, the heater circuit breaker was not tripped as it would have been had the voltage actually been 290 V.

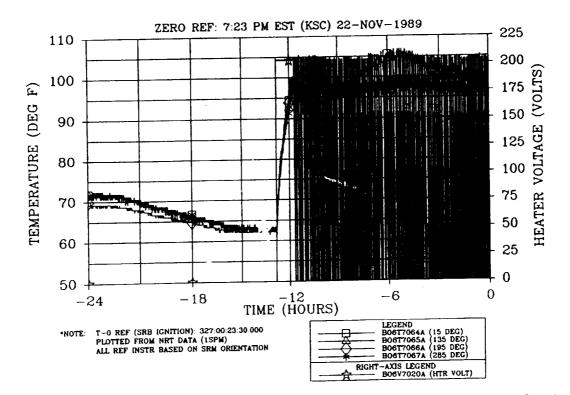
Figure 4.8-91. LH SRM Center Field Joint Temperature (overlaid with heater voltage)

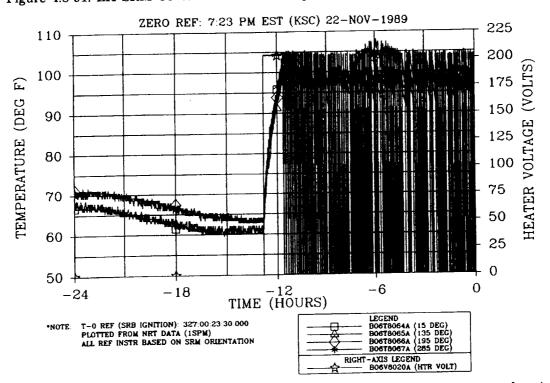
Figure 4.8-92. RH SRM Center Field Joint Temperature (overlaid with heater voltage)

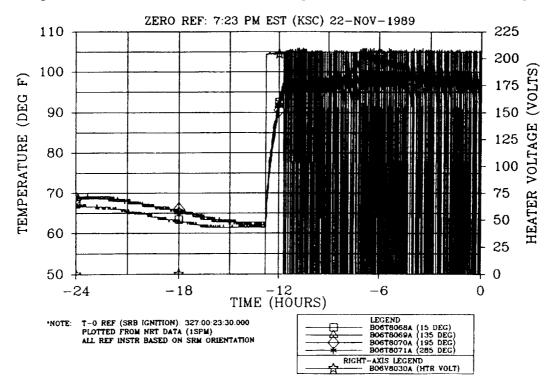
Figure 4.8-94. RH SRM Aft Field Joint Temperature (overlaid with heater voltage)

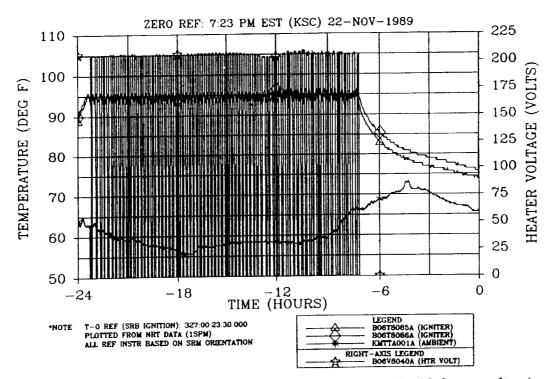
Figure 4.8-96. RH SRM Igniter Joint Temperature (overlaid with heater voltage)

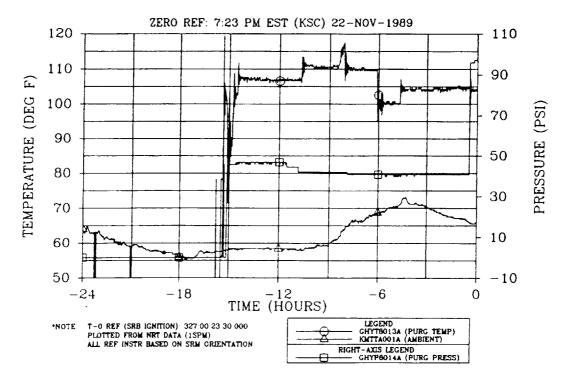
Figure 4.8-97. Aft Skirt Purge Temperature and Pressure (overlaid with ambient)

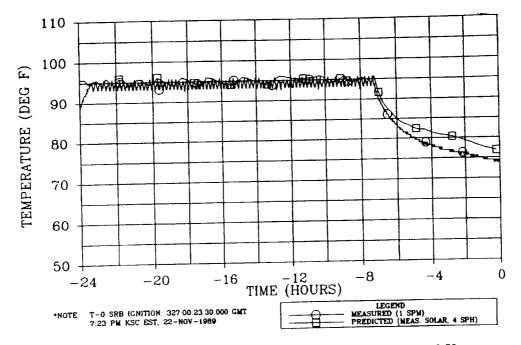
Figure 4.8-98. LH SRM Igniter Joint Temperatures--Measured Versus Postflight Prediction (B06T7085A, igniter)

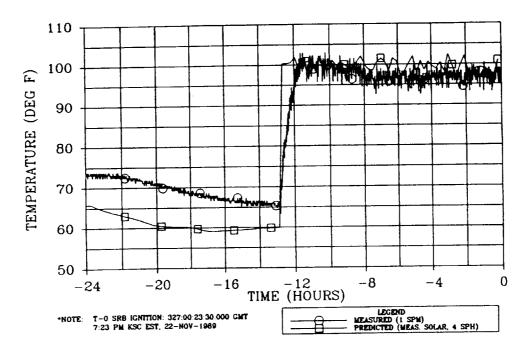
Figure 4.8-102. RH SRM Forward Field Joint Temperature--Measured Versus Postflight Prediction (B06T8063A, 285 deg)

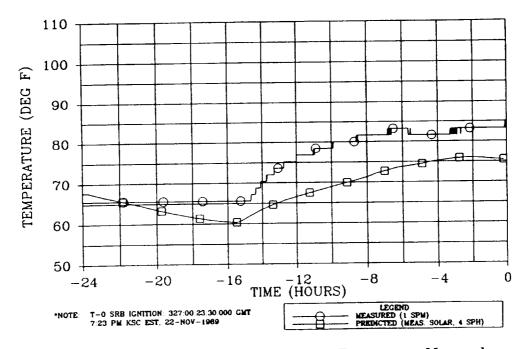
Figure 4.8-103. RH SRM Case-to-Nozzle Joint Temperature--Measured Versus Postflight Prediction (B06T8049A, 180 deg)

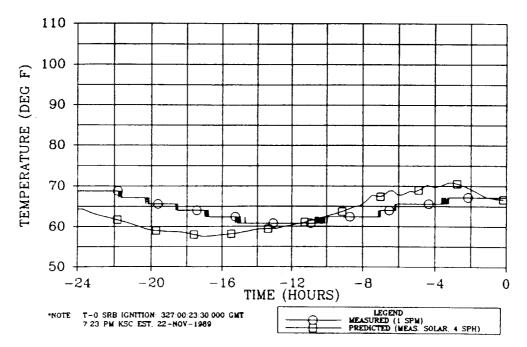
Figure 4.8-104. LH SRM Systems Tunnel Bondline Temperature--Measured Versus Postflight Prediction (B06T7031A, aft)

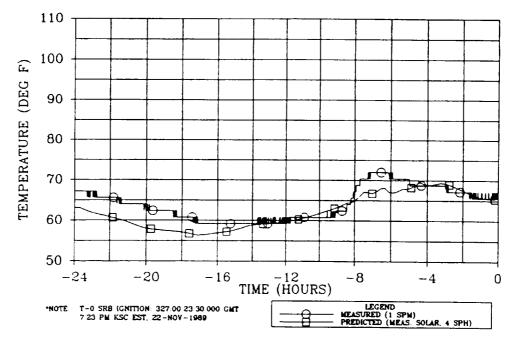
Figure 4.8-105. RH SRM Case Acreage Temperature at Station 931.5--Measured Versus Postflight Prediction (B06T8010A, 135 deg)

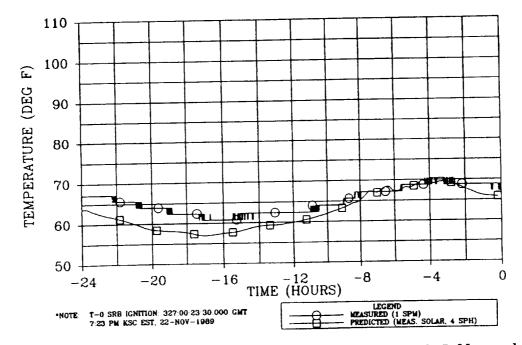
Figure 4.8-106. RH SRM Case Acreage Temperature at Station 931.5--Measured Versus Postflight Prediction (B06T8011A, 45 deg)

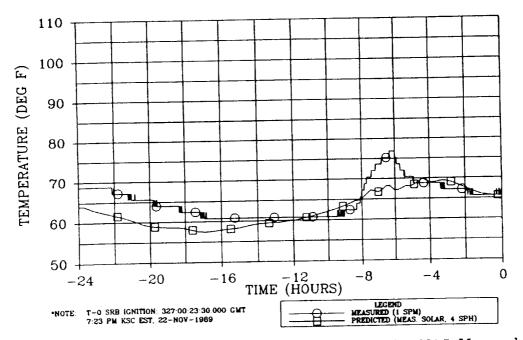
Figure 4.8-107. RH SRM Case Acreage Temperature at Station 931.5--Measured Versus Postflight Prediction (B06T8012A, 215 deg)

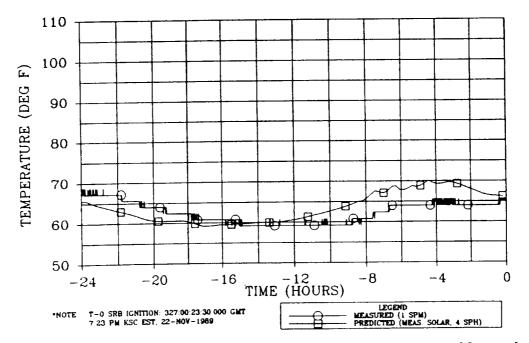
Figure 4.8-108. RH SRM Case Acreage Temperature at Station 931.5--Measured Versus Postflight Prediction (B06T8013A, 270 deg)

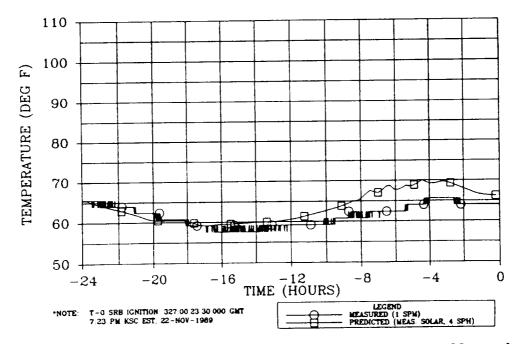
Figure 4.8-109. RH SRM Case Acreage Temperature at Station 931.5--Measured Versus Postflight Prediction (B06T8014A, 325 deg)

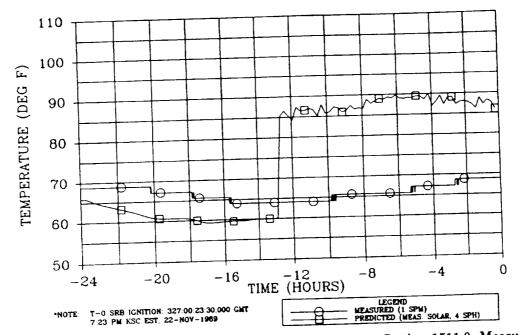
Figure 4.8-110. LH SRM ET Attach Region Temperature at Station 1511.0--Measured Versus Postflight Prediction (B06T7027A, 274 deg)

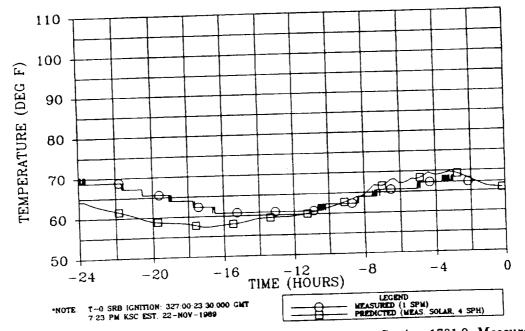
Figure 4.8-111. RH SRM Aft Factory Joint Temperature at Station 1701.9--Measured Versus Postflight Prediction (B06T8032A, 150 deg)

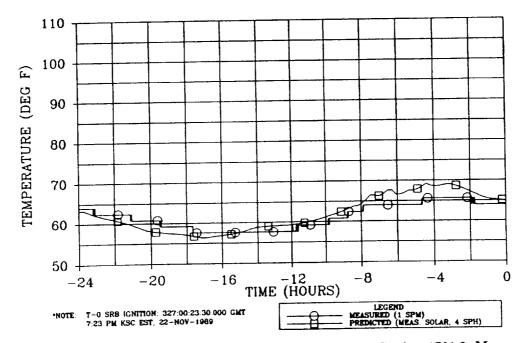
Figure 4.8-112. RH SRM Aft Factory Joint Temperature at Station 1701.9--Measured Versus Postflight Prediction (B06T8033A, 30 deg)

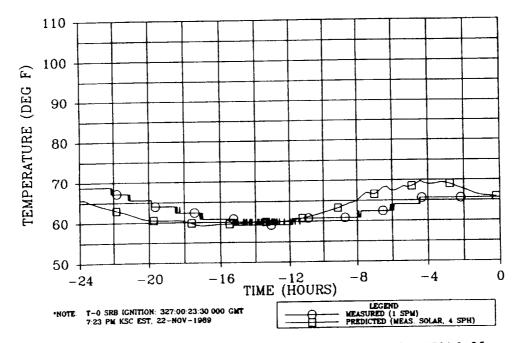
Figure 4.8-113. RH SRM Aft Factory Joint Temperature at Station 1701.9--Measured Versus Postflight Prediction (B06T8034A, 270 deg)
