Prepared for the
35th Aerospace Mechanisms Symposium
cosponsored by the Lockheed Martin Missiles and Space and the
Aerospace Mechanisms Symposium Committee
Mountain View, California, May 9–11, 2001

THE ROLE OF BEARING AND SCAN MECHANISM LIFE TESTING IN FLIGHT QUALIFICATION OF THE MODIS INSTRUMENT

This paper describes the results of accelerated and operational life tests on bearings for the Moderate Resolution Imaging Spectroradiometer (MODIS). It also describes the post test analysis of the disassembled bearings. Analysis was performed using micro-Raman, micro-FTIR, X-ray Photoelectron Spectroscopy (XPS), Scanning Electron Microscopy (SEM), and Size Exclusion Chromatography (SEC). In general, the three sets of bearings in each of three test stations were in very good condition after accumulating 68, 144, and 209 million cycles, respectively. Some of the bearings exhibited lubricant degradation, indicated by viscous lubricant deposits on the cage and raceways.

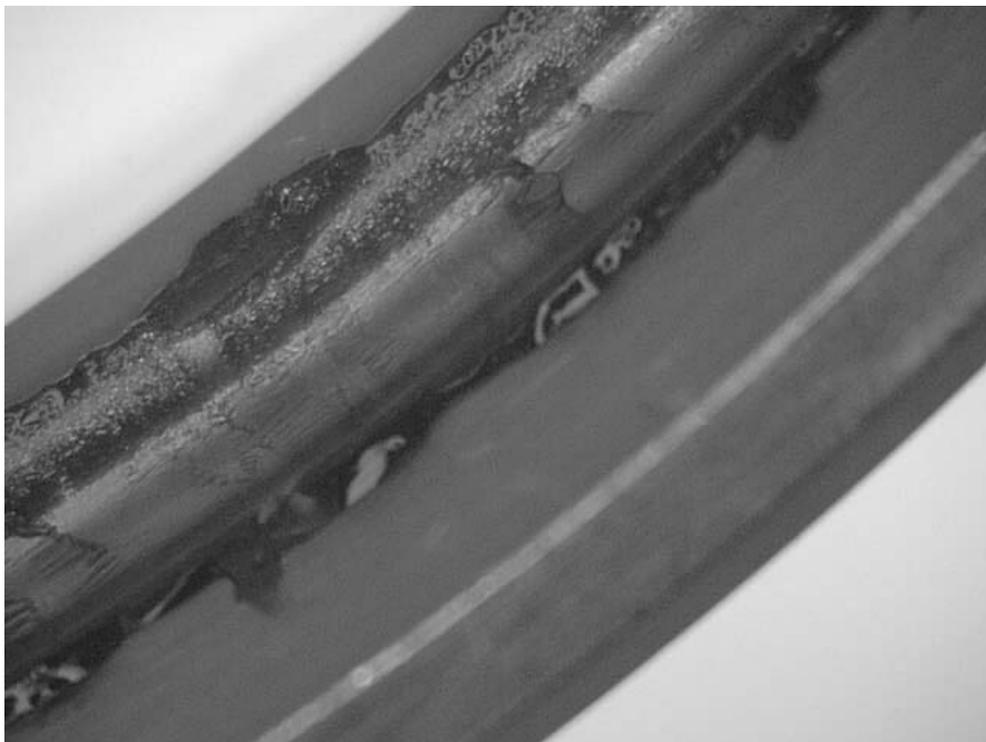
Figure 9 – Darkened lubricant deposit

One of the disassembled bearings (4-012) is shown in Figure 8. Although not easily seen in the macro photograph (Figure 8), dark viscous deposits were observed on the cage and raceways. A higher magnification photograph (Figure 9) shows an example of these deposits in a raceway. Two other photographs showing the variation and distribution of lubricant within the raceways appear in Figures 10 (greater amount of lubricant) and Figure 11 (lesser amount of lubricant).

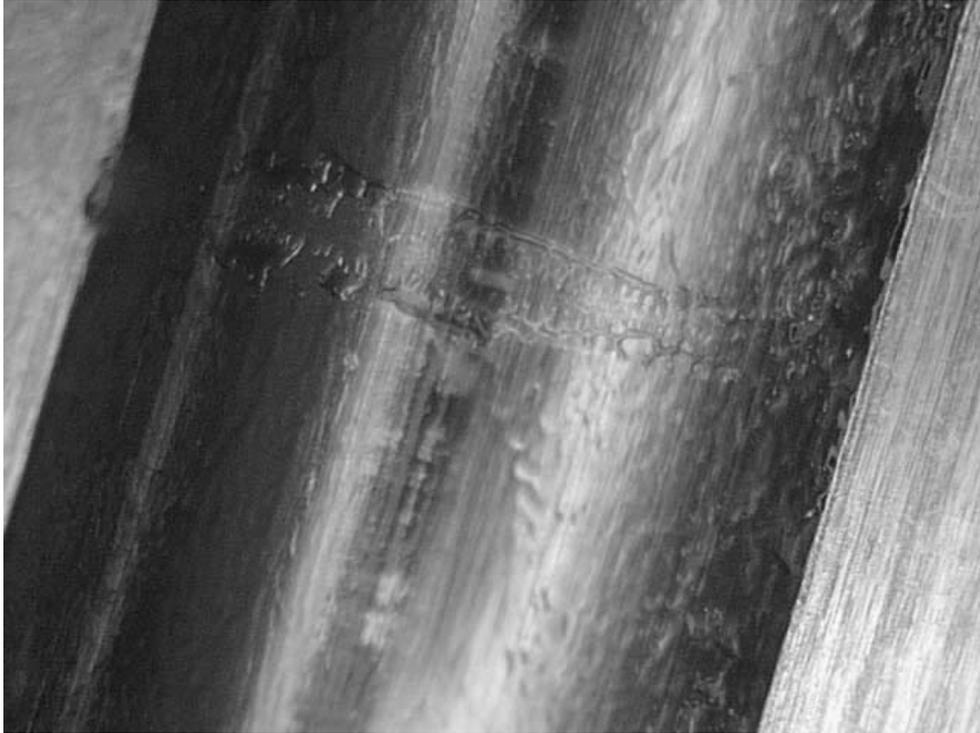
Figure 10 – One bearing from station II with a greater amount of lubricant
