Dredging in an Active Artillery Impact Area Eagle River Flats, Alaska

Special Report 96-22

**U.S. Army Corps
of Engineers**
Cold Regions Research &
Engineering Laboratory

Prepared for
U.S. ARMY ENVIRONMENTAL CENTER

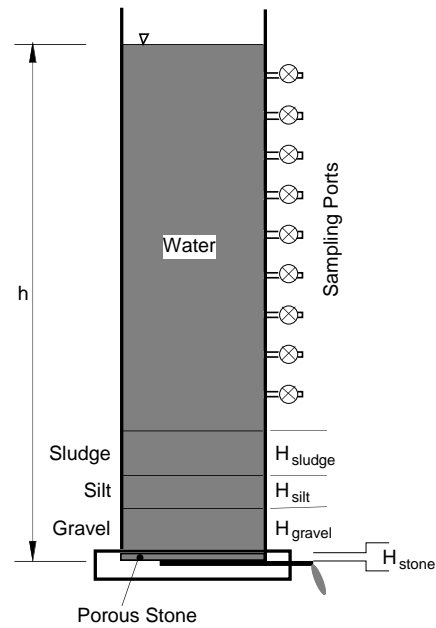
Figure 2. Montgomery tube used for sedimentation tests.

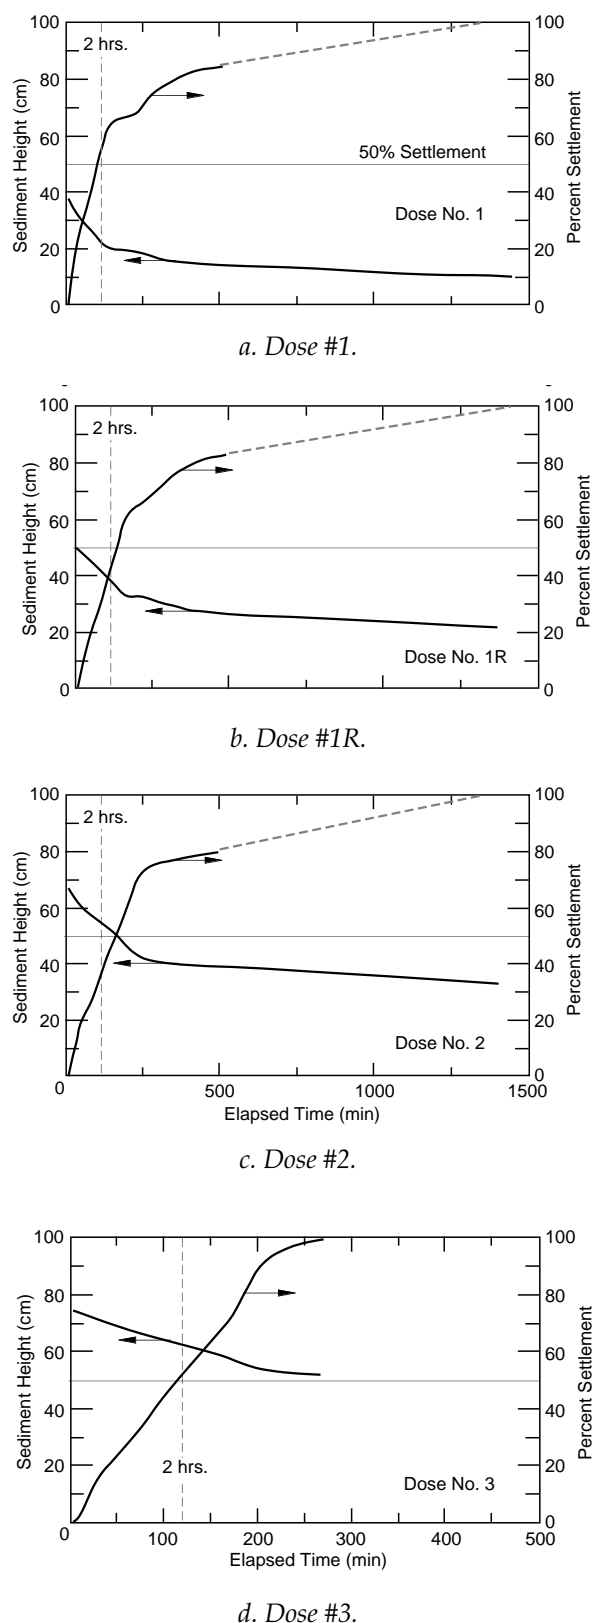
Figure 3. Sedimentation test results in Montgomery tube.

days required for freshwater sediments. More rigorous laboratory settlement tests following the method of Montgomery (1978) confirmed the preliminary tests. These sedimentation tests were conducted in a 15-cm-diameter polycarbonate tube with a length of about 1.8 m. The tube had a porous stone and drainage port in its base (see Fig. 2). Water was prepared at a salinity of 5 ppt and mixed with sediment at a ratio of four parts water to one part wet sediment by volume (70% water content by weight). The water content for the sediment was obtained from an estimate of the water content in the sediments that the dredge would pump into the settling pond. The sediment was thoroughly mixed to its initial water content in a laboratory blender (in contrast to hand mixing in the preliminary tests) and then mixed in a barrel with the saline water using a stirring agitator. It was then quickly poured into the sediment tube. The elevation of the interface at the top of the sediments was then monitored for at least 24 hours. A definite interface formed within a few minutes, the water above the interface being relatively transparent. Table 2 and Figure 3 show the test results. In all cases, 50% of the total settlement occurred in about two hours. In the preliminary tests, 50% of the total settlement occurred in about 15 minutes. The difference between these results is probably related to the size of the soil aggregates used in the two tests and the quality of the mixing. The aggregates were much coarser in the hand-mixed test than the machine-mixed tests, thus settling more quickly. The two cases probably bracket the range of results that would be achieved in the dredging operation.

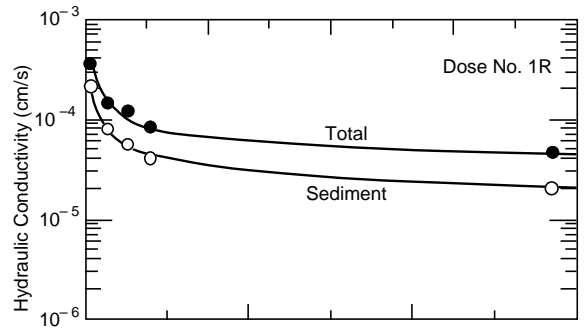
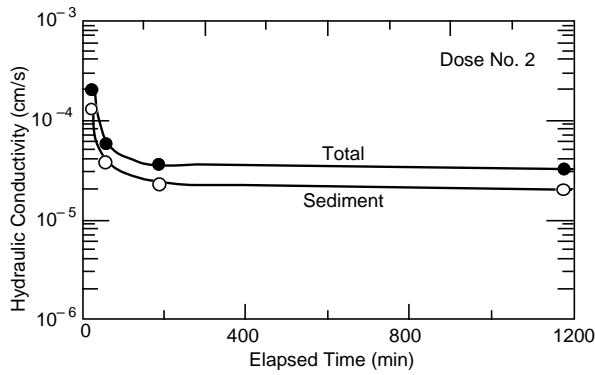
a. Dose #1.

b. Dose #1R.

c. Dose #2.

d. Dose #3.

Figure 10. Permeability of sediment in column.

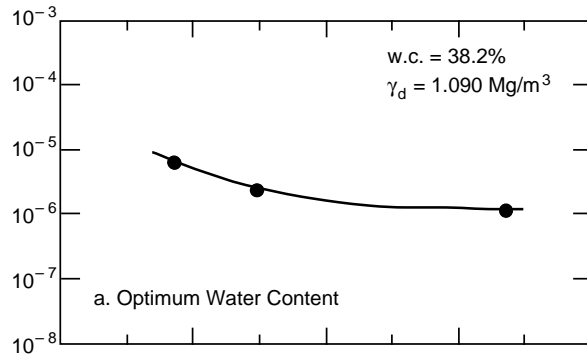
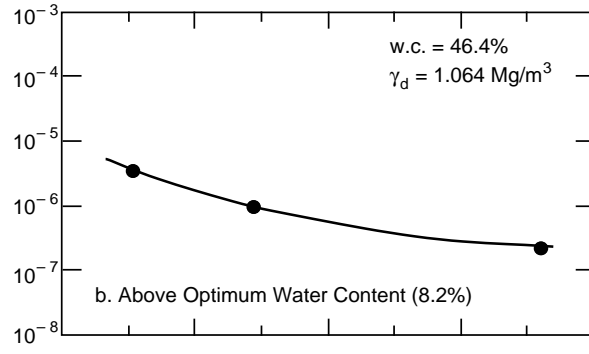
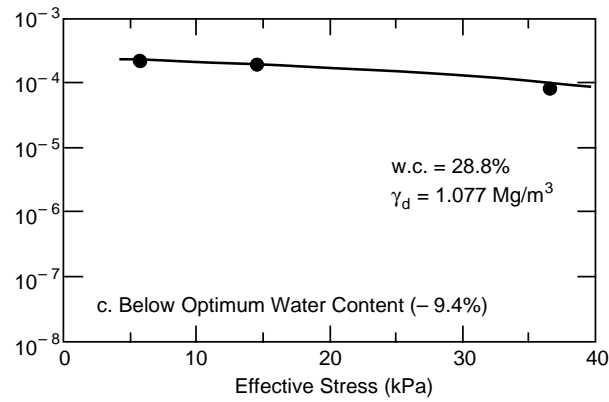
a. Optimum water content.

b. Above optimum water content.

c. Below optimum water content.

Figure 12. Results of laboratory permeability tests.

creasing stress level. The results (Fig. 12c) for the test specimen with a water content of about 29% (9% below optimum) did not pass the 1×10^{-5} cm/s litmus test. This was not unexpected, as according to Lambe and Whitman (1969) the hydraulic conductivity for fine-grained soils significantly increases at water contents below the optimum level. The importance of this finding is that the field water content during compaction must be near or above 38%. This appeared to be no problem as the water content in the borrow pit was estimated to be 38%.

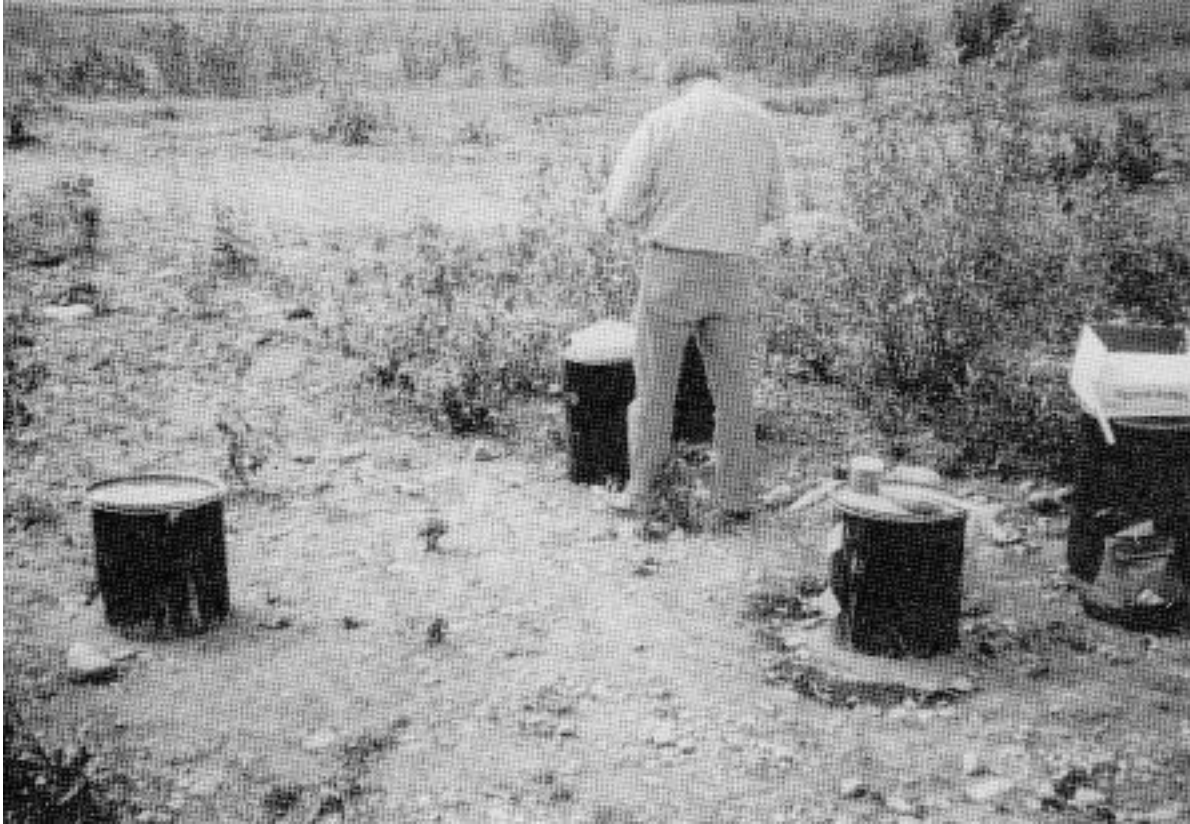
a. Location of tests on the EOD pad.

Figure 13. Hydraulic conductivity barrel test cells on the EOD pad.

b. Test site.

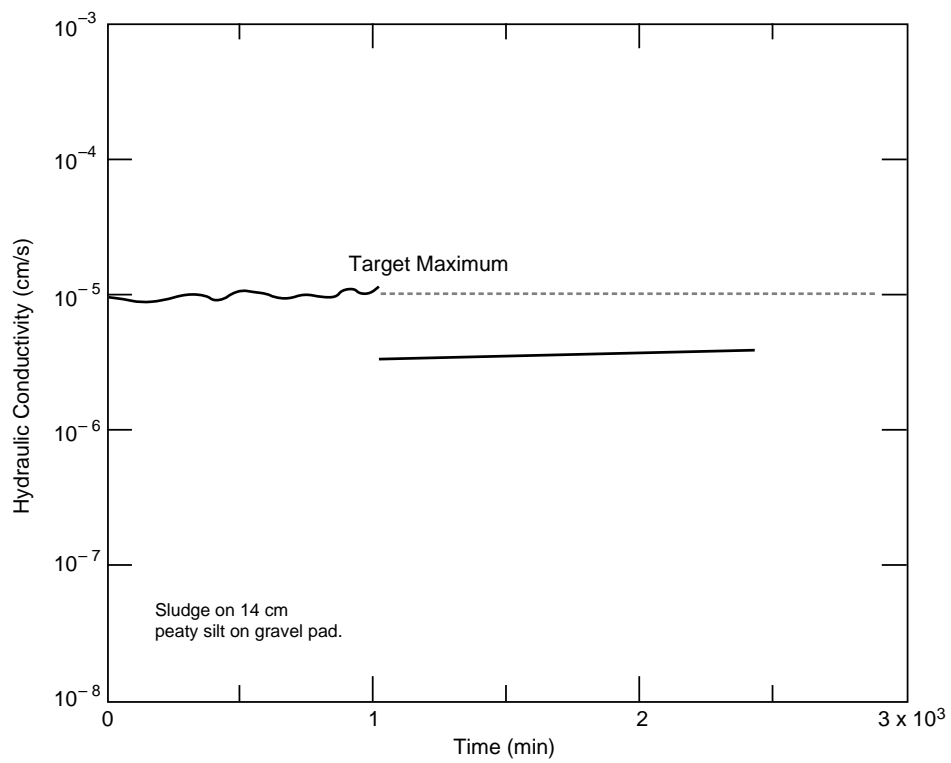
Figure 16. Results of barrel infiltration tests for sludge on peaty silt.

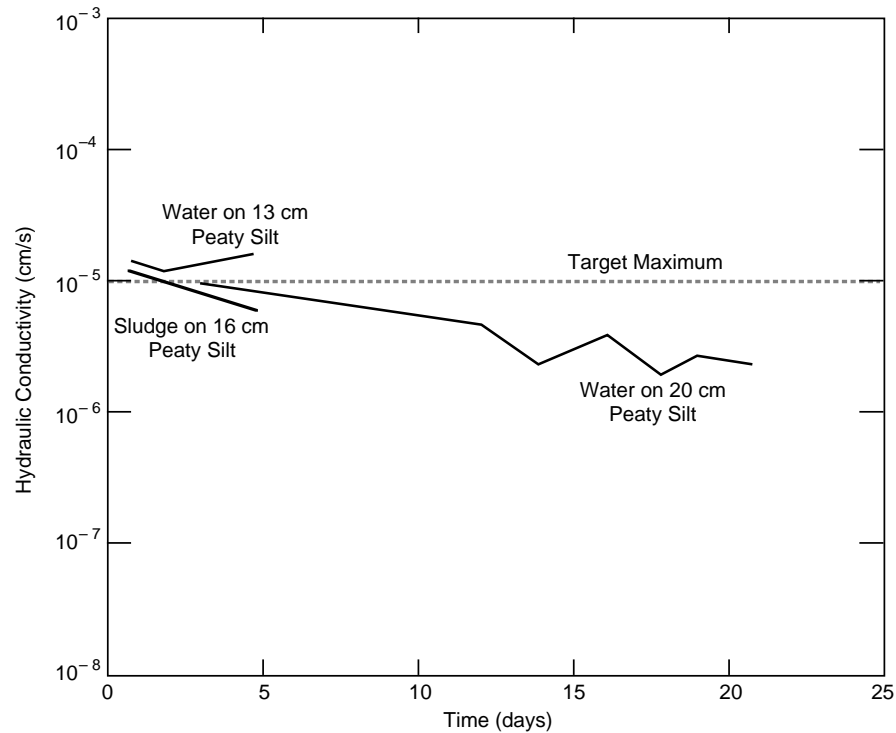
Figure 19. Results of barrel infiltration tests for sediment on peaty silt liner.

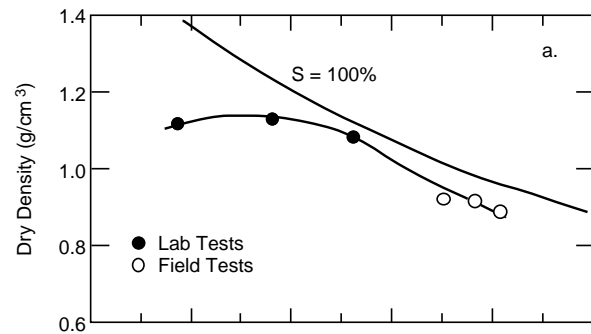
a. Dry density vs. water content.

b. Hydraulic conductivity vs. water content.

Figure 20. Composite of lab and field permeability test results for peaty silt.

conductivity of 1×10^{-5} cm/s or less in the basin area with the peaty silt as a liner is achievable. Figure 20b shows that as long as the water content is in the range of about 38–60%, the peaty silt will provide the desired protection against infiltration. At water contents below 38% the hydraulic conductivity of the peaty silt increases significantly, much as would be expected.

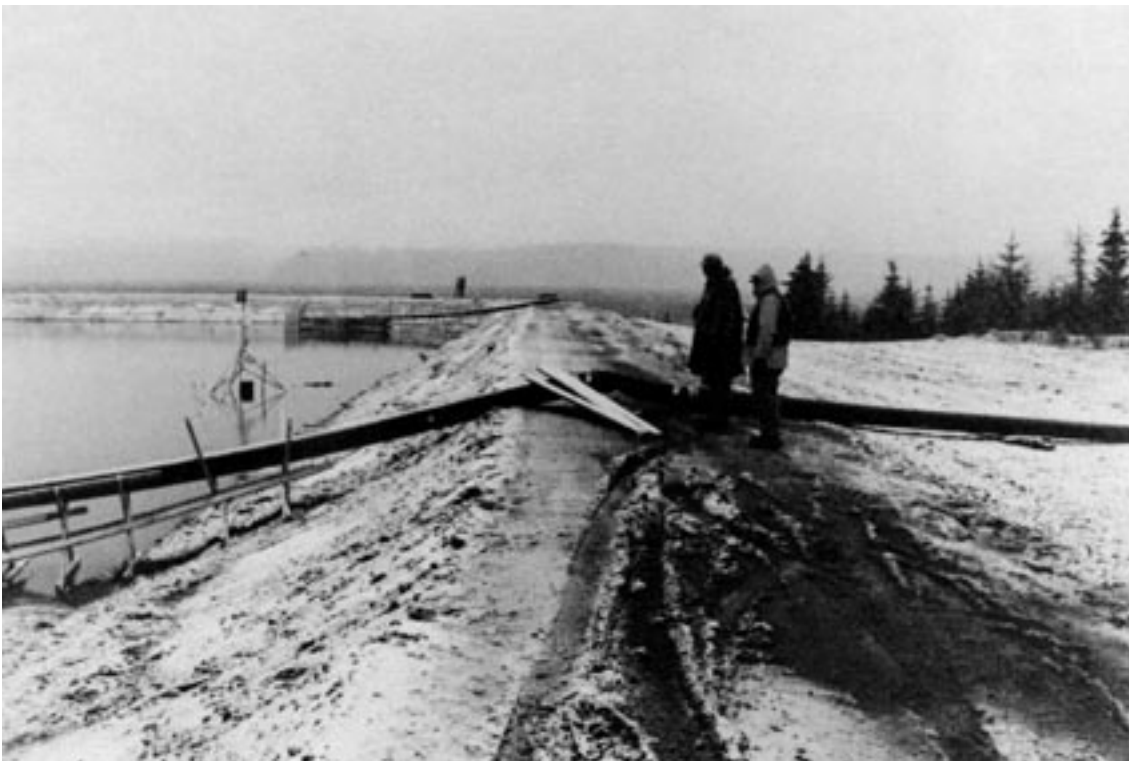
Figure 21. Retention basin berms.

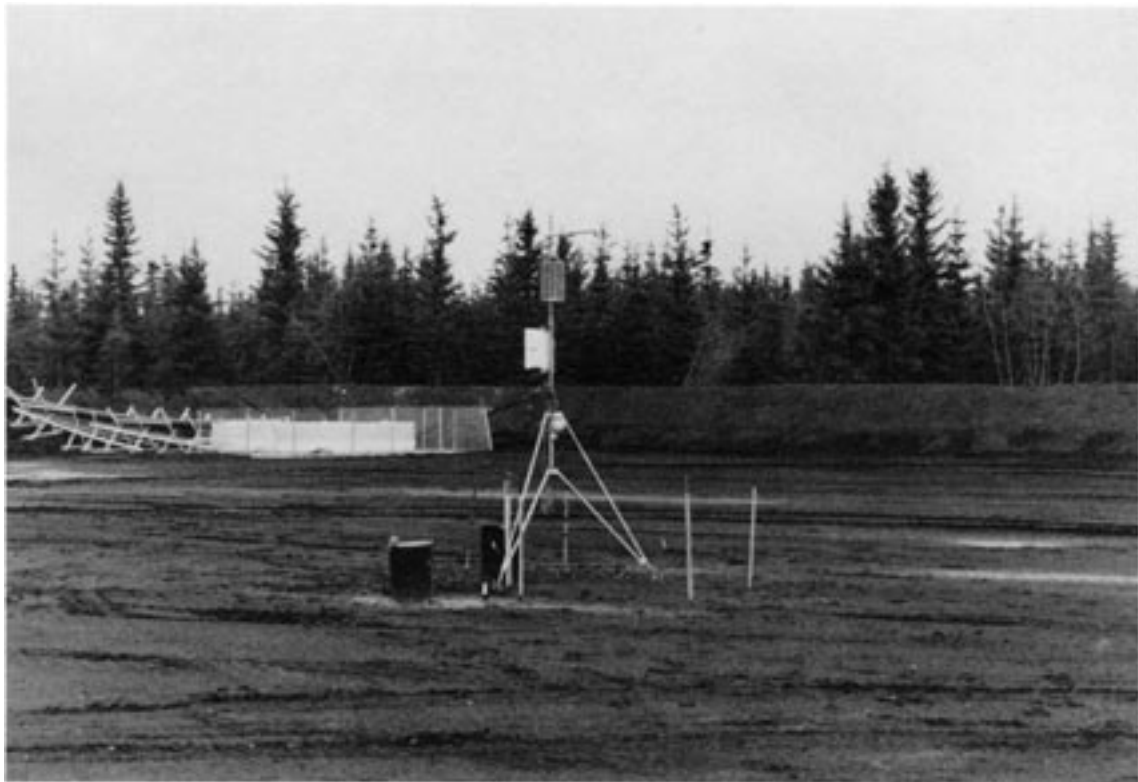
Figure 26. Retention basin instrumentation station.

fect the natural remediation of the WP, four solar-powered instrumentation stations were erected (Fig. 26). Each station contains a rechargeable 12-V power supply, a Campbell CR-10 datalogger, an SM-716 storage module, a four-sensor thermistor string, and a four-sensor moisture block string. Temperature and moisture content are two factors that greatly influence the sublimation process of white phosphorus and thus must be monitored to evaluate remediation efficiency.* In addition to the standard sensor suite, one instrumentation station, located in the center of the basin, has an ultrasonic water level gauge and an air temperature sensor. The water level sensor is a Campbell Model UDG01 Ultrasonic Depth Gauge, which incorporates a Polaroid ultrasonic transducer and model 6500 sonar ranging module. It is mounted on an arm located about 2.5 m above the original basin bottom. The air temperature sensor is a Campbell Model 701 thermistor sensor mounted in a gilled enclosure. Air temperature and spoils level are monitored as part of the remediation process within the basin.

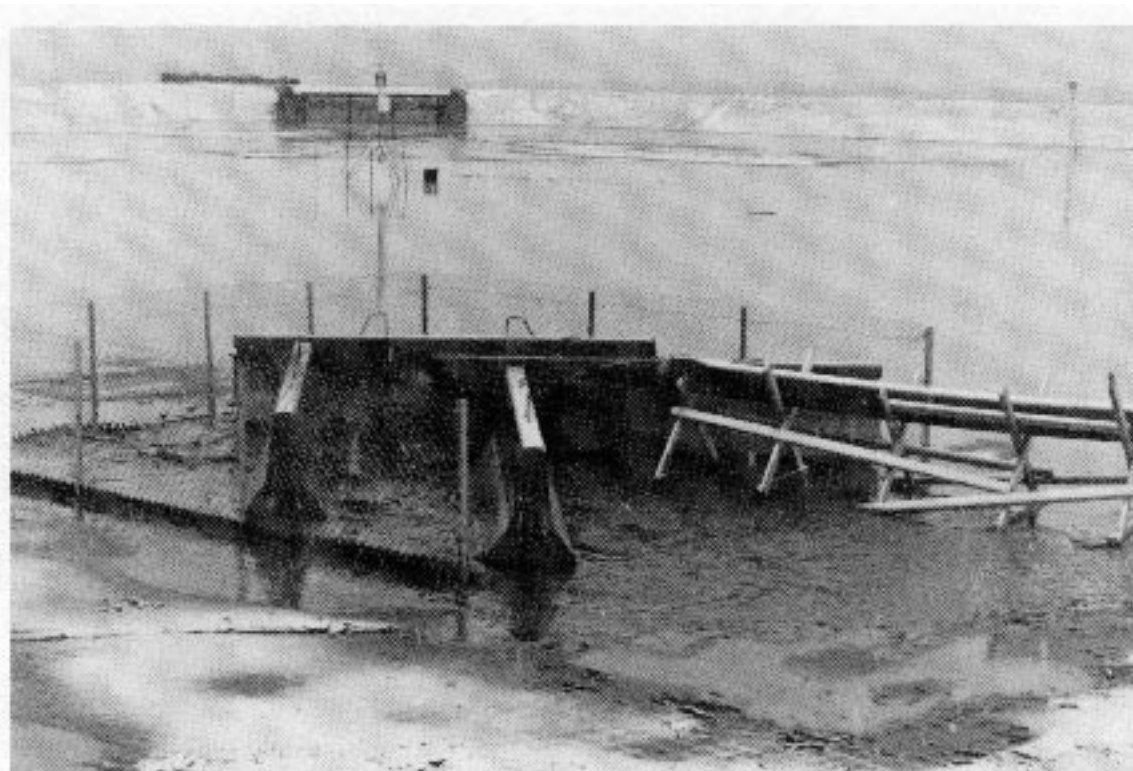
Figure 30. Pumping contaminated spoils from the Flats.
