# ASSESSMENT OF POTENTIAL DEBRIS-FLOW PEAK DISCHARGES FROM BASINS BURNED BY THE 2002 MISSIONARY RIDGE FIRE, COLORADO

By  
**Susan H. Cannon, U.S. Geological Survey**  
**John A. Michael, U.S. Geological Survey**  
**Joseph E. Gartner, U.S. Geological Survey**  
**J. Andrew Gleason, Colorado Geological Survey**  
2003

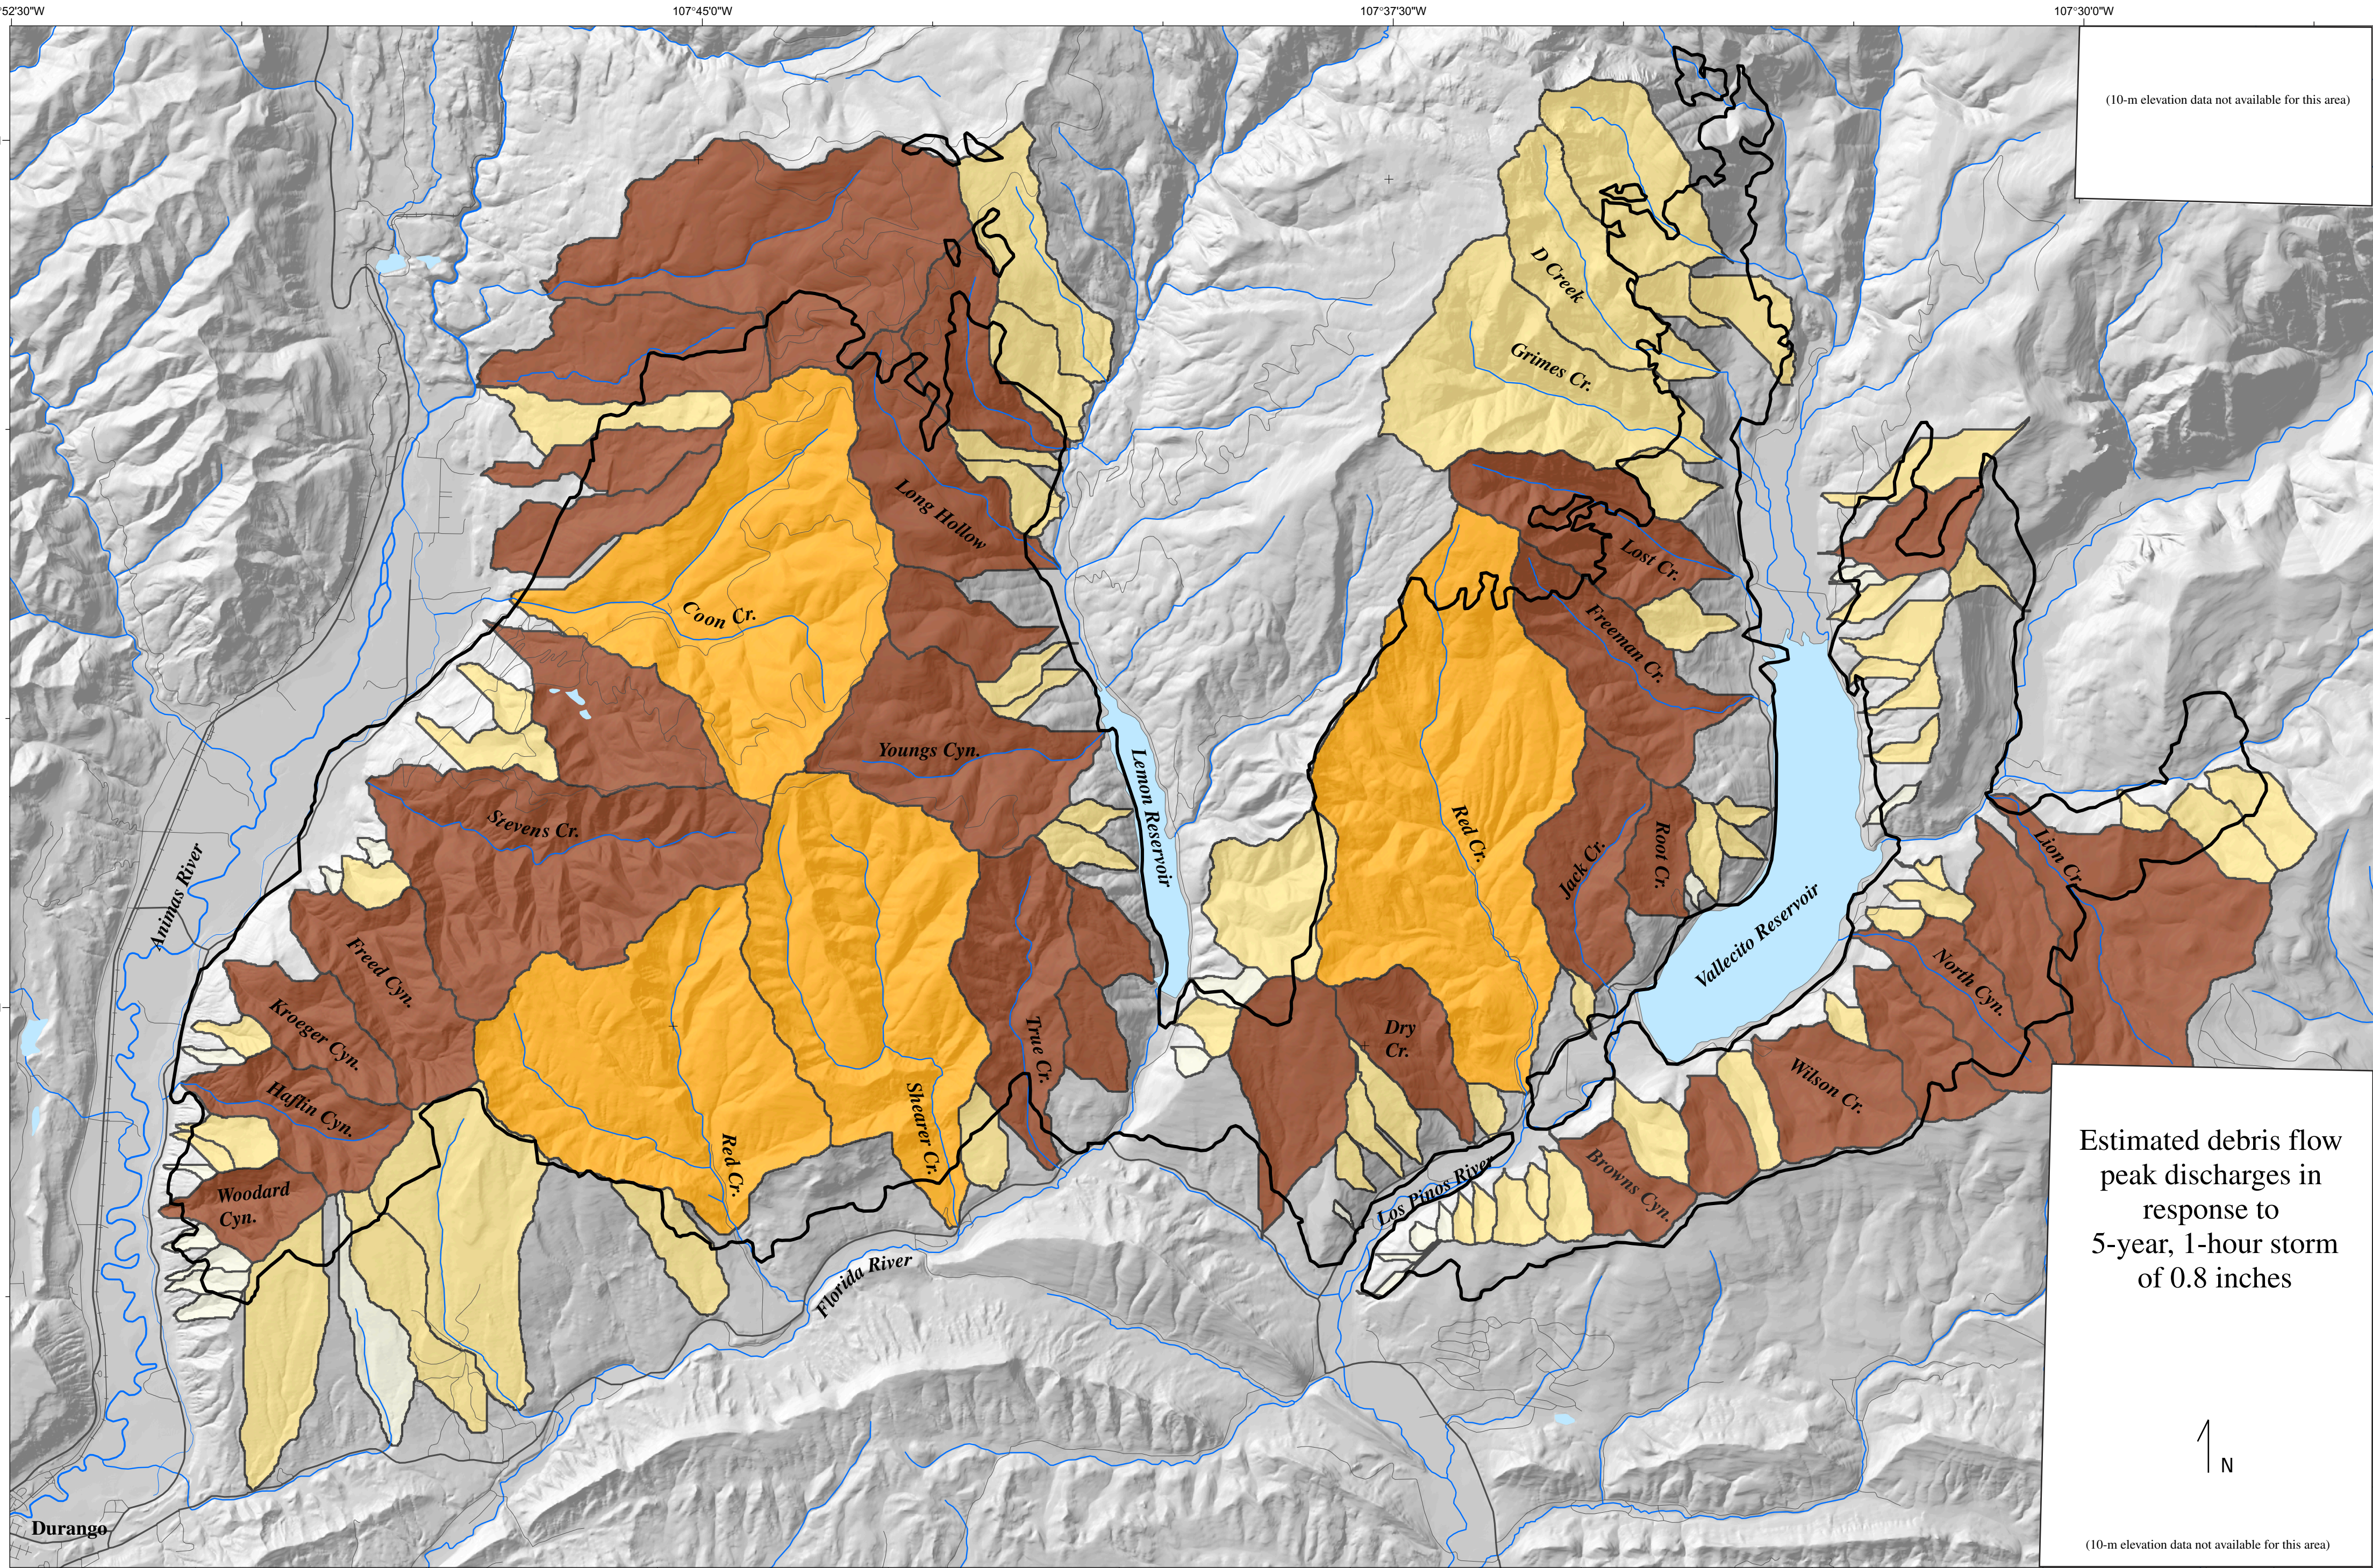
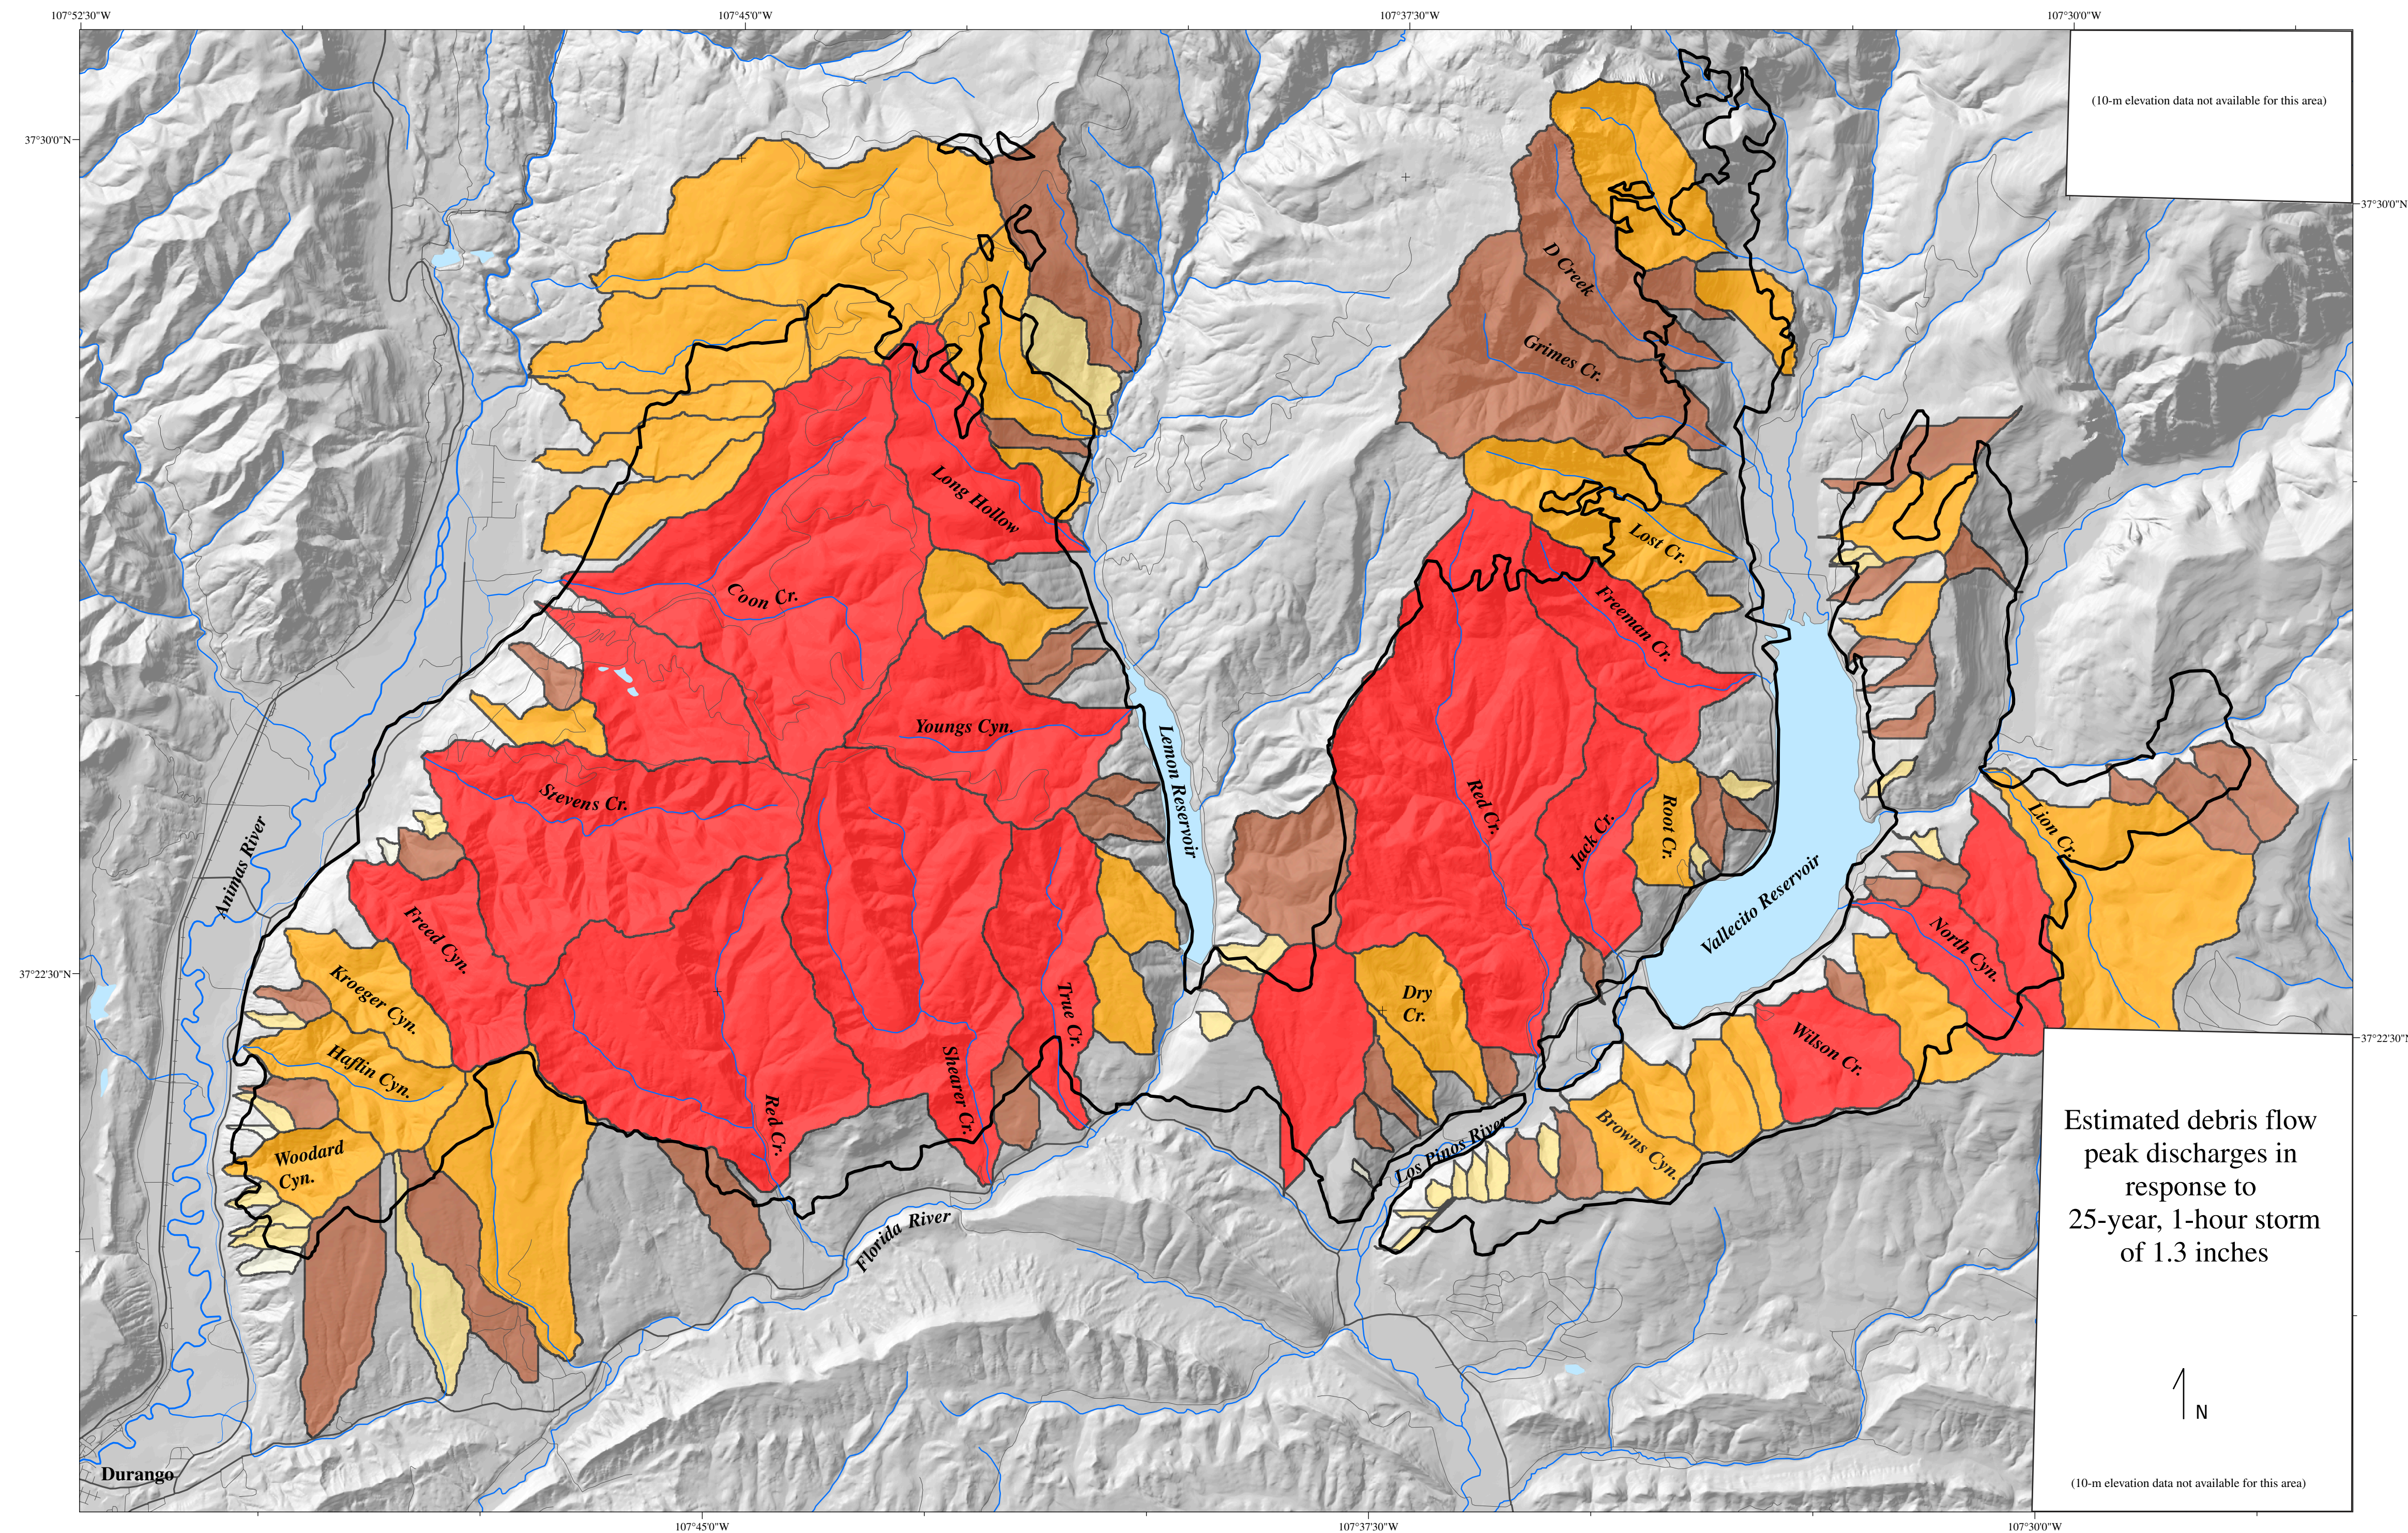
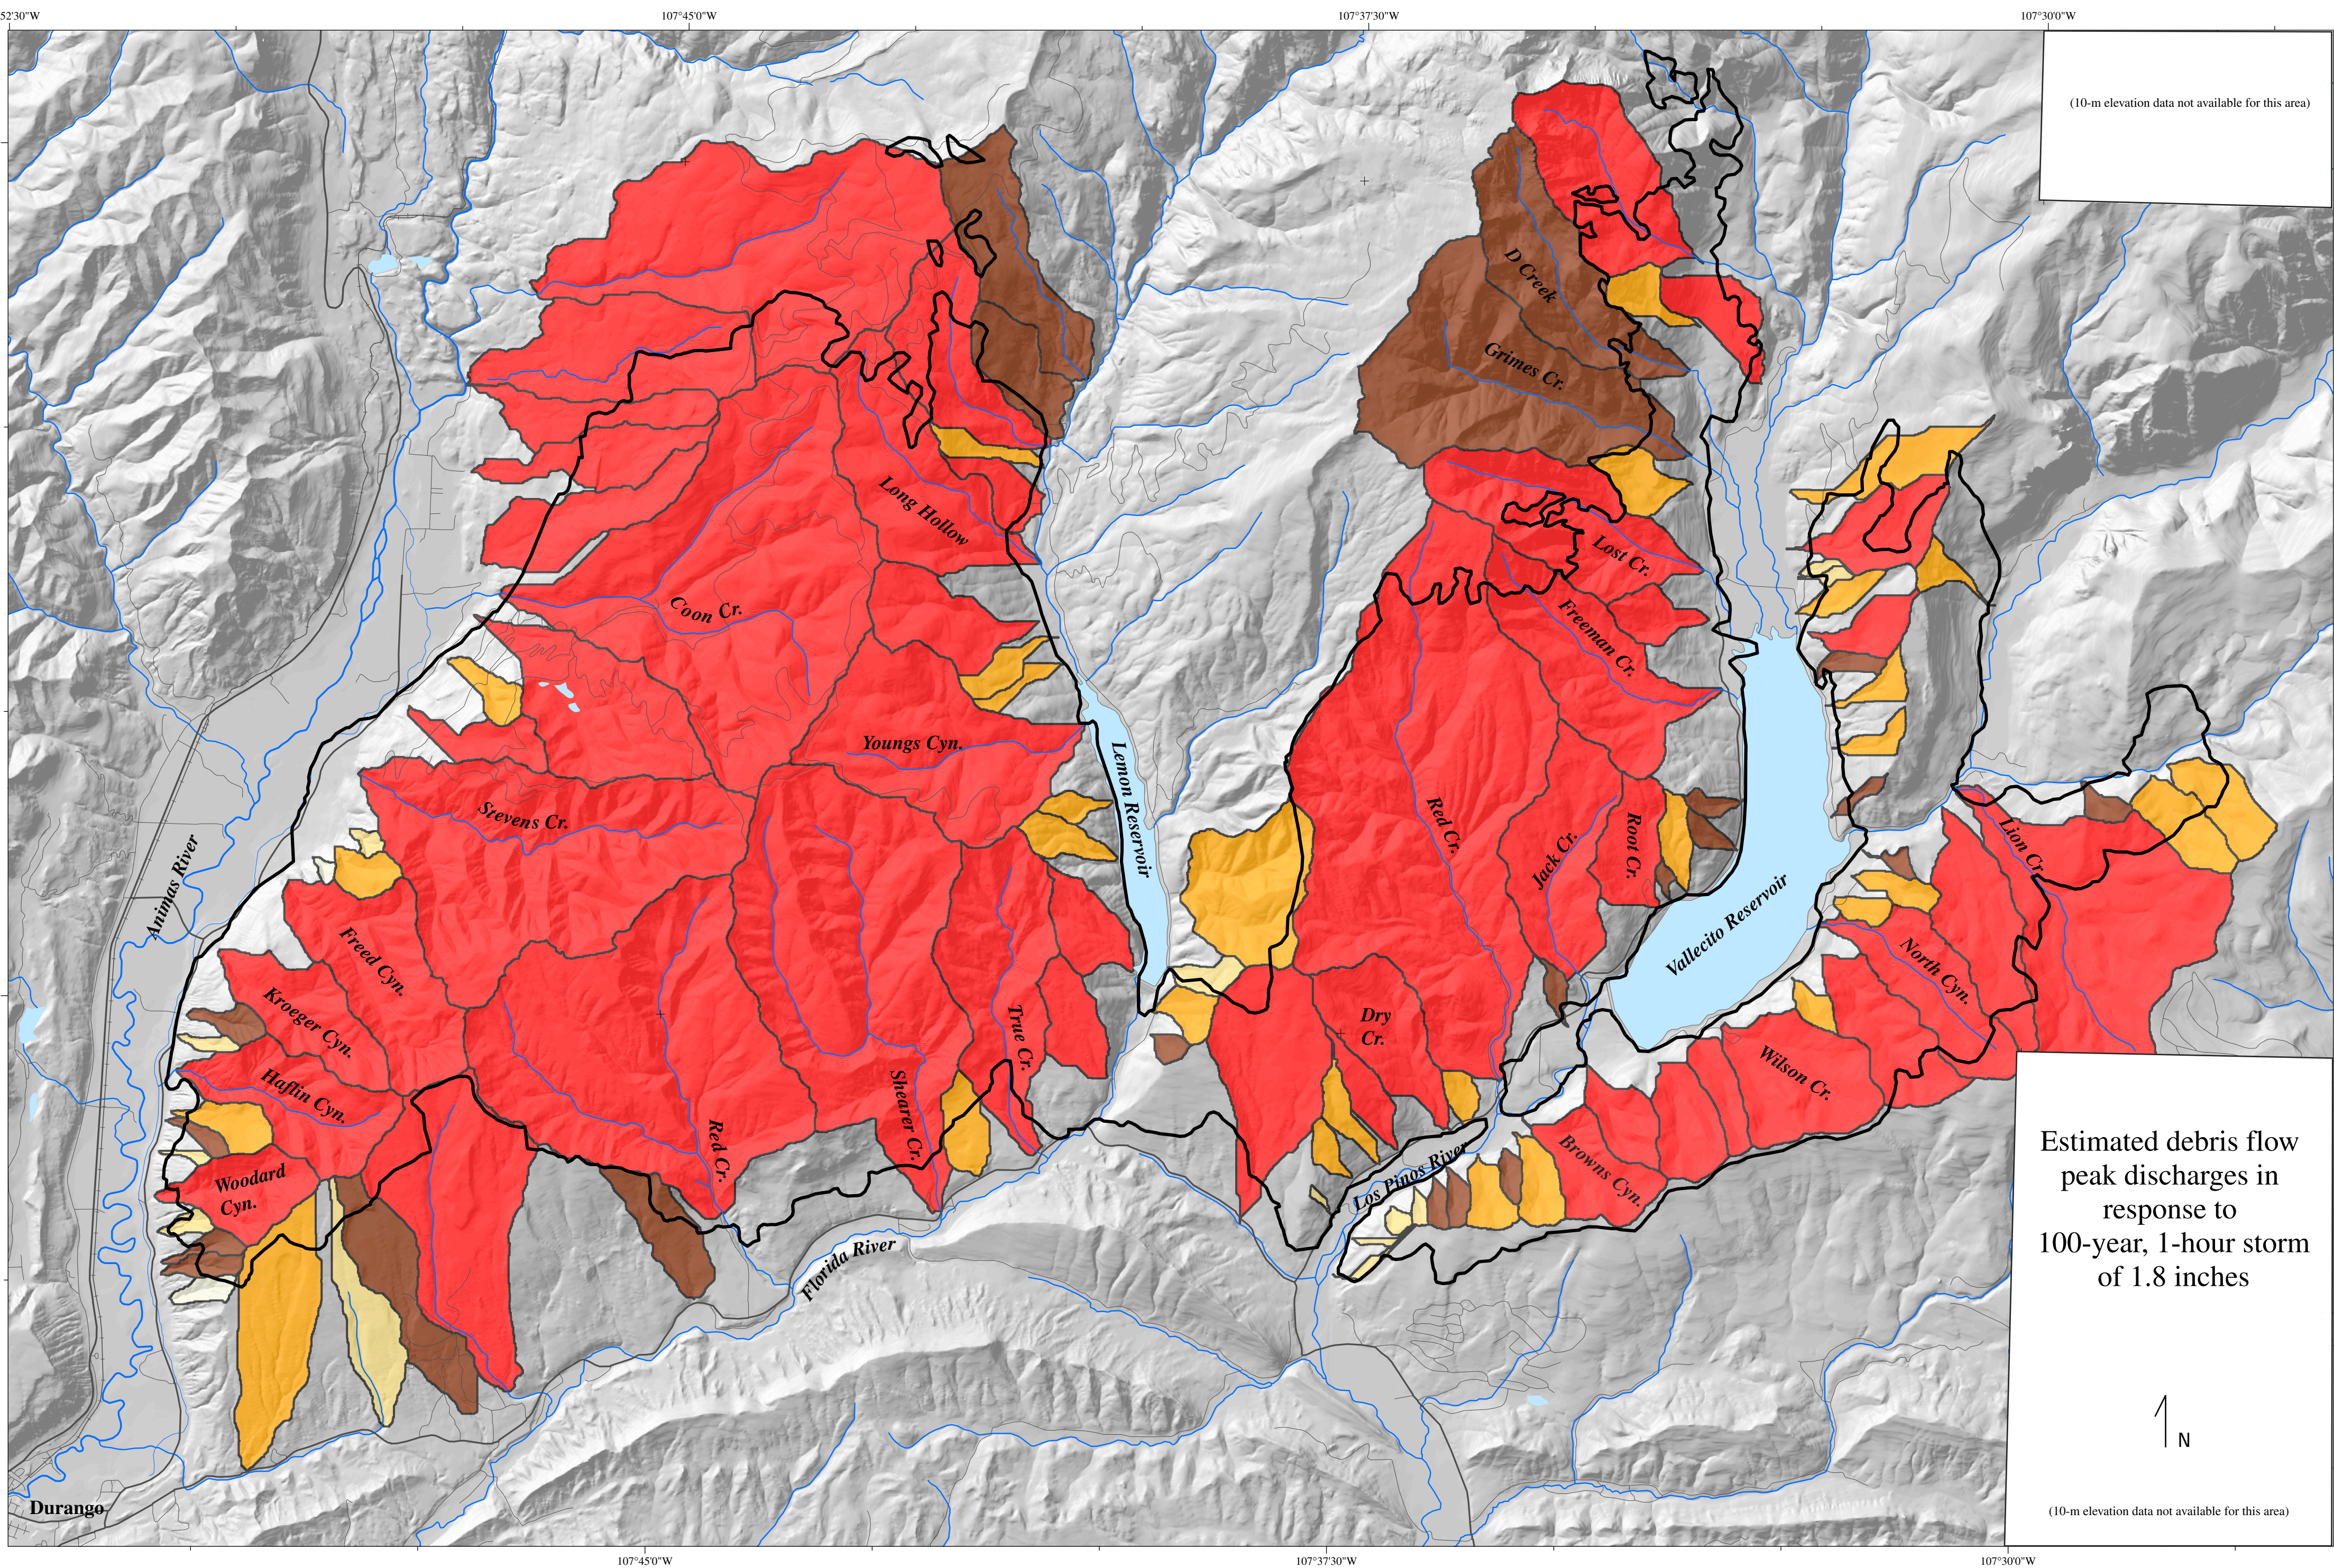
## RANGE OF POTENTIAL DEBRIS-FLOW MAGNITUDES (PEAK DISCHARGES)

Peak discharges calculated for basins burned by the Missionary Ridge fire for the 5-year, 1-hour storm of 0.80 inches (20 mm) ranged between 1 ft/s (0.03 m/s) and 6,446 ft/s (183 m/s). Peak discharges for the 25-year, 1-hour storm of 1.3 inches (34 mm) and the 100-year, 1-hour storm of 1.8 inches (46 mm) ranged between 1 ft/s (0.03 m/s) and >8,000 ft/s (227 m/s).

These maps provide estimates of possible ranges of peak discharges of debris flows that can potentially generate from the basins burned by the Missionary Ridge fire in response to the 5-year, 25-year, and 100-year, 1-hour storm. The maps are intended to be used by emergency personnel and citizens to identify the possible magnitude, in terms of peak discharge, of the debris-flow response. This information can be used to focus additional mitigation efforts, to aid in the design of mitigation structures and in decisions for evacuation, shelter, and escape routes in the event of the prediction of summer thunderstorms of similar magnitude to those evaluated here. Note that the potential for debris-flow activity decreases with time and concurrent revegetation and stabilization of hillslopes. Although we are not aware of studies that address burned area recovery rates for terrains similar to those evaluated here, work by Moody and Martin (2001) in decomposed granite terrains in Colorado indicates that recovery to pre-fire conditions can occur within about 4 years of the fire. We thus conservatively expect that the maps presented here may be valid for approximately 5 years after the fire.

Our modeling indicates that in response to the 5-year storm, Coon Creek (on the east side of the Animas Valley), Red and Shearer Creeks (tributaries to the Florida River), and Red Creek (tributary to the Los Pinos River) have the potential to produce debris flows with peak discharges between 6,000 and 8,000 ft/s (170 to 227 m/s).

In response to a 25-year storm on the east side of the Animas Valley, Coon Creek, Elkhorn Canyon, Stevens Creek, and Freed Canyon have the potential to produce debris flows in excess of 8,000 ft/s (>227 m/s). Red, Shearer, True Creeks, Young Canyon, and Long Hollow (all tributaries to the Florida River) have the potential for a similar response, as do Freeman, Jack, Red and Wilson Creeks, two unnamed creeks, and North Canyon in the Los Pinos River basin. The modeling effort indicates that in response to a 100-year recurrence storm, all basins both with the gentlest gradients and sparse burn can be expected to produce a debris-flow response in excess of 8,000 ft/s (>227 m/s). Estimates of peak discharges from debris-flow events that occurred during the summer of 2002 in response to storms with 2 year, or less, recurrence intervals indicate that the values presented here for the 5-year storm are reasonable (Cannon et al., 2003).
