14 PRESERVATION BRIEFS

New Exterior Additions to Historic Buildings: Preservation Concerns

National Park Service
U.S. Department of the Interior
Technical Preservation Services

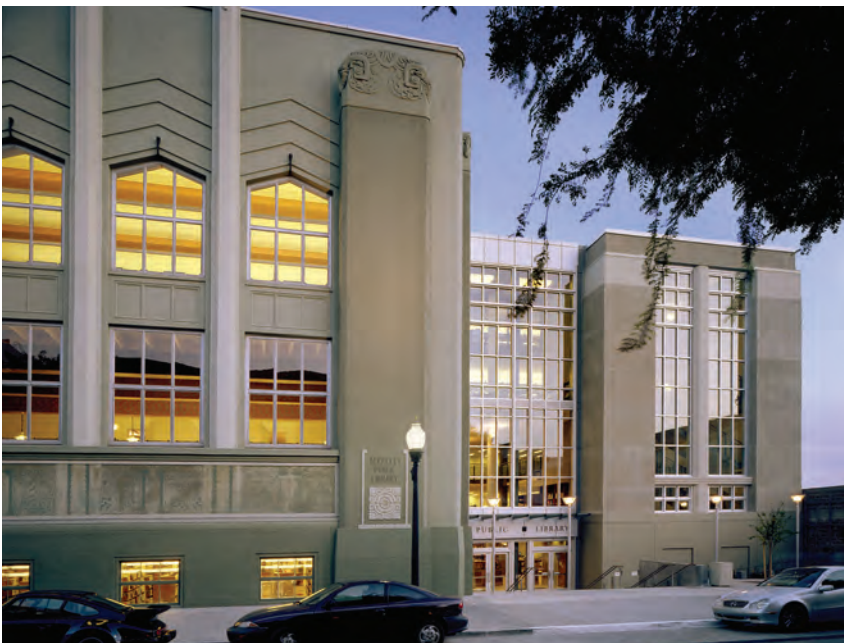
Figure 1. The addition to the right with its connecting hyphen is compatible with the Collegiate Gothic-style library. The addition is set back from the front of the library and uses the same materials and a simplified design that references, but does not copy, the historic building. Photo: David Wakely Photography.

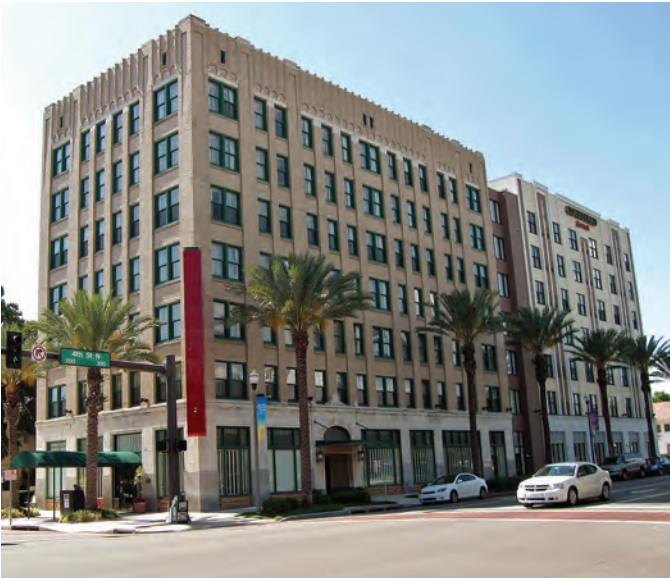
Figure 2. The new section on the right is appropriately scaled and reflects the design of the historic Art Deco-style hotel. The apparent separation created by the recessed connector also enables the addition to be viewed as an individual building.

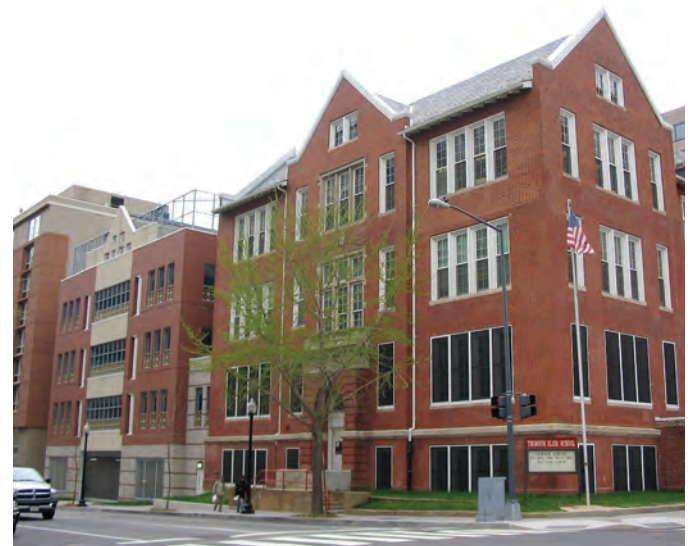
Figure 3. The red and buff-colored parking addition with a rooftop playground is compatible with the early-20th century school as well as the neighborhood in which it also serves as infill in the urban setting.

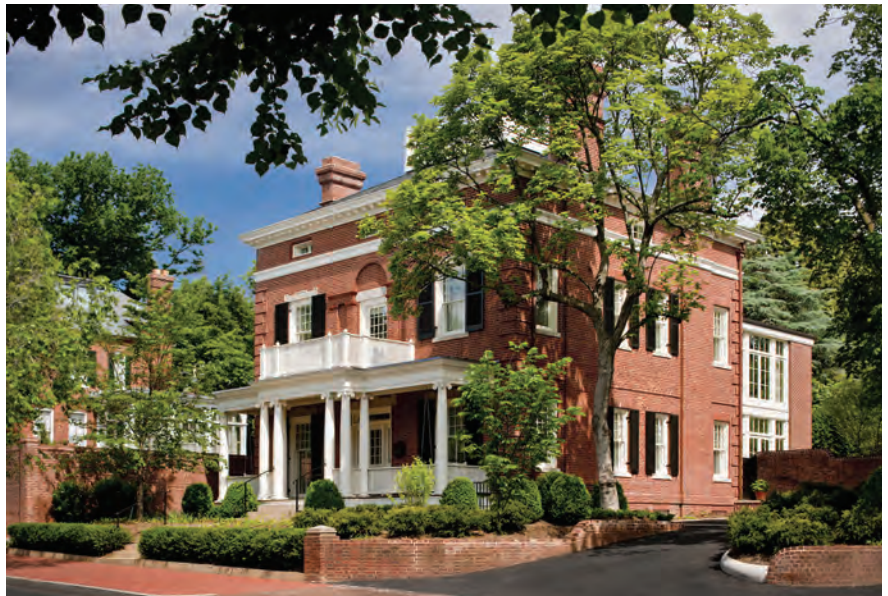
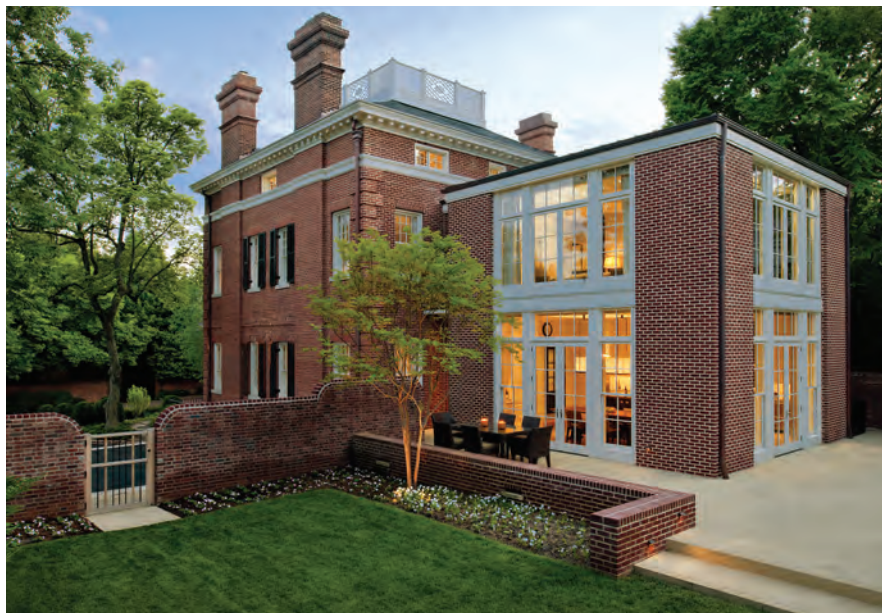
Figure 4. This glass and brick structure is a harmonious addition set back and connected to the rear of the Colonial Revival-style brick house. Cunningham/Quill Architects. Photos: © Maxwell MacKenzie.

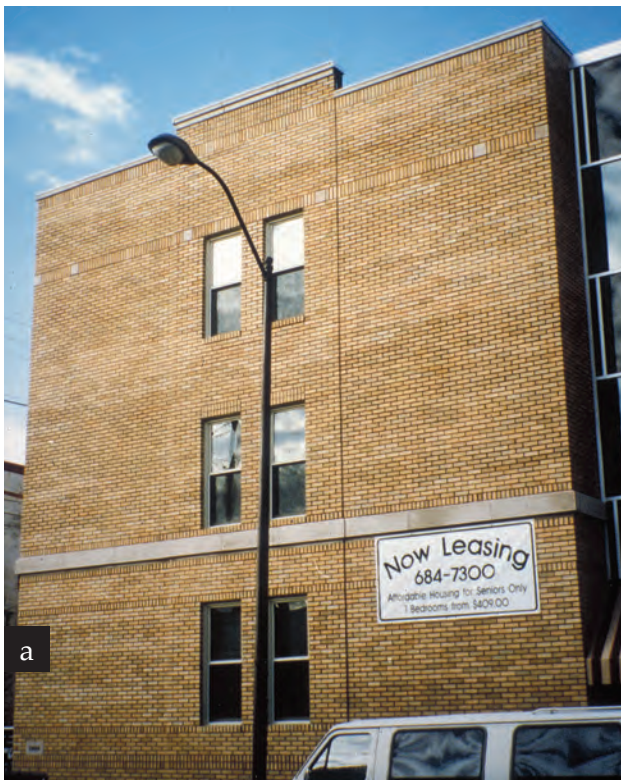
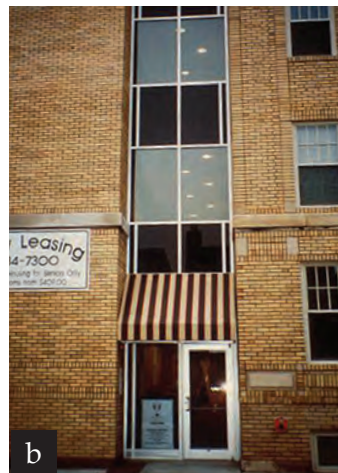
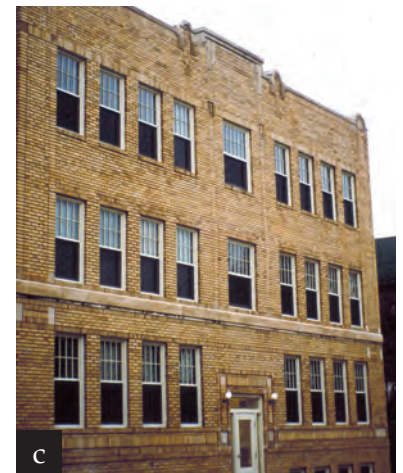
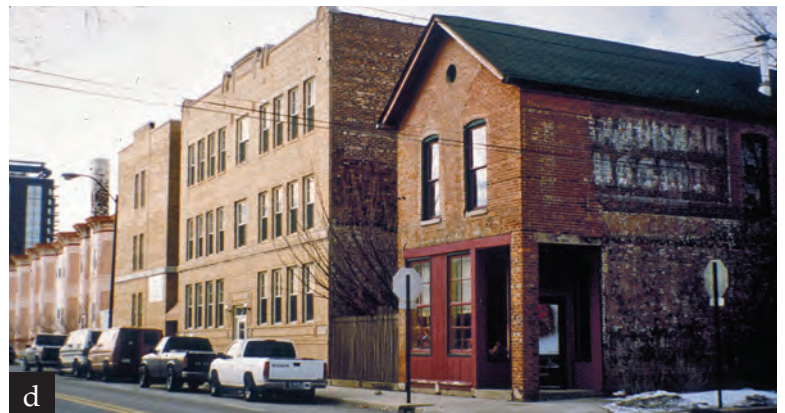
Figure 5. This addition (a) is constructed of matching brick and attached by a recessed connector (b) to the 1914 apartment building (c). The design is compatible and the addition is smaller and subordinate to the historic building (d).

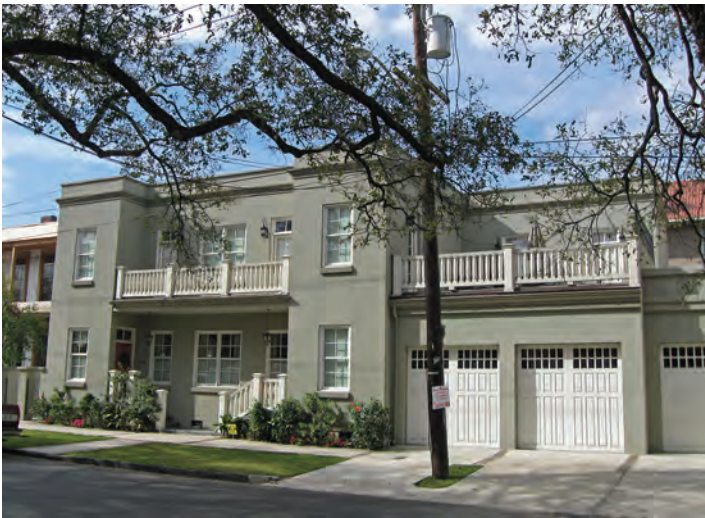
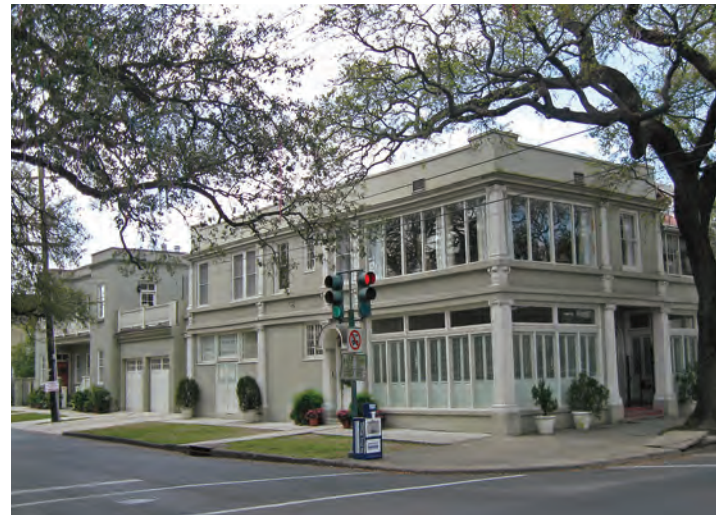
Figure 6. A new addition (left) is connected to the garage which separates it from the main block of the c. 1910 former florist shop (right). The addition is traditional in style, yet sufficiently restrained in design to distinguish it from the historic building.

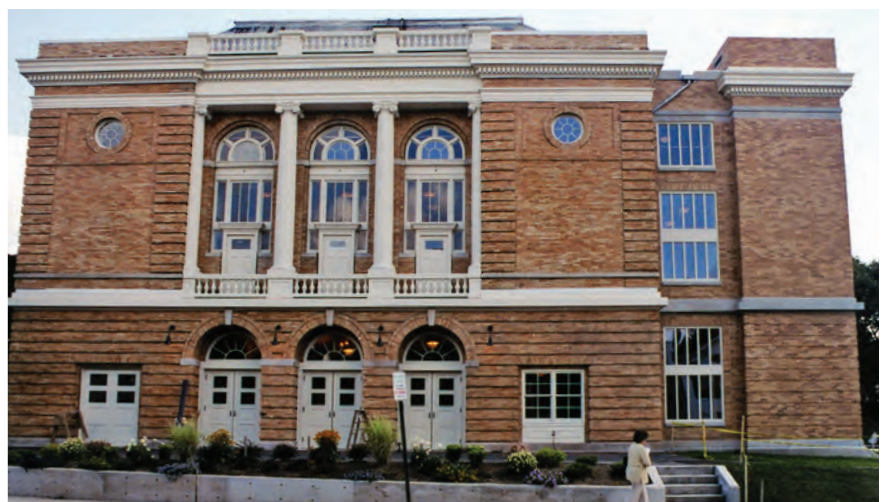
Figure 7. A vacant side lot was the only place a new stair tower could be built when this 1903 theater was rehabilitated as a performing arts center. Constructed with matching materials, the stair tower is set back with a recessed connector and, despite its prominent location, it is clearly subordinate and differentiated from the historic theater.

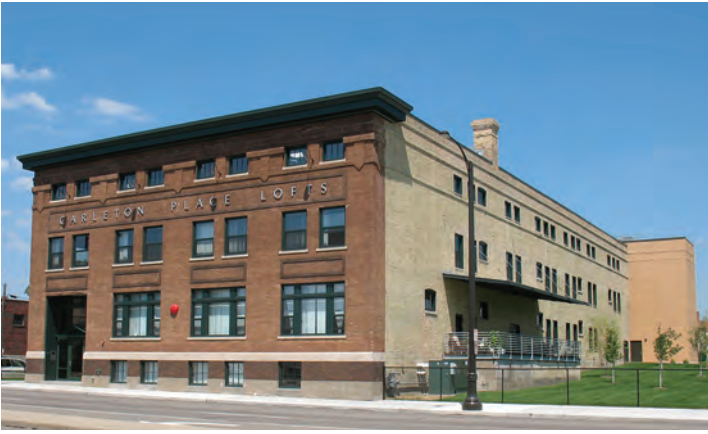
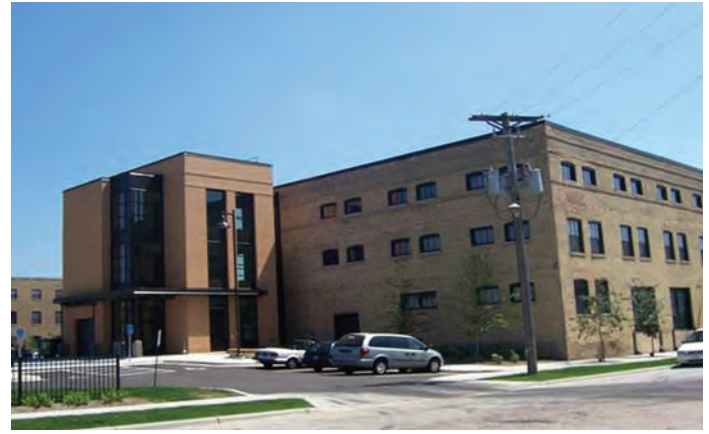
Figure 8. The rehabilitation of this large, early-20th century warehouse (left) into affordable artists' lofts included the addition of a compatible glass and brick elevator/stair tower at the back (right).

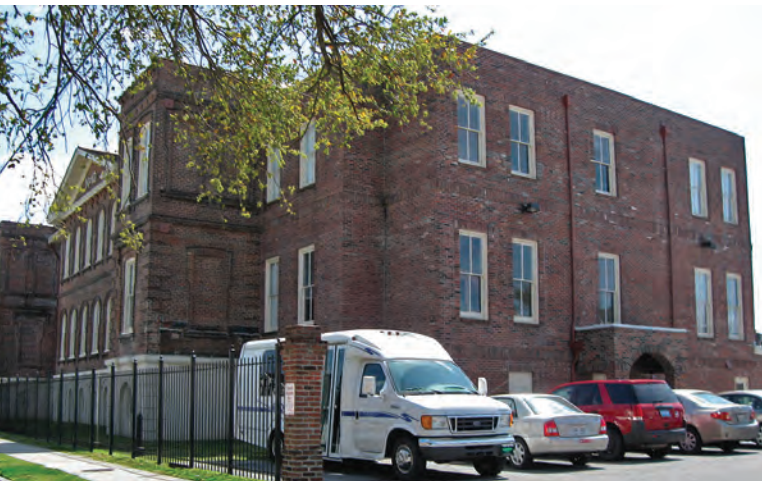
Figure 9. A simple, brick stair tower replaced two non-historic additions at the rear of this 1879 school building when it was rehabilitated as a women's and children's shelter. The addition is set back and it is not visible from the front of the school.

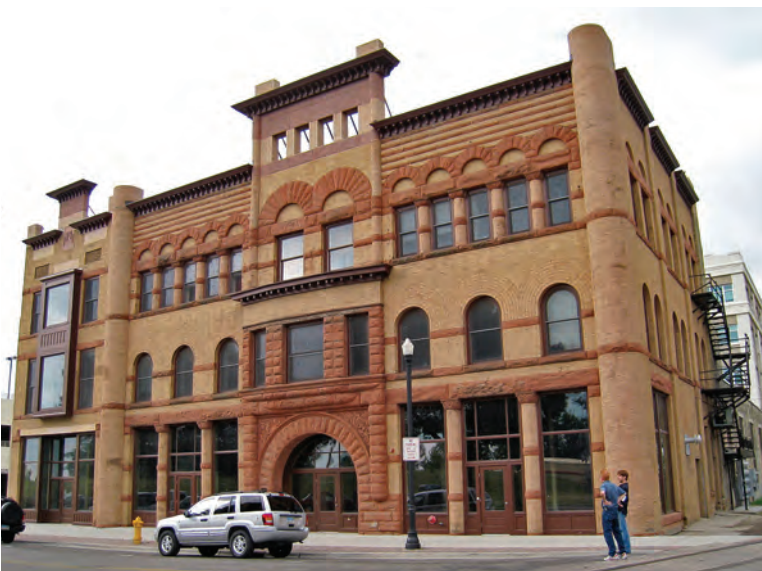
Figure 10. The small size and the use of matching materials ensures that the new addition on the left is compatible with the historic Romanesque Revival-style building.

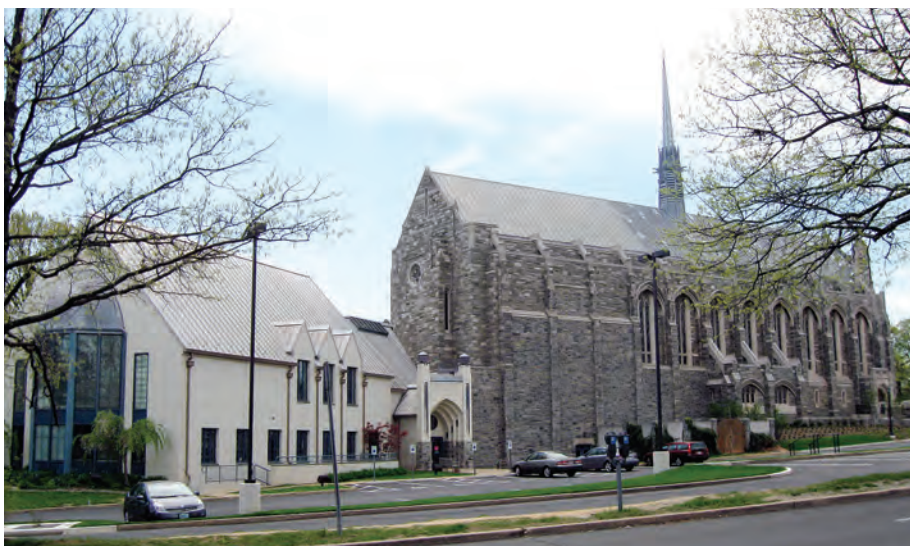
Figure 11. The addition to this early-20th century Gothic Revival-style church provides space for offices, a great hall for gatherings and an accessible entrance (left). The stucco finish, metal roof, narrow gables and the Gothic-arched entrance complement the architecture of the historic church. Placing the addition in back where the ground slopes away ensures that it is subordinate and minimizes its impact on the church (below).

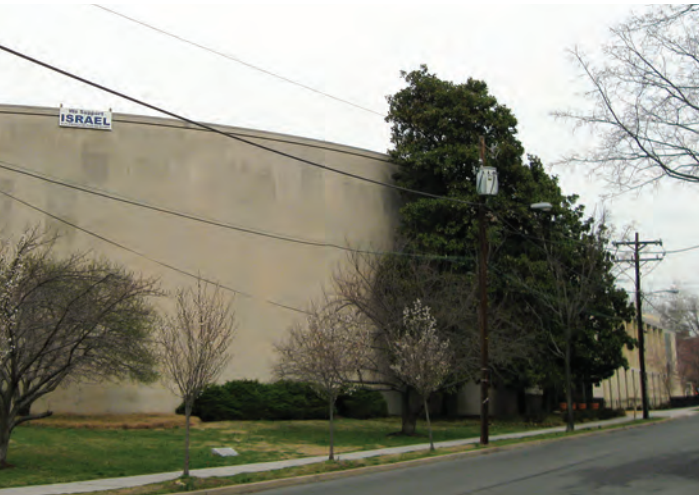
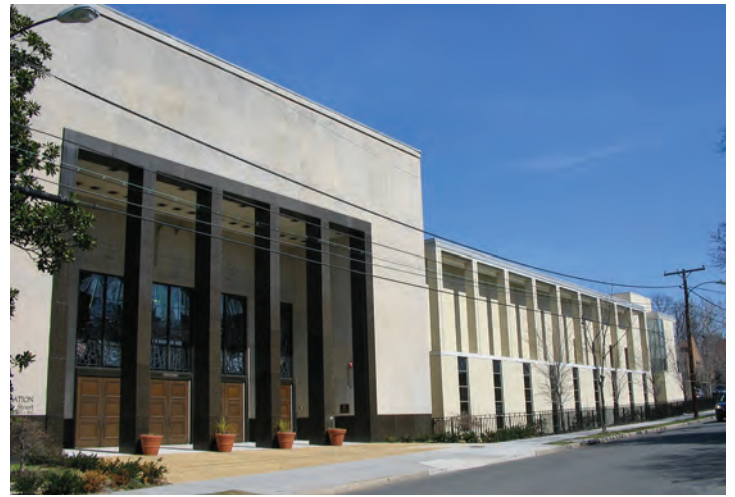
Figure 12. This 1954 synagogue (left) is accessed through a monumental entrance to the right. The new education wing (far right) added to it features the same vertical elements and color and, even though it is quite large, its smaller scale and height ensure that it is secondary to the historic resource.

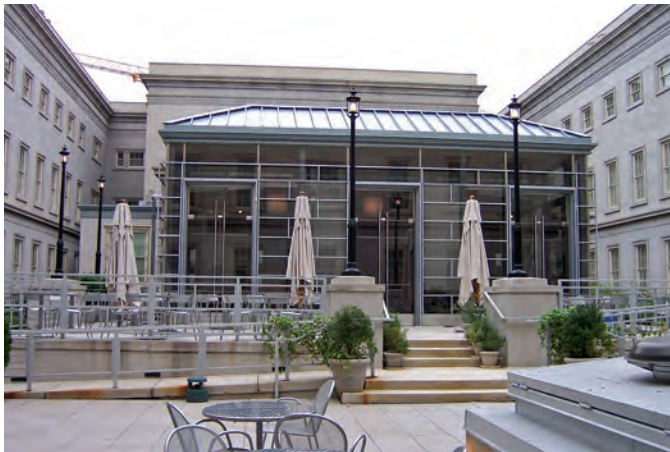
Figure 13. A glass and metal structure was constructed in the courtyard as a restaurant when this 1839 building was converted to a hotel. Although such an addition might not be appropriate in a more public location, it is compatible here in the courtyard of this historic building.

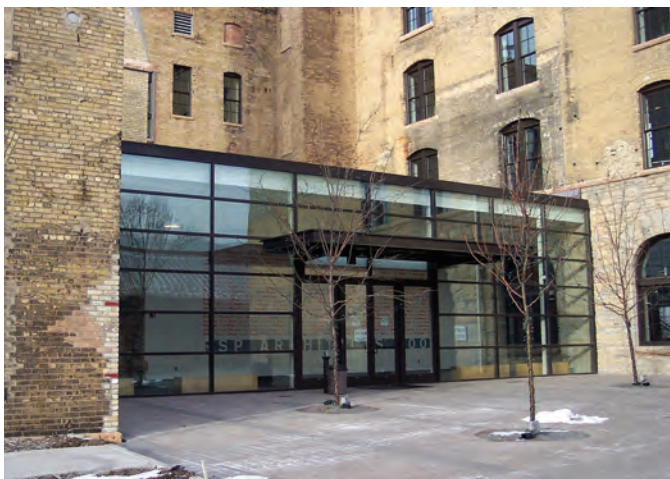
Figure 14. This glass addition was erected at the back of an 1895 former brewery during rehabilitation to provide another entrance. The addition is compatible with the plain character of this secondary elevation.

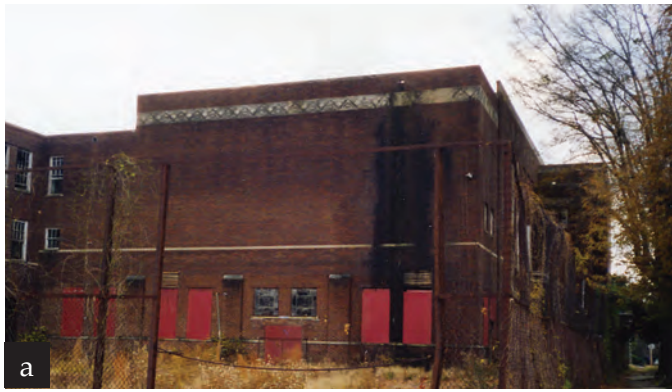
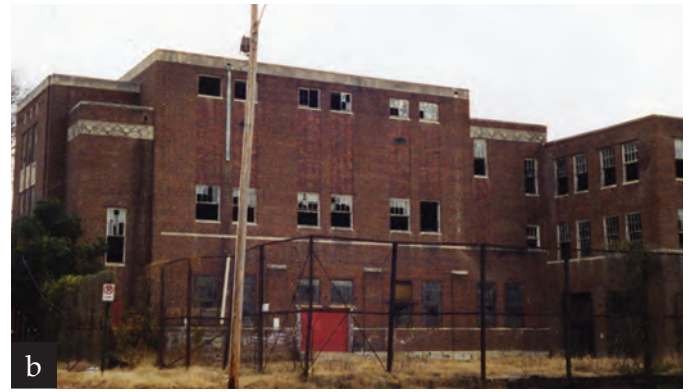
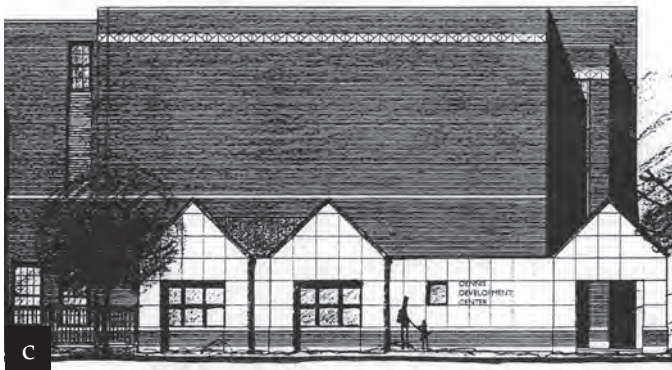
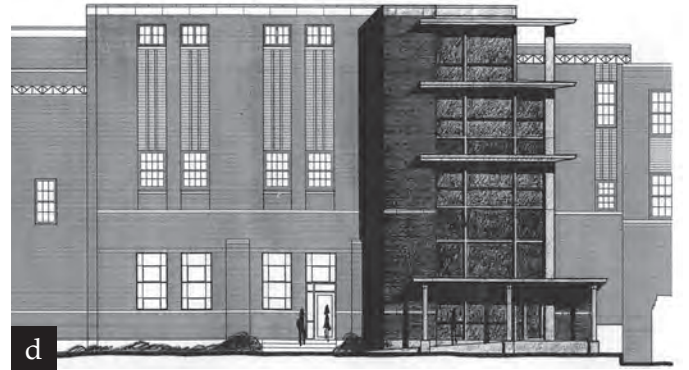
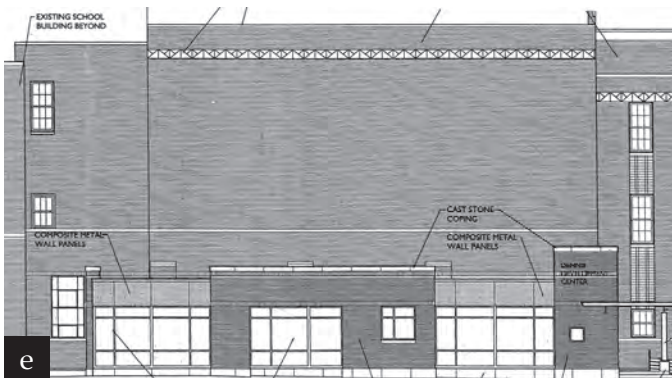
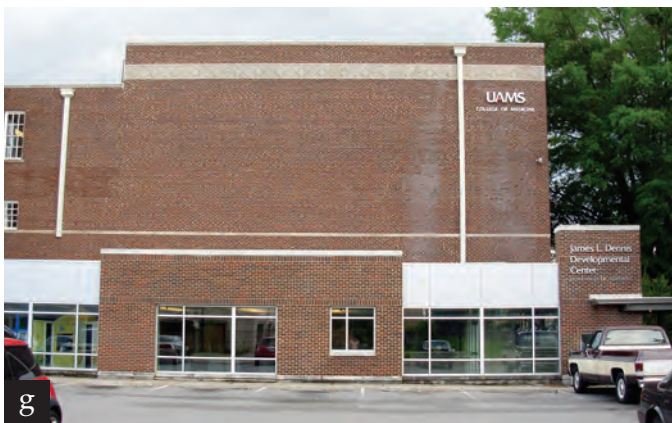
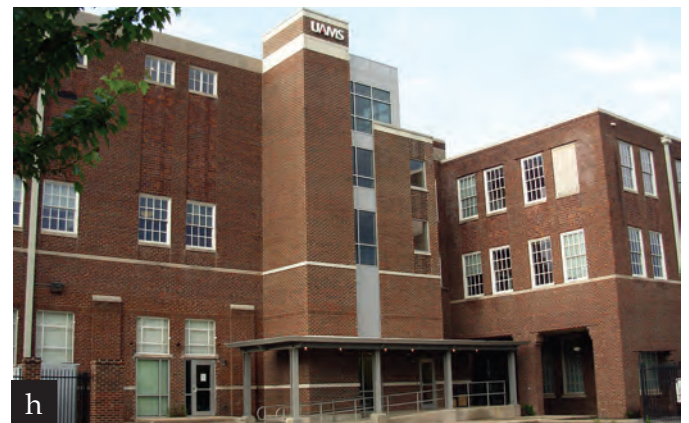
Figure 15. The rehabilitation of a c. 1930 high school auditorium for a clinic and offices proposed two additions: a one-story entrance and reception area on this elevation (a); and a four-story elevator and stair tower on another side (b). The gabled entrance (c) first proposed was not compatible with the flat-roofed auditorium and the design of the proposed stair tower (d) was also incompatible and overwhelmed the historic building. The designs were revised (e-f) resulting in new additions that meet the Standards (g-h).

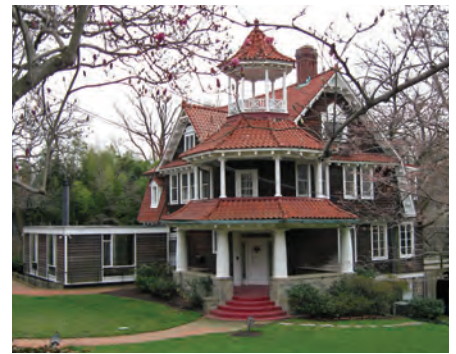
Figure 17. The small addition on the left is starkly different and it is not compatible with the eclectic, late-19th century house.

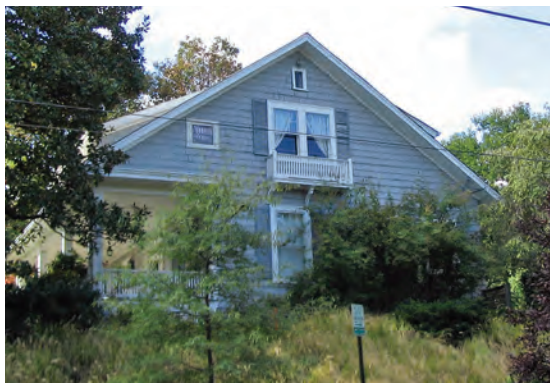
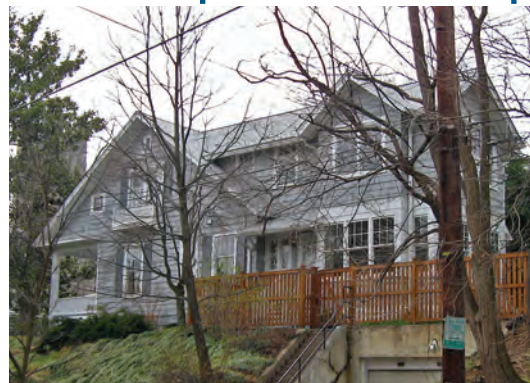
Figure 18. The expansion of a one- and one-half story historic bungalow (left) with a large two-story rear addition (right) has greatly altered and obscured its distinctive shape and form.

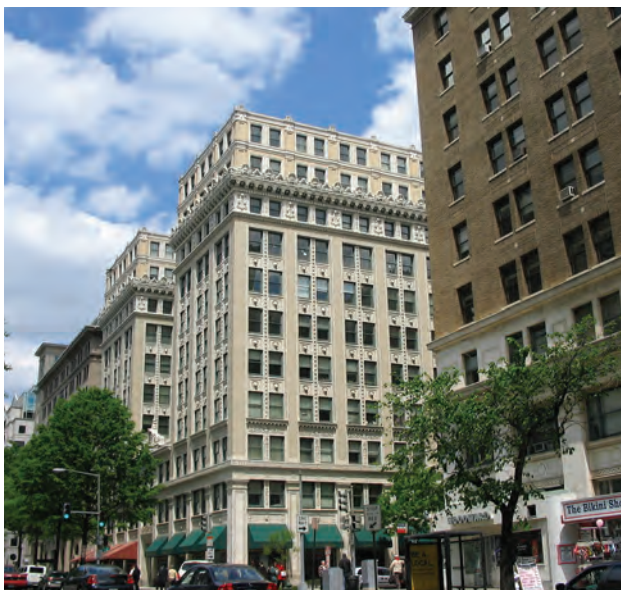
Figure 19. The upper two floors of this early-20th century office building were part of the original design, but were not built. During rehabilitation, the two stories were finally constructed. This treatment does not meet the Standards because the addition has given the building an appearance it never had historically.

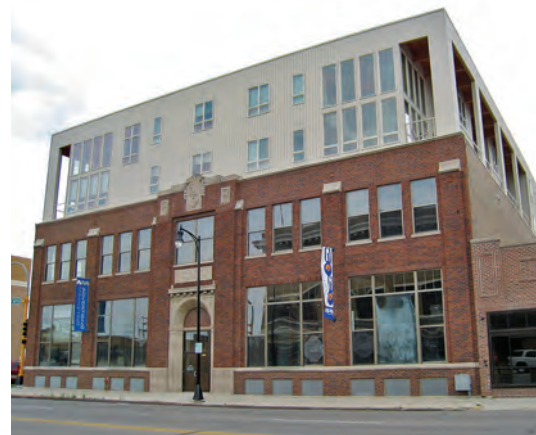
Figure 20. The height, as well as the design, of these two-story rooftop additions overwhelms the two-story and the one-story, low-rise historic buildings.

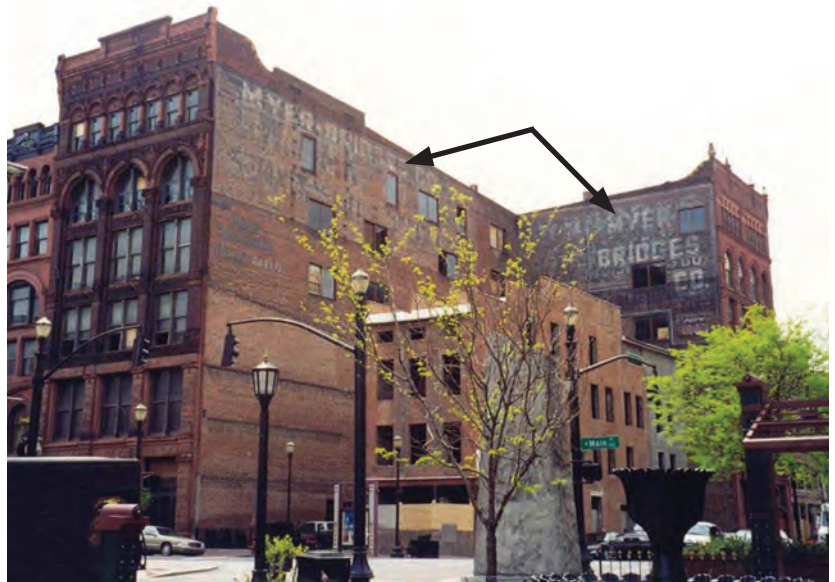
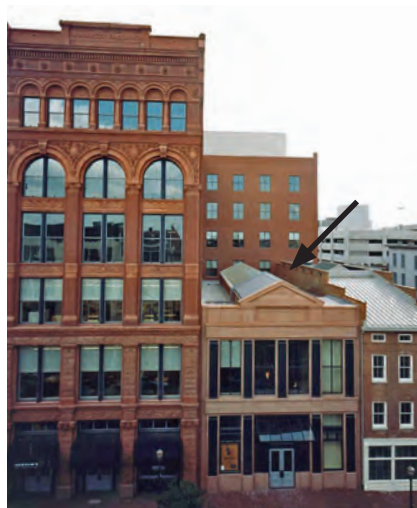
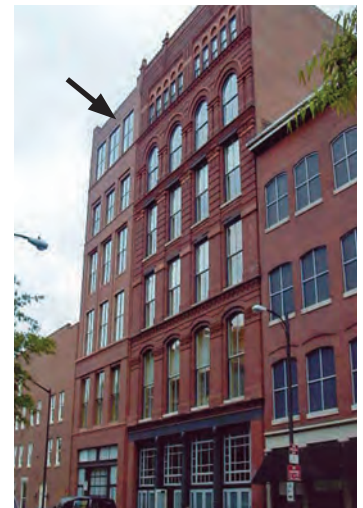
Figure 21. Both wings of this historic L-shaped building (top), which fronts on two city streets, adjoined vacant lots. A two-story addition was constructed on one lot (above, left) and a six-story addition was built on the other (above, right). Like the historic building, which has two different facades, the compatible new additions are also different and appear to be separate structures rather than part of the historic building.

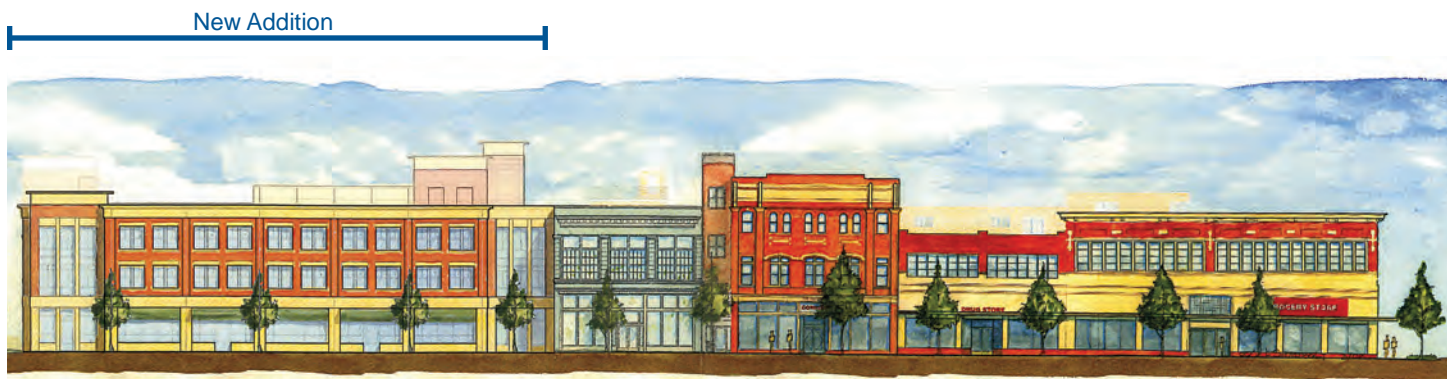
Figure 22. The proposed new addition is compatible with the historic buildings that remain on the block. Its design with multiple storefronts helps break up the mass.

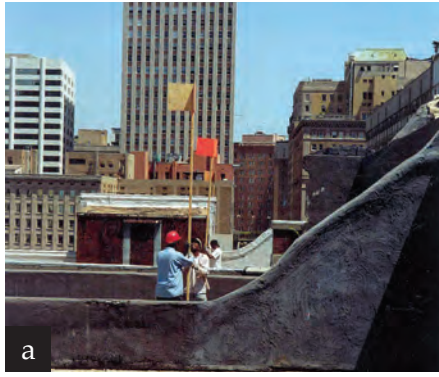
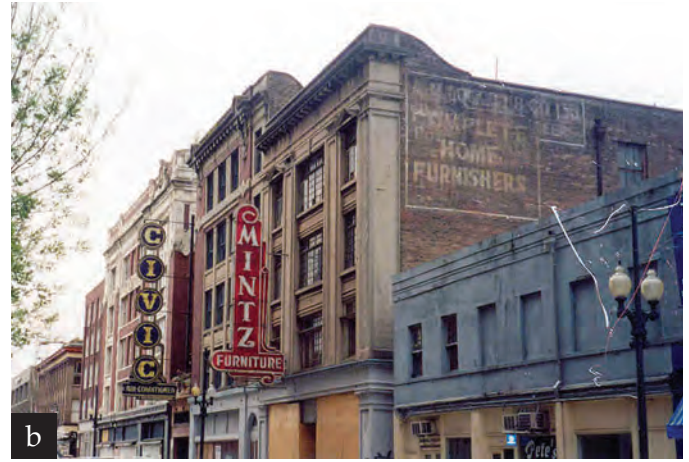
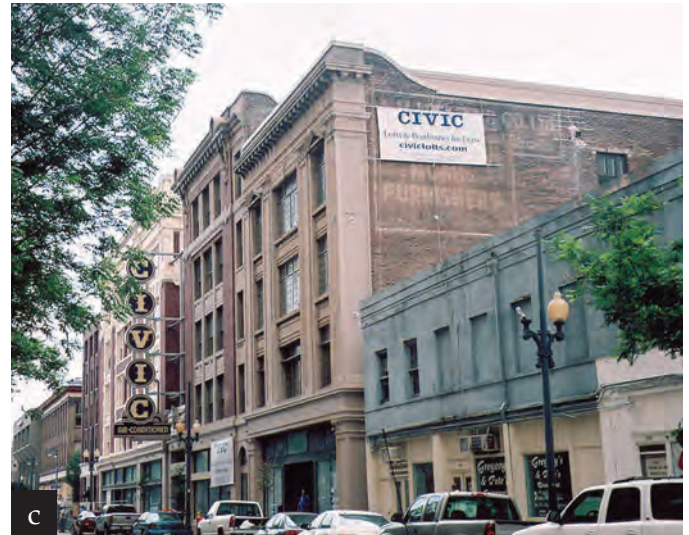
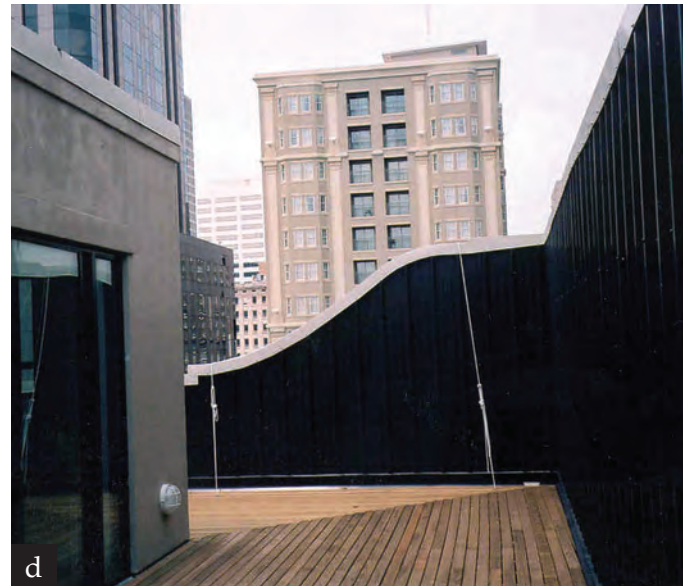
Figure 23. Colored flags marking the location of a proposed penthouse addition (a) were placed on the roof to help evaluate the impact and visibility of an addition planned for this historic furniture store (b). Based on this evaluation, the addition was constructed as proposed. It is minimally visible and compatible with the 1912 structure (c). The tall parapet wall conceals the addition from the street below (d).

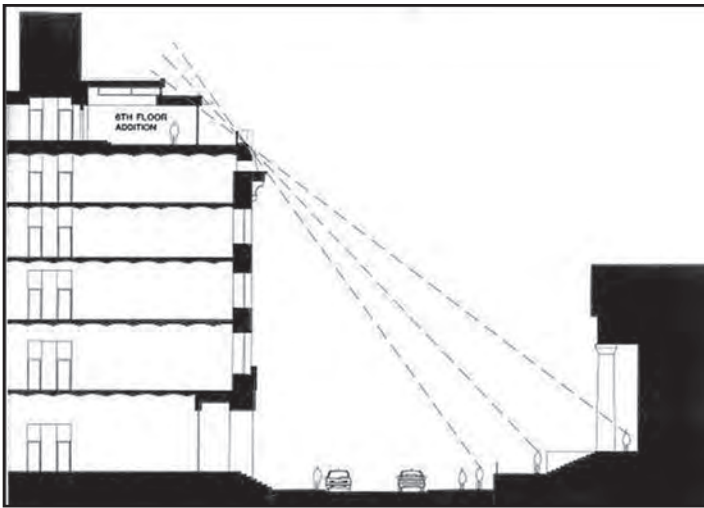
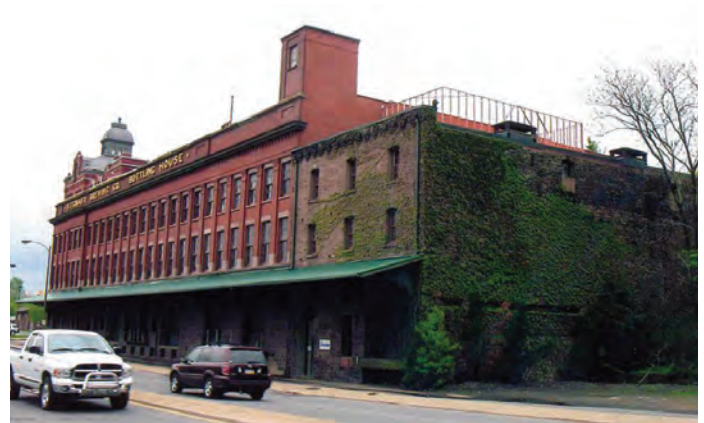
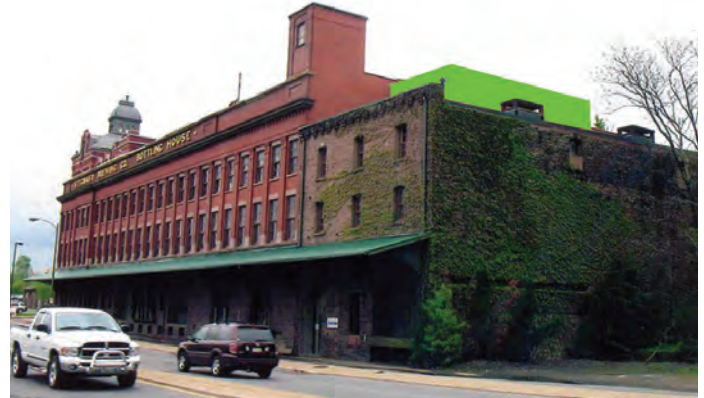
Figure 24. How to Evaluate a Proposed Rooftop Addition.
A sight-line study (above) only factors in views from directly across the street, which can be very restrictive and does not illustrate the full effect of an addition from other public rights of way. A mock up (above, right) or a mock up enhanced by a computer-generated rendering (below, right) is essential to evaluate the impact of a proposed rooftop addition on the historic building.

A number of methods may be used to help evaluate the effect of a proposed rooftop addition on a historic building and district, including pedestrian sight lines, three-dimensional schematics and computer-generated design. However, drawings generally do not provide a true "picture" of the appearance and visibility of a proposed rooftop addition. For this reason, it is often necessary to construct a rough, temporary, full-size or skeletal mock up of a portion of the proposed addition, which can then be photographed and evaluated from critical vantage points on surrounding streets.

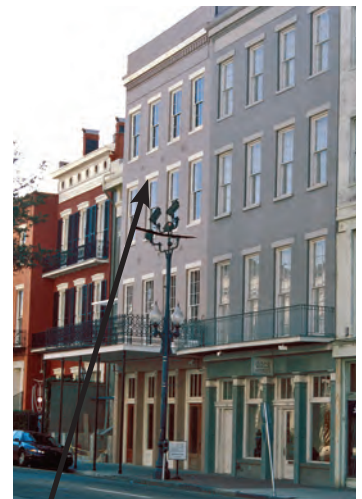
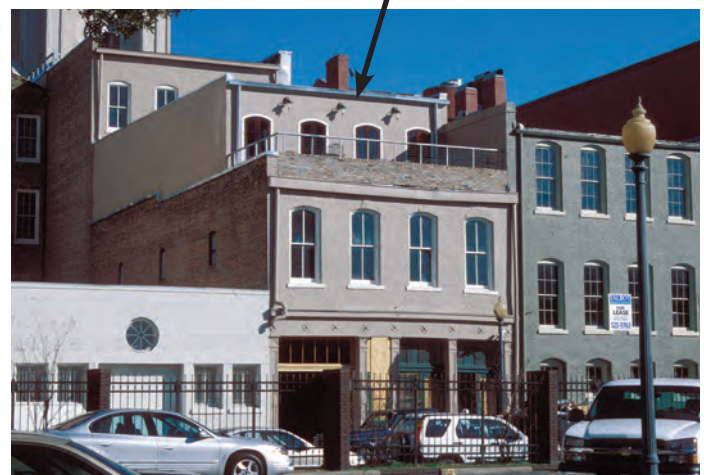
Figure 26. A rooftop addition would have negatively impacted the character of the primary facade (right) of this mid-19th century, four-story structure and the low-rise historic district. However, a third floor was successfully added on the two-story rear portion (below) of the same building with little impact to the building or the district because it blends in with the height of the adjacent building.

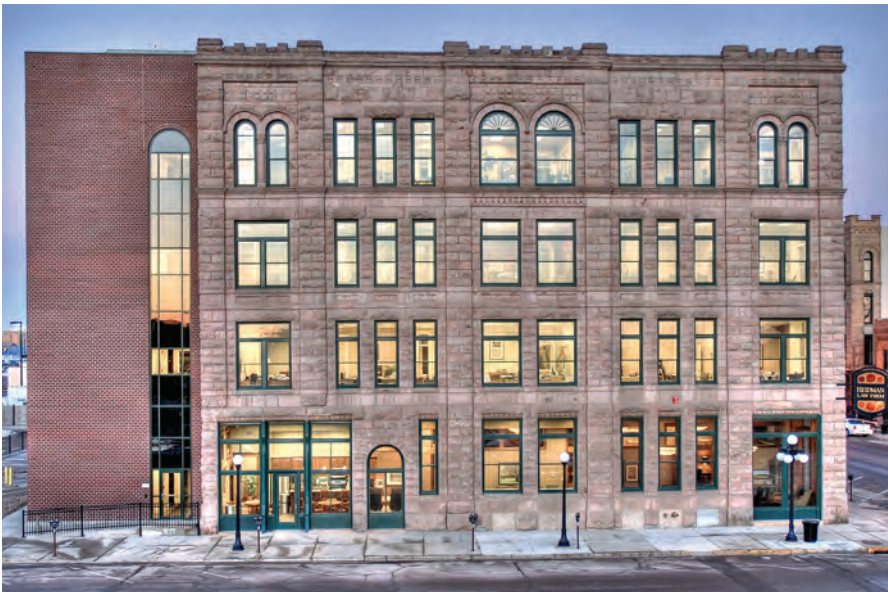
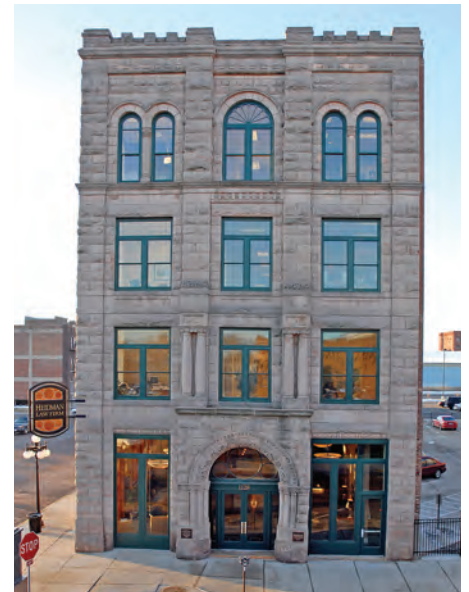
Figure 27. Although the new brick stair/elevator tower (left) is not visible from the front (right), it is on a prominent side elevation of this 1890 stone bank. The compatible addition is set back and does not compete with the historic building. Photos: Chadd Gossmann, Aurora Photography, LLC.

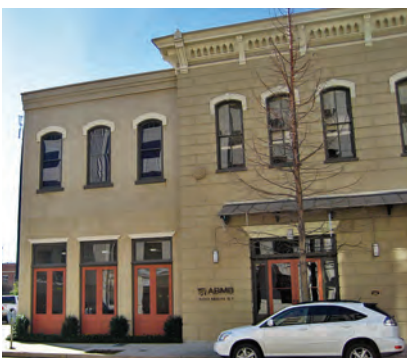
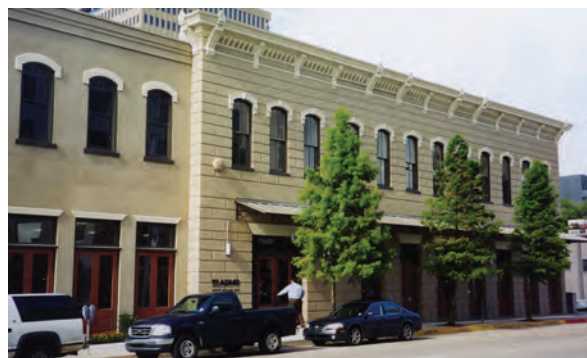
Figure 28. A small addition (left) was constructed when this 1880s train station was converted for office use. The paired doors with transoms and arched windows on the compatible addition reflect, but do not replicate, the historic building (right).

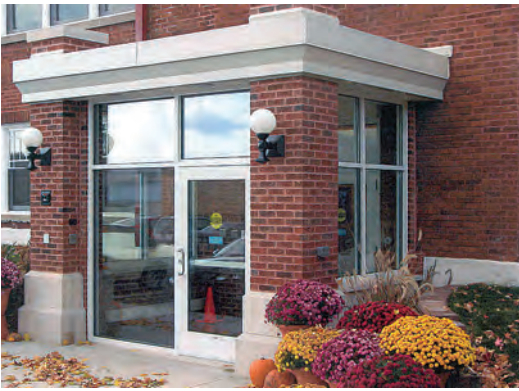
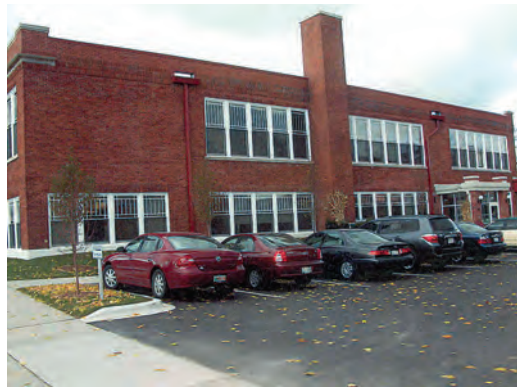
Figure 29. This simple glass and brick entrance (left) added to a secondary elevation of a 1920s school building (right) is compatible with the original structure.

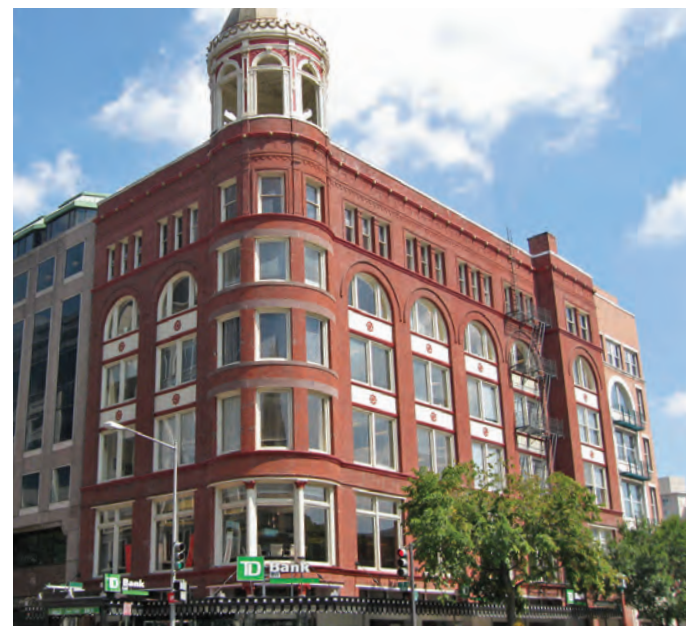
Figure 30. The small addition on the right of this late-19th century commercial structure is clearly secondary and compatible in size, materials and design with the historic building.

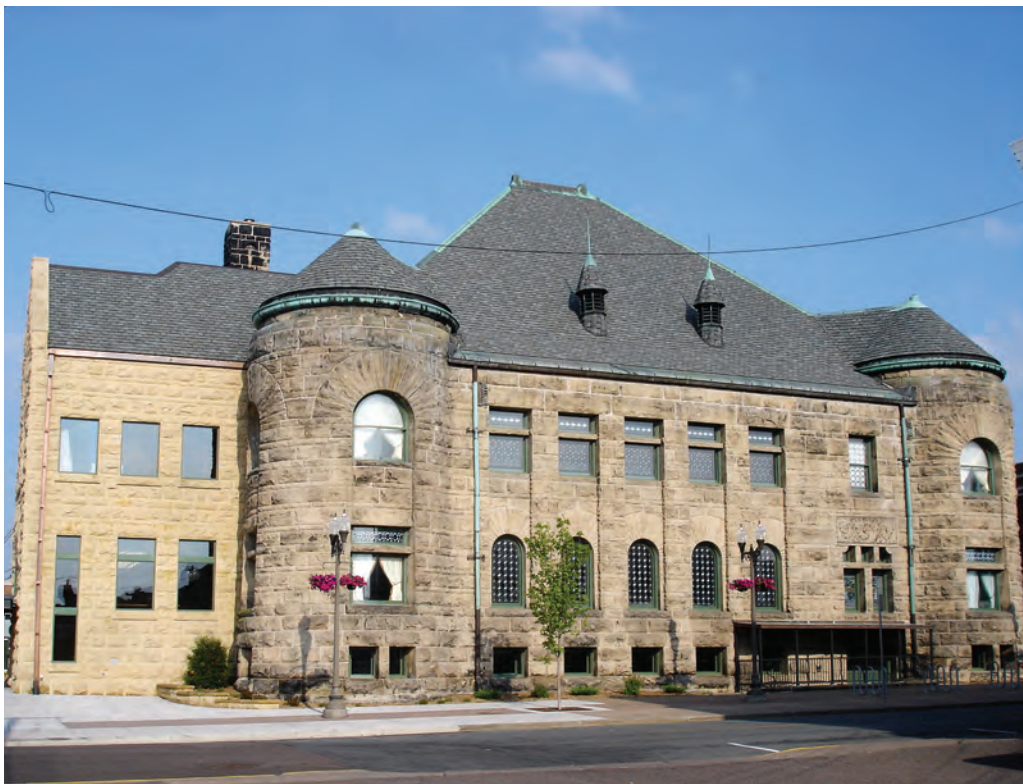
Figure 31. An elevator/stair tower was added at the back of this Richardsonian Romanesque-style theater when it was rehabilitated. Rough-cut stone and simple cut-out openings ensure that the addition is compatible and subordinate to the historic building. Photo: Chuck Liddy, AIA.

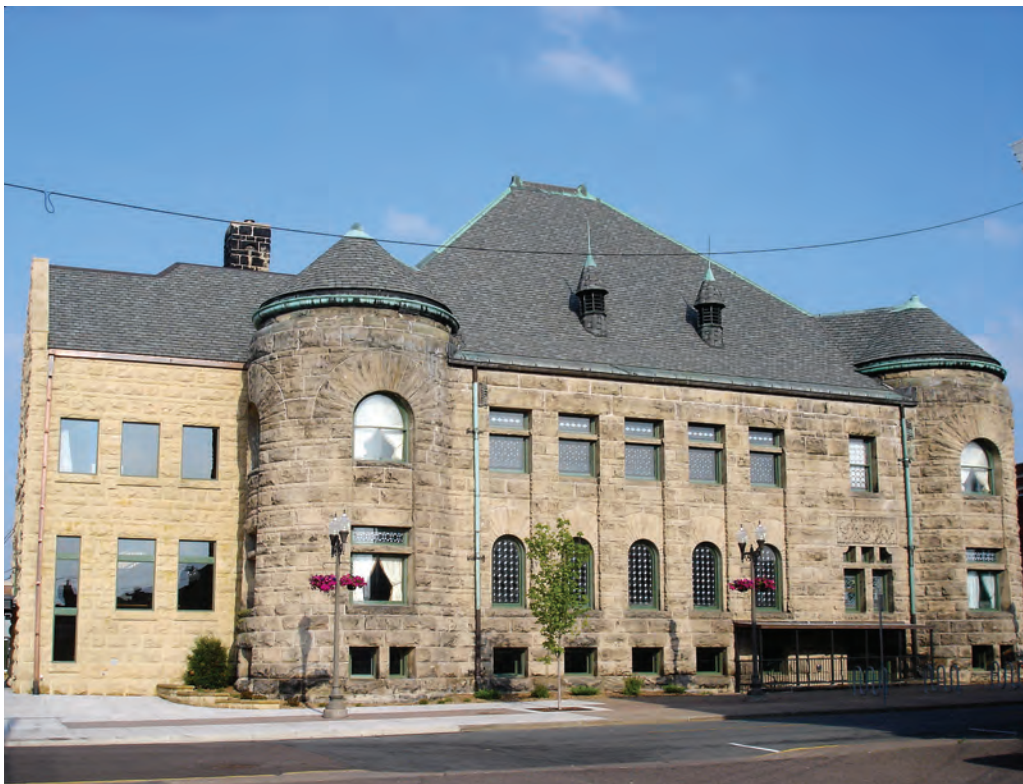
Figure 31. An elevator/stair tower was added at the back of this Richardsonian Romanesque-style theater when it was rehabilitated. Rough-cut stone and simple cut-out openings ensure that the addition is compatible and subordinate to the historic building. Photo: Chuck Liddy, AIA.
