34 PRESERVATION BRIEFS

Applied Decoration for Historic Interiors Preserving Composition Ornament

Jonathan Thornton and William Adair, FAAR

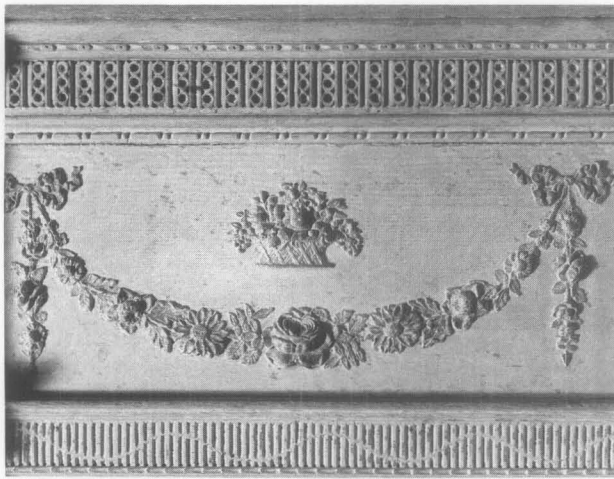
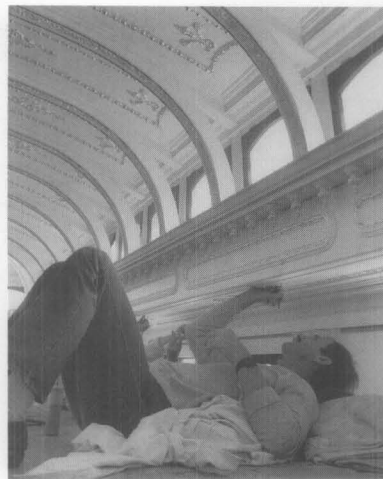
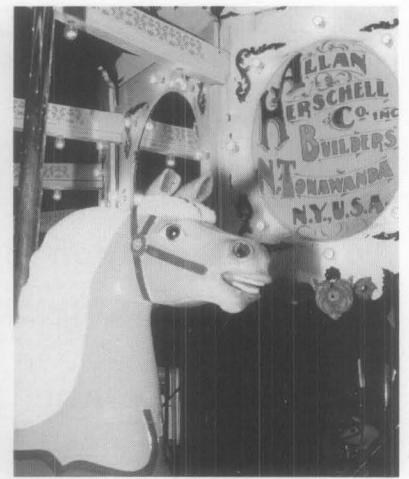
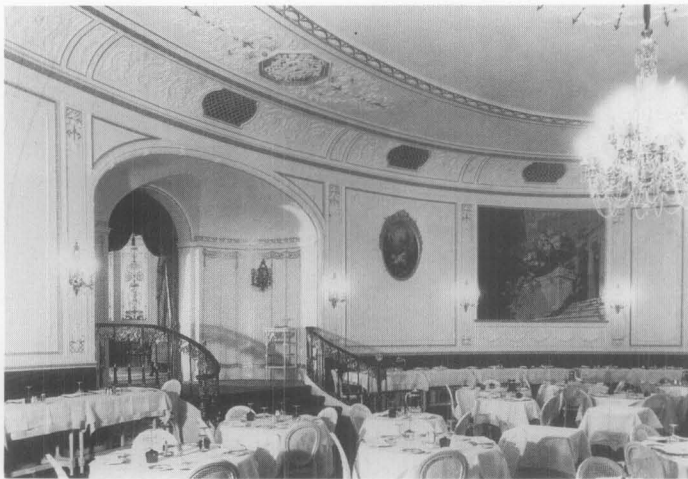
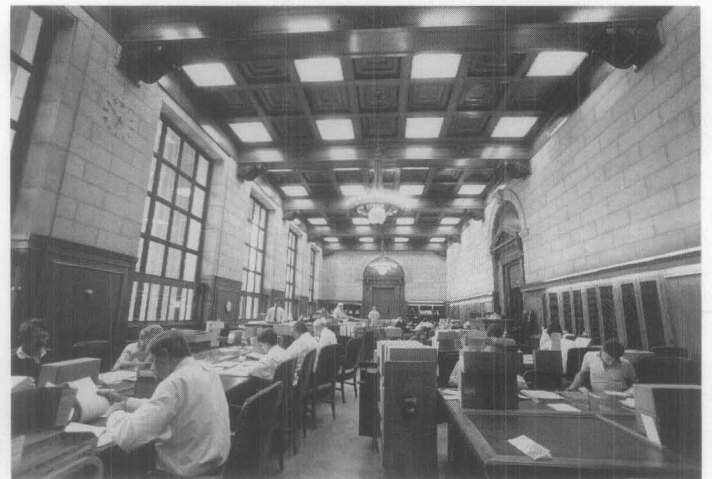
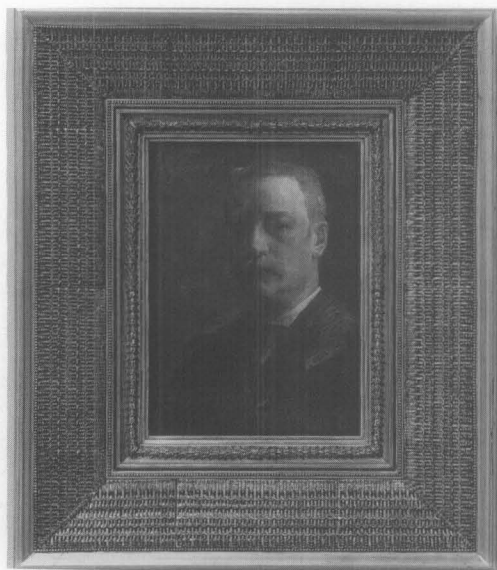
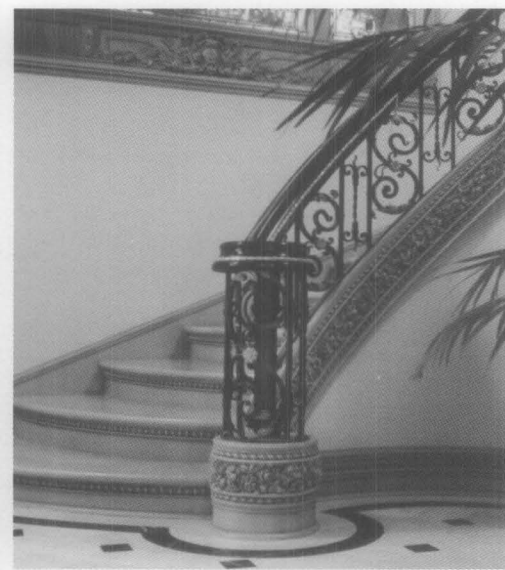
Figure 2. Composition ornament has been used in America for over two hundred years in a variety of applications: (a) a floral festoon and basket in the Adam style for an 1803 mantelpiece; (b) the social saloon of an 1866 steamship, S.S. China; (c) scenery panels on a 1916 Allan Herschell carousel; (d) ceiling decoration in a 1920s hotel; (e) the coffered ceiling of the National Archives library, 1938; (f) a modern reproduction of a Stanford White-designed frame; and (g) 1990s compo ornamentation for a re-modeled residence. (a) Courtesy, Gold Leaf Studios, Inc.; (b) Philip L. Molten; (c) Elizabeth Brick; (d) Courtesy, J.P. Weaver Co.; (e) Courtesy, National Archives; (f) 06.218: Self Portrait of Thomas Wilmer Dewing (1851-1938). American, 1906. Oil on wood panel: 50.8 x 36.8 cm. Courtesy, Freer Gallery of Art, Smithsonian Institution, Washington, D.C.; (g) Courtesy, J.P. Weaver Co.

Generally adhered to wood, historic composition ornament is most often found decorating flat surfaces such as interior cornice and chair rail moldings, door and window surrounds, mantelpieces, wainscot paneling, and staircases—indeed, anywhere that building designers and owners wanted to delight and impress the visitor, but stay within a budget. While composition was cheaper than carved ornament, it was still meticulously hand made and applied; thus, it was more often used in "high style" interiors. But the types of structures historically decorated with composition ornament were more democratic, encompassing residential, commercial, and institutional buildings, and even including specialty applications such as the social saloon of a steamship (see Fig. 2).

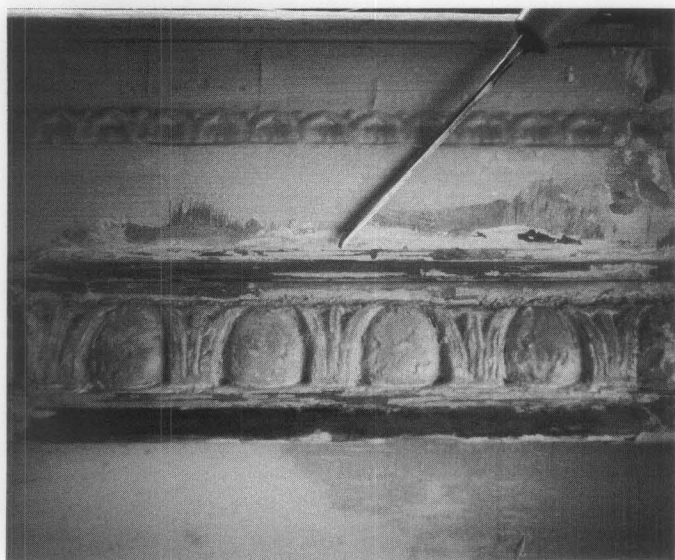
Figure 3. When this historic composition window surround was mistakenly identified as plaster, then treated with a caustic paint stripper, a section of it was destroyed. Photo: Bryan Blundell.

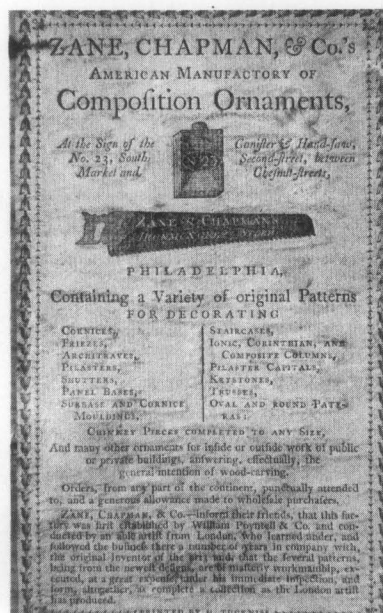
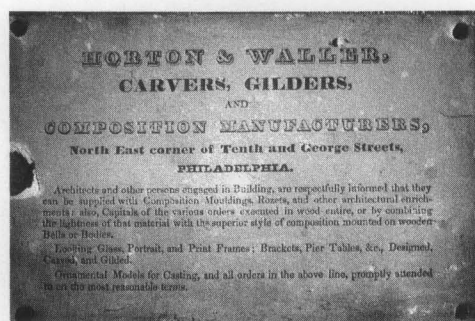
Figure 4. Compo ornament could be applied to simple and complex surfaces, including cornices, friezes, architraves, pilasters, and chimney pieces and to looking glass and picture frames. Manufacturers' ads such as these were commonplace in 19th century America, particularly in eastern cities. Left: Zane, Chapman, & Co. Right: Horton & Waller. Photo left: Courtesy, Jonathan Thornton. Photo right: Courtesy, Gold Leaf Studios, Inc.

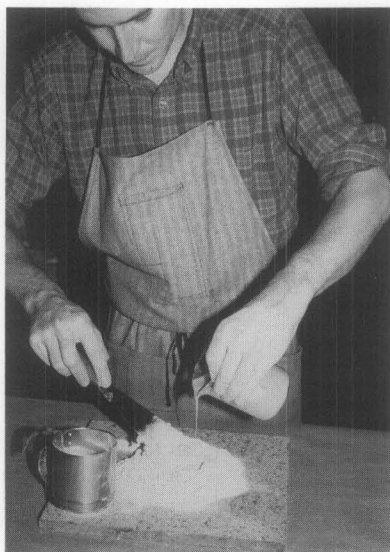
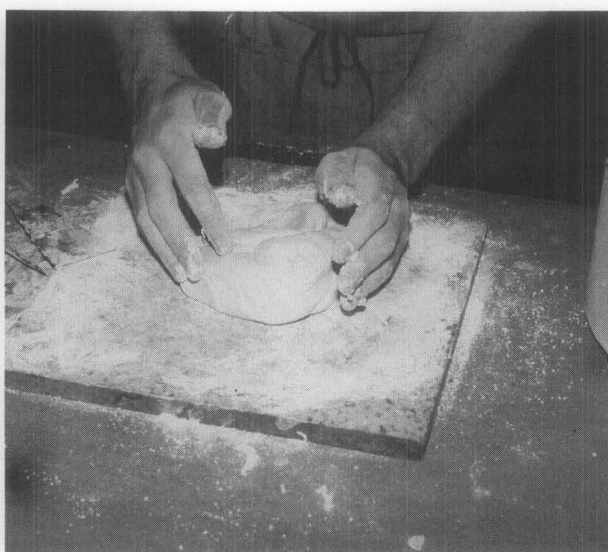
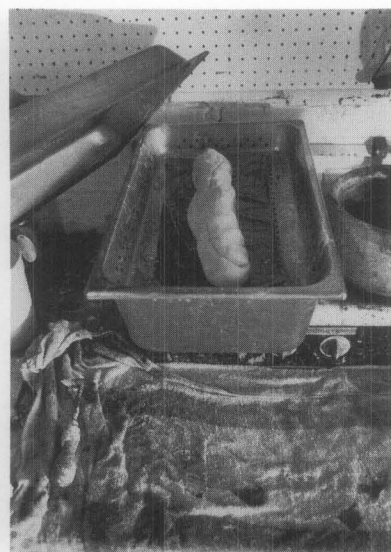
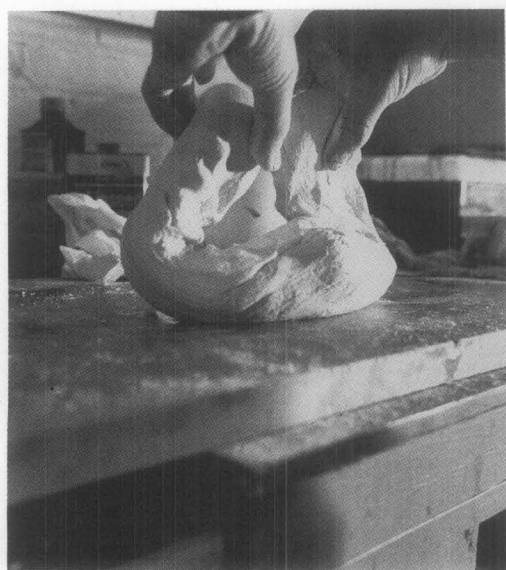
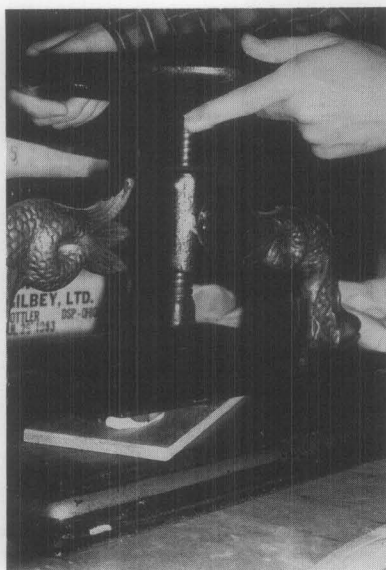
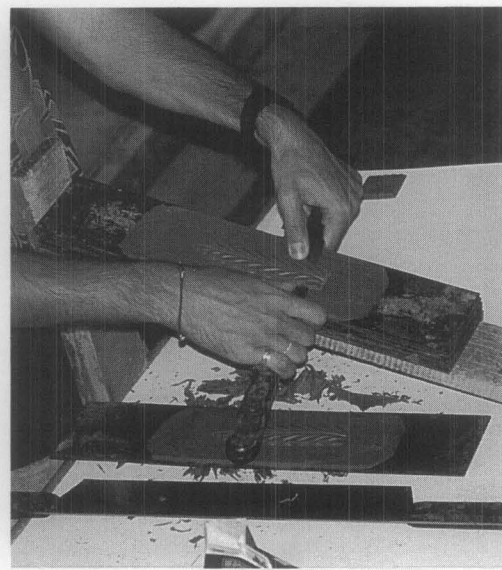
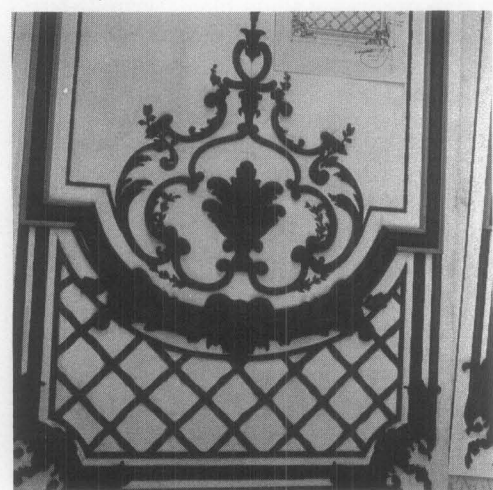
Figure 5. The steps of making composition ornament: (a) pouring compo "batter" into a pile of whiting on a warm granite slab; (b) an almost finished ball of composition; (c) warming compo in a steamer; (d) kneading compo; (e) pressing or squeezing compo into a mold using a screw press; (f) slicing ornament from a pressing board; and (g) a compo design made up from several "squeezes." Note its familiar brown color prior to painting, staining, or gilding. Photos: (a)(b) Jonathan Thornton; (c)(d) William Adair; (e) Jonathan Thornton; (f)(g) Lenna Tyler Kast.

To mold a decoration, the compo was first warmed in a steamer, and the mold prepared with a thin coating of oil and a dusting with talcum powder. A piece was then kneaded and folded to produce a smooth and wrinkle-free surface on one side. The good side was placed down over the rigid mold, and pressed in loosely with the fingers,

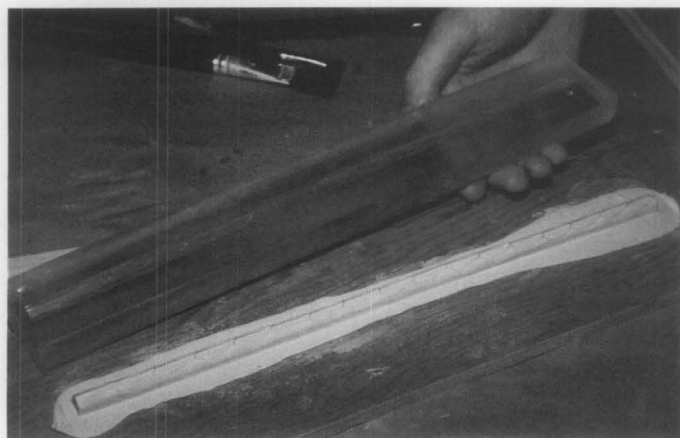
Figure 6. This finished length of compo molding is stuck to its pressing board. The newly made piece will be sliced off the board, then applied. Photo: Jonathan Thornton.

Originally meant to copy other materials such as wood, plaster, and stone, composition had its own unique properties and advantages that were soon exploited in both technical and artistic terms. It has distinct characteristics in each of its three states: pliable, rubbery, and hard. When warm and pliable, it can be modeled by a skilled worker and it is capable of receiving the finest detail when squeezed into a mold. After it has chilled to room temperature and is gelled, it is rubbery, flexible, and tough. The detail is essentially set and cannot be easily damaged as the ornaments are manipulated (see Fig. 6).

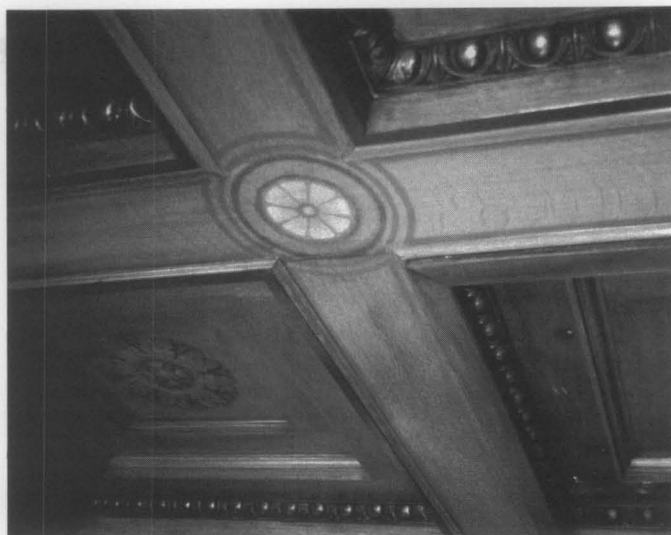
Figure 7. The coffered ceiling of the 1938 National Archives library in Washington, D.C. features egg-and-dart composition molding finished with a dark brown stain. While compo design is more often light and delicate, here, it has a bold, massive quality. Photo: Bryan Blundell.

Finally, when completely hard, it could be given a polished marble shine with nothing but a damp cloth. It could be stained, coated with any sort of paint, varnish, or oil gilded without any further preparation (see Fig. 7).

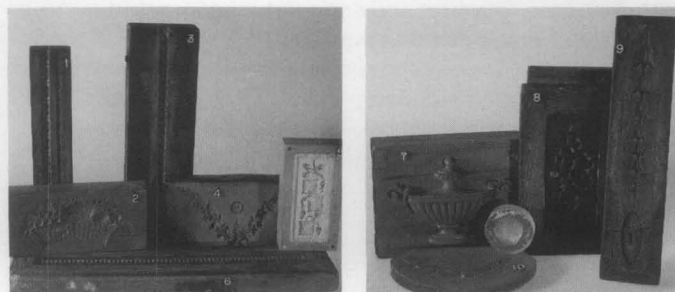
Figure 8. Several historic and reproduction compo molds are shown to underscore the variety of materials used to make them: 1. applewood mold 2. pearwood mold 3. boxwood mold encased in beech 4. boxwood mold 5. sulfur mold encased in maple 6. pewter mold encased in pine and oak 7. positive pattern for pitch mold carved in pearwood 8. pitch mold encased in oak 9. composition mold encased in maple 10. epoxy and polyester molds reinforced with glass fabric. Photos: Jonathan Thornton.

A technical discussion of composition is not complete without an examination of the molds used to create the ornament. These were the ornament maker's largest investment in time and expense, and were the key to the craft (see Fig. 8).

Composition molds were always made of rigid materials that would withstand the considerable pressure used in pressing the ornaments. All of these materials and methods have been used in sculptural crafts since the Renaissance. The comparative listing that follows helps explain their advantages and disadvantages.

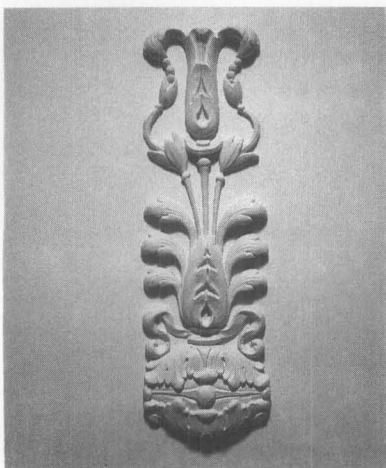
Figure 15. Naturalistically carved lily pattern molds reflect the early 20th century Arts and Crafts movement in the United States. Photo: Jonathan Thornton.

The 20th Century. The Arts and Crafts and related styles, such as the more decorative Art Nouveau, were well rooted in America by the beginning of the century (see Fig. 15). Pitch molds made from relief-carved patterns had become common in America. The carving tool marks could be accentuated in these patterns in keeping with current vogue. Open-grained woods, such as mahogany, were often chosen so that the finished composition ornaments would have a wood-like grain that showed through stains and varnishes (see Fig. 16). A uniquely 20th century application of composition ornament was in the lavishly decorated movie palaces of the Depression era (see Fig. 17).

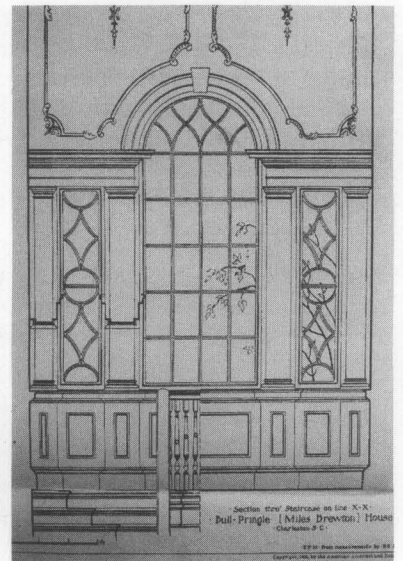
Figure 19. A drawing from the 1930s shows original ornament on the wall above a Palladian window in the 1760s Miles-Brewton House, Charleston, South Carolina. When the ornament was subsequently removed and lost, this scale drawing was used as documentation to fabricate matching ornament. Photo: Jonathan Thornton.

In summary, detailed physical evidence, as well as written and pictorial documentation, can provide a valid framework for replacement at a particular site. With careful detective work, missing historic ornamentation may be successfully identified and replaced with matching ornament (see Fig. 30; see also Fig. 19).

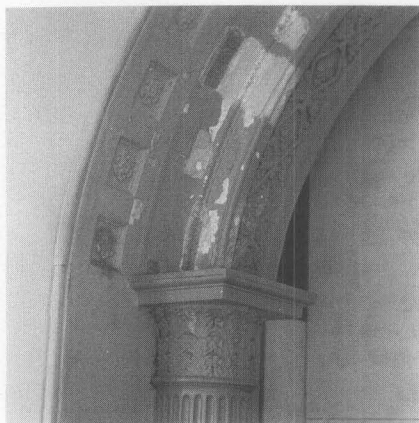
Figure 20. The Octagon House, in Washington, D.C., was constructed between 1801-1802. During recent project work, it was discovered that early repairs to the composition ornament in this doorway had been made with plaster. The plaster repairs were removed during restoration of the doorway to its original appearance. Photo: Lonnie J. Hovey, AIA.

After having identified the presence of composition ornament, its overall condition can be evaluated. Layers of paint may obscure fine detailing as well as deterioration problems. Degrees of damage and deterioration should be recorded. These are typical questions that need to be answered. Is the surface merely "crazed", requiring no action or limited repair, or are the cracks severe enough to require replacement? Are pieces missing? Are the attachment brads rusted or missing? The condition of the substrate is also important. Is the wood surface intact, or is it in need of repair? After answering key questions, the conservator will make random tests to differentiate original compo from later repairs, some of which may well have been done with plaster, rather than compo (see Fig. 20).

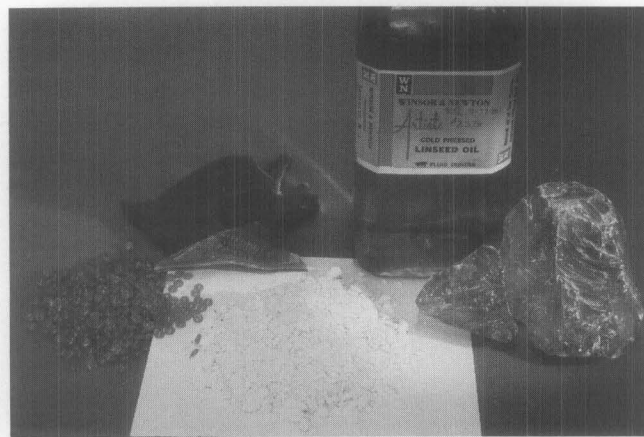
Compo: The Basic Ingredients (clockwise from front center)

Chalk: Chalk is whiting in solid form. It is a type of white, soft limestone.

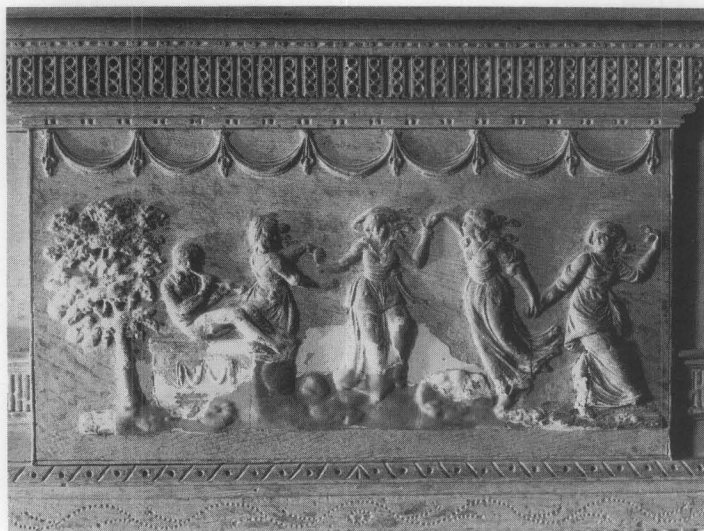
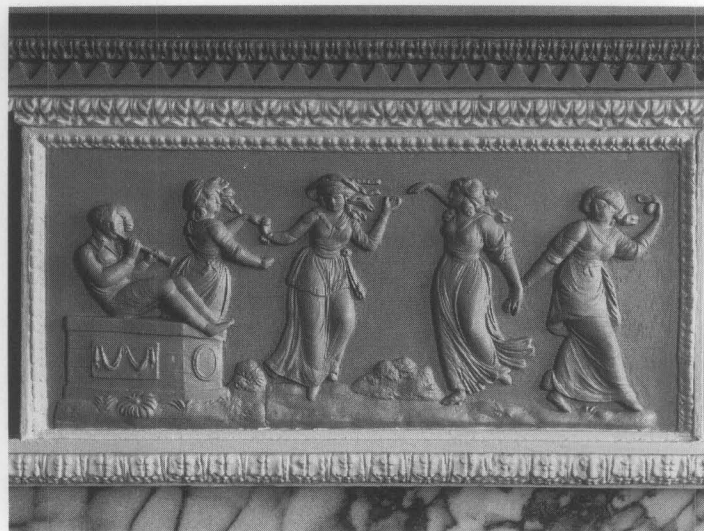
Figure 21. The same theme on two early mantelpieces, *A Country Dance*, dramatically illustrates the visual difference between cleaned and uncleared composition ornament. When old paint layers are removed, the exquisite detailing is revealed. Left: George Read II House, 1801-1803, New Castle, Delaware; Right: First Harrison Gray Otis House, 1796, Boston, Massachusetts. Photo left: Gold Leaf Studios, Inc. Photo right: David Bohl. Courtesy, Society for the Preservation of New England Antiquities.

For purposes of this Brief and the guidance paragraphs that follow, it is assumed that all layers of paint are being removed in order to reveal the fine detailing of the composition ornament (see Fig. 21).

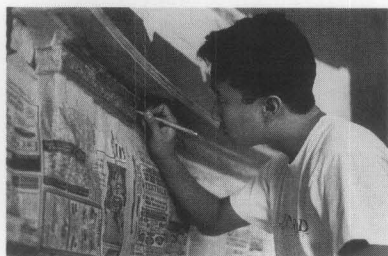
Figure 22. Careful dry scraping of a chimney piece to remove paint residue signaled the successful conclusion of a conservation project at the Octagon House, in Washington, D.C. Photo: Lonnie J. Hovey, AIA.

A conservator will more often use organic solvents, such as methylene chloride, in conjunction with small implements such as a dental tool or toothbrush. (A small area is always tested first to establish the safety and effectiveness of any technique. Improper use of stripping tools can damage intricate surfaces beyond repair.) A solvent is applied according to manufacturer's recommendations, permitted to soak into and soften the paint, then re-applied as necessary, as the conservator gently removes paint from the intricate carved surfaces (see Fig. 22).

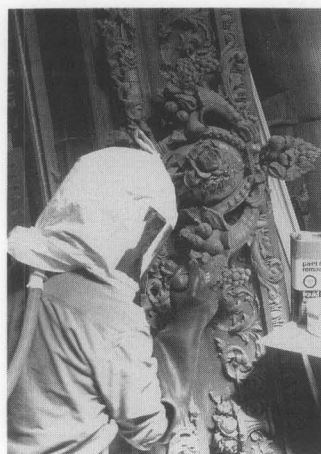
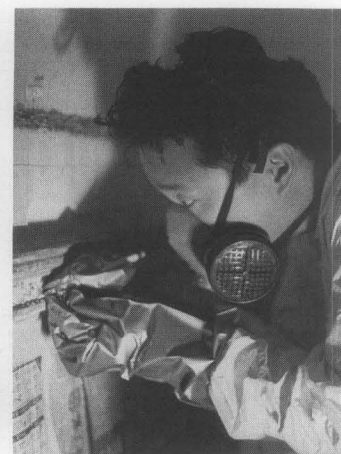
Figure 23. Methylene chloride fumes can be deadly, so protecting the worker is imperative. Left: a hooded, air-fed unit. Right: a vapor mask with organic solvent cartridges. Photo left: William Adair. Photo right: Lonnie J. Hovey, AIA.

It should be emphasized that any amount of exposure to toxic chemicals without proper precautions can cause severe health problems. A hooded, air-fed, personal unit is desirable when using methylene chloride-based strippers if fume hoods or paint spray booths that exhaust effectively to the outside are not available. Organic vapor masks may not

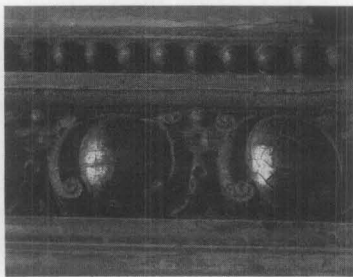
Figure 24. Treatment would be optional for the age cracking that has occurred in the egg-like portions of this composition ornament. Photo: William Adair.

Surface cracking. Surface cracking indicates age and, thus, the history of the ornamentation itself (see Fig. 24). It does not necessarily mean that cracks have to be fixed. But if cracking interferes with the overall design pattern, then the conservator may elect to fill the cracks with suitable fill material. For example, "light weight" spackles bulked with microballoons are excellent because they are soft and compressible and will accommodate changes in the size of cracks due to moisture fluctuation. After stabilization, the surface is finished to match the existing area.

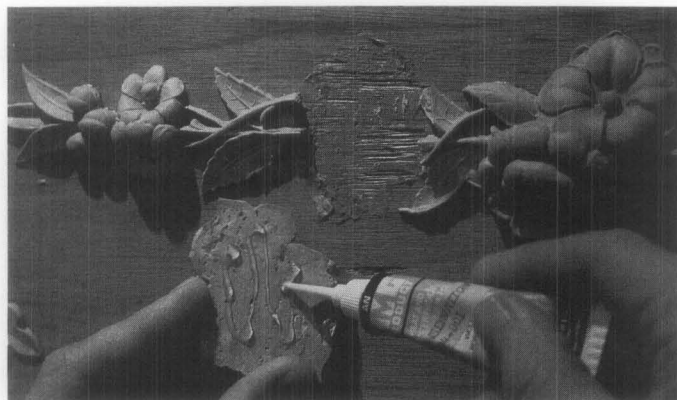
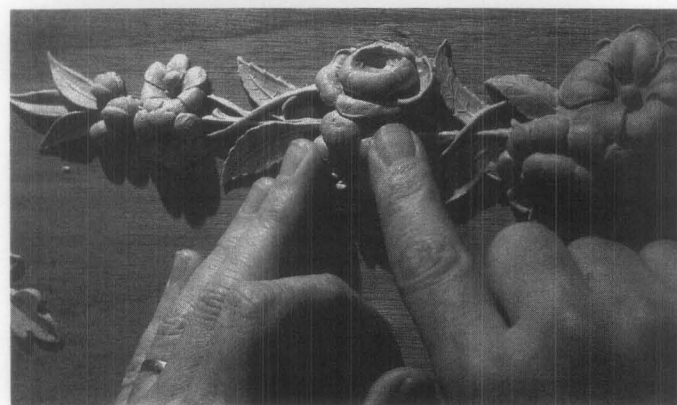
Figure 25. (a) Adhesive is being applied to this 19th century composition ornament that has de-laminated from its wood substrate; and (b) The compo fragment is held in place until the quick-setting adhesive takes hold. Photos: Jonathan Thornton.

Delamination. Delamination or separation of the compo from the wood substrate is the simplest repair problem to remedy. The conservator begins by testing cracked areas with slight finger pressure to determine which parts of the design need consolidation. Compo sections that have separated from the substrate, but are otherwise intact, can be glued back in place using emulsion type adhesives such as "white" glues or a clear, solvent-release adhesive (see Fig. 25). For vertical surfaces, the glue is painted onto the back of the delaminated compo as well as the wood base and, when slightly tacky, re-attached, and held with clamps until dry.

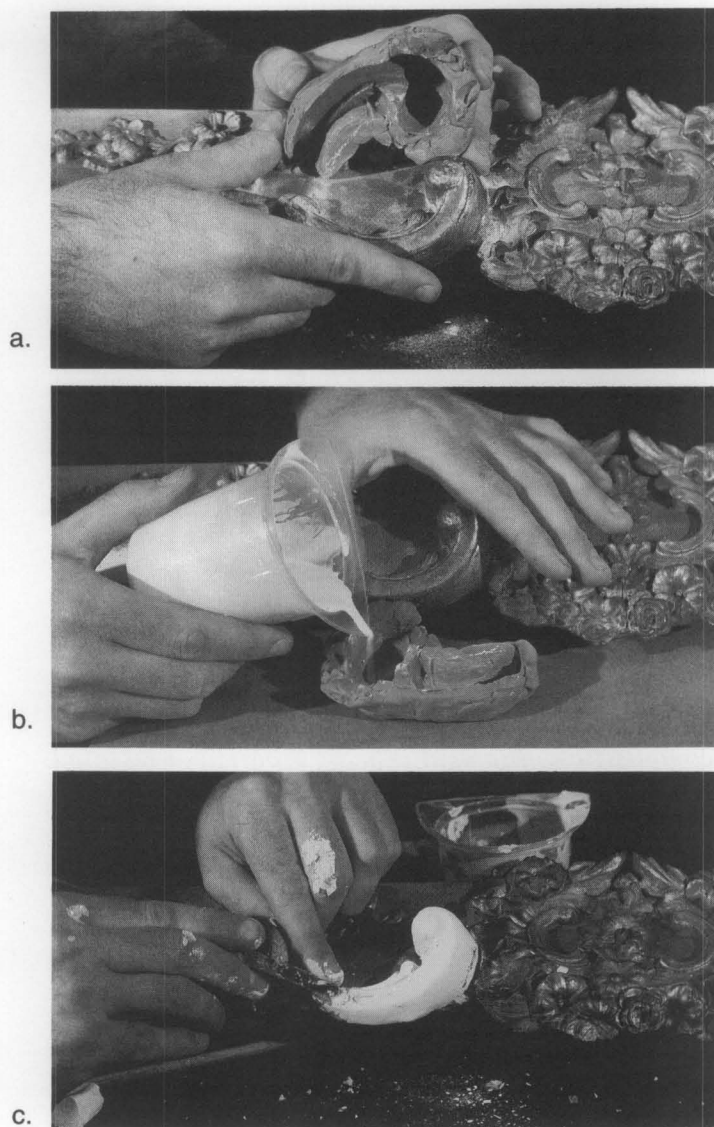
Figure 26. When a small amount of ornamentation needs to be replaced, (a) plastilina clay is recommended as an impression material. Next (b), a plaster-like, liquid material is used to cast the replacement piece. Finally, (c) the new piece is smoothed and fixed in place. Photos: Roland White.

Repairs to broken or damaged compo. When some original compo has been lost, additional work is required to make a repair. One particularly easy and inexpensive method of repairing broken ornamentation is to use non-hardening clay ("plastilina") or polymer-based modeling materials as an impression material to make a mold. After a mold is made from existing ornament, missing or deteriorated portions of the historic design can be duplicated with a durable gypsum plaster (see Fig. 26). Especially in cases where economic considerations dictate procedure, use of this substitute material may be helpful because it is cheaper. Alternatively, an existing studio mold may sometimes be used to make small replacement pieces in a repair project (see Fig. 27).

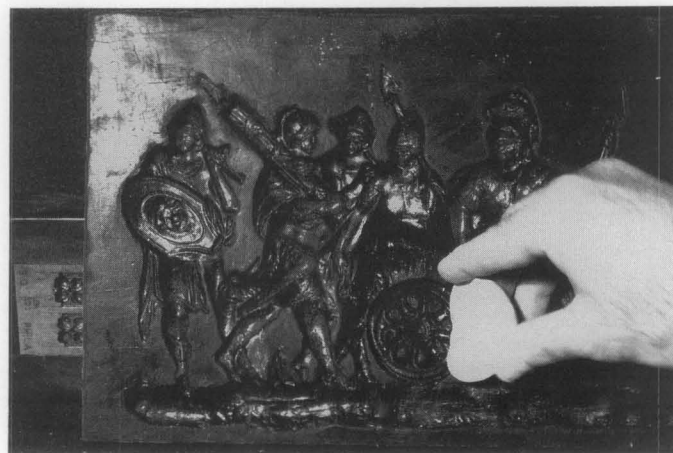
Figure 27. When a compo frieze depicting *The Triumph of Mars* was found to be damaged, improperly restored, and its intricate design clogged with paint, the first step was to replace a missing wheel on the chariot. Because molds depicting classical themes are part of many professional studio collections, it was possible to fabricate a new wheel from the rubber mold shown here. Photo: William Adair.

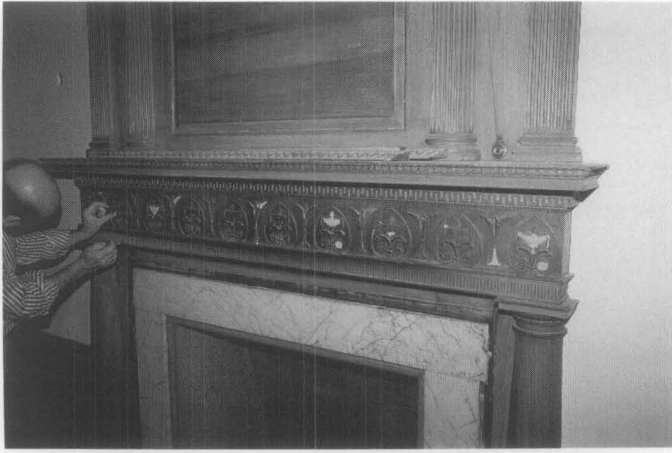
Figure 28. A conservator is replacing broken pieces of compo ornamentation on a mantel during restoration of the Nightingale-Brown House in Providence, Rhode Island. Photo: Courtesy, Irving Haynes and Associates.

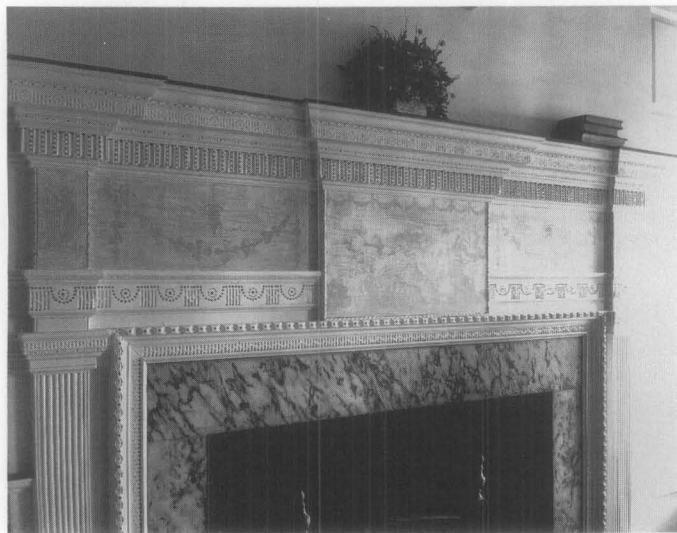
Figure 29. The ghost marks of compo past—floral swags or festoons—are in clear evidence on a mantelpiece in the back bedroom of the George Read II House, New Castle, Delaware. This physical evidence will be used to assure their accurate re-creation in a restoration project. Photo: Courtesy, Gold Leaf Studios, Inc.

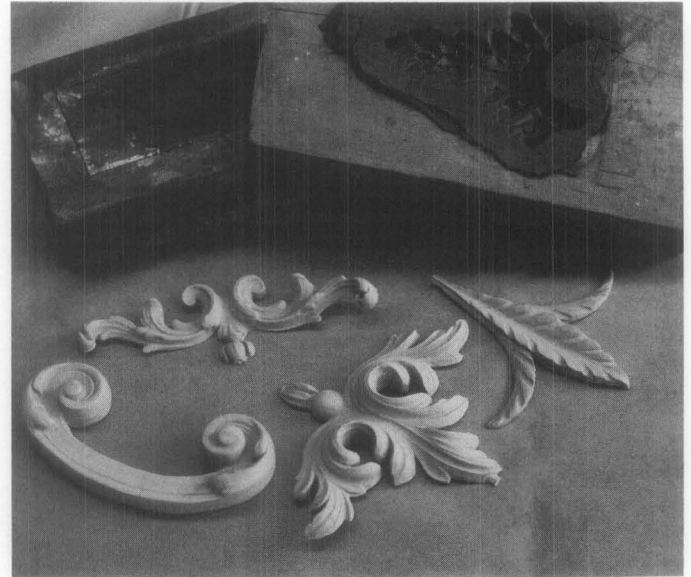
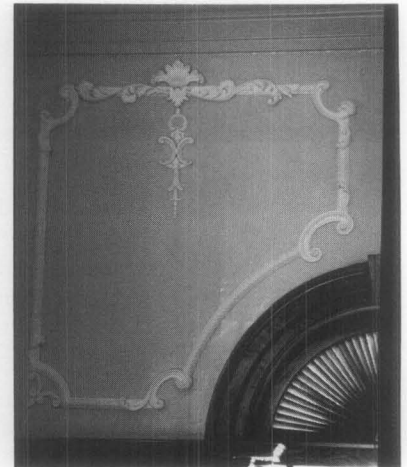
Figure 30. Based on documentary and physical evidence, missing composition ornament was accurately re-created for the Miles-Brewton House, Charleston, South Carolina. First (a) the conservator used molds to fabricate ornament in small pieces and lengths; and (b) the new ornament was attached to thin birch plywood backing with glue and brads to create larger sections. These sections were then fastened to the original paneling with stainless steel screws. Photos: Jonathan Thornton
