39 PRESERVATION BRIEFS

Holding the Line: Controlling Unwanted Moisture in Historic Buildings

Sharon C. Park, AIA

U.S. Department of the Interior
National Park Service
Cultural Resources
Heritage Preservation Services

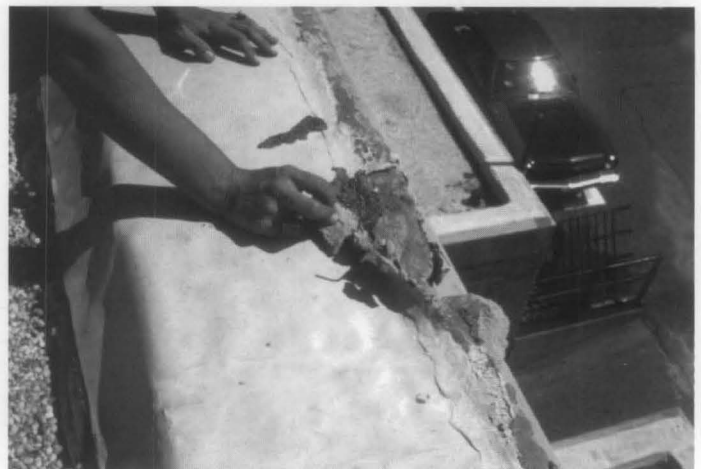
Fig. 1. Moisture problems, if not properly corrected, will increase damage to historic buildings. This waterproof coating trapped moisture from the leaking roof, causing portions of the masonry parapet to fail. Photo: NPS Files.

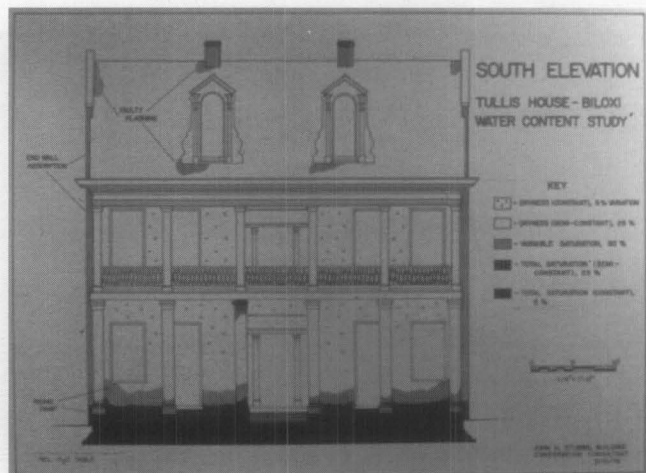
Fig. 2. Historic buildings plagued by dampness problems will benefit from systematic documentation to set a baseline against which moisture changes can be measured. Exterior areas with higher moisture levels may have algae growth or discoloration stains. Drawing: John H. Stubbs.

Identifying the type of moisture damage and discovering its source or sources usually involves the human senses of sight, smell, hearing, touch, and taste combined with intuition. Some of the more common signs of visible as well as hidden moisture damage (see fig. 2, 3) include:

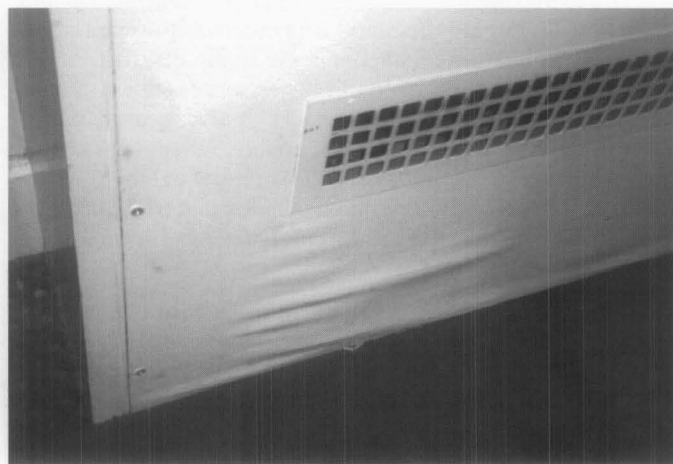
Fig. 3. The deterioration of this wooden cover was a sign that water was leaking from the fan coil unit behind. Photo: author.

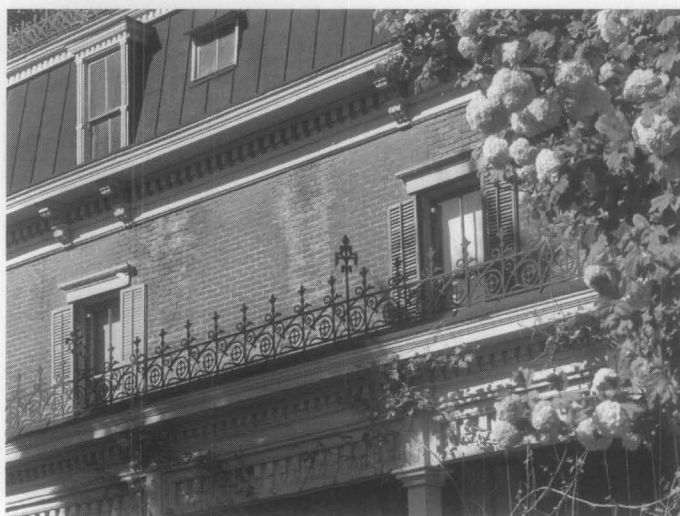
Fig. 4. Deferred maintenance often leads to blocked gutters and downspouts. This cracked gutter system allowed moisture to penetrate the upper exterior wall, erode mortar joints, and rot fascia boards. Photo: NPS files.

Above grade exterior moisture generally results from weather related moisture entering through deteriorating materials as a result of deferred maintenance, structural settlement cracks, or damage from high winds or storms (see fig. 4). Such sources as faulty roofs, cracks in walls, and open joints around window and door openings can be corrected through either repair or limited replacement. Due to their age, historic buildings are notoriously “drafty,” allowing rain, wind, and damp air to enter through missing mortar joints; around cracks in windows, doors, and wood siding; and into uninsulated attics. In some cases, excessively absorbent materials, such as soft sandstone, become saturated from rain or gutter overflows, and can allow moisture to dampen interior surfaces. Vines or other vegetative materials allowed to grow directly on building

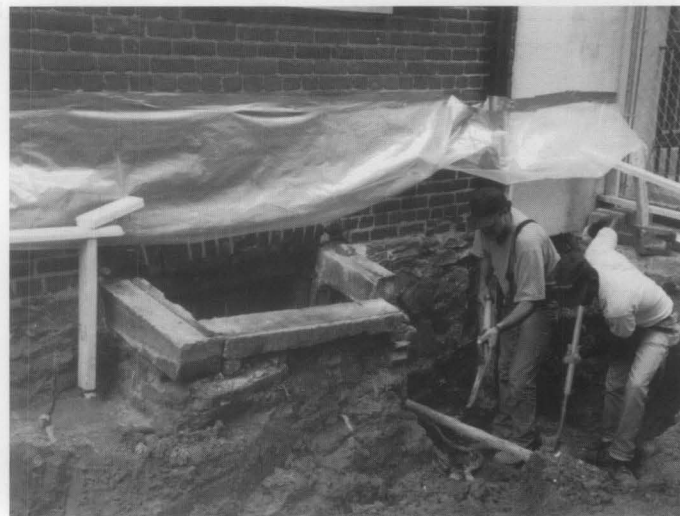
Fig. 5. Excavating this foundation revealed that the downspout pipe had corroded at the “u-trap” and was leaking moisture into the soil. Openings around the horizontal water supply line and cracks in the wall allowed moisture to penetrate the basement in multiple locations. Photo: author.

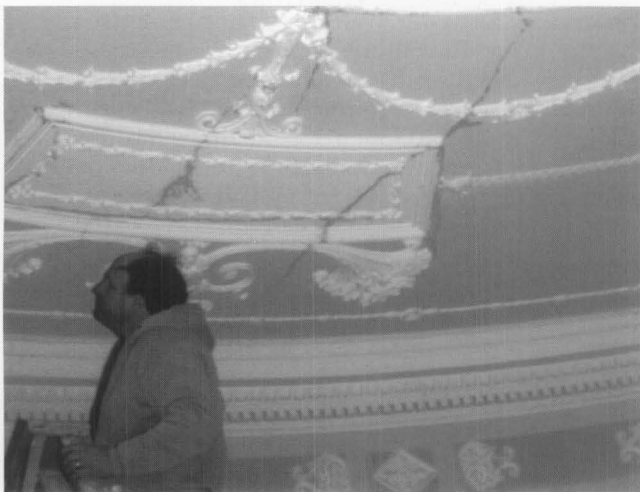
Fig. 6. Uninsulated plumbing pipes close to the exterior wall froze and cracked, wetting this ornamental plaster ceiling before the water supply line could be shut off. As a result, limited portions of the ceiling needed reattaching. Photo: author.

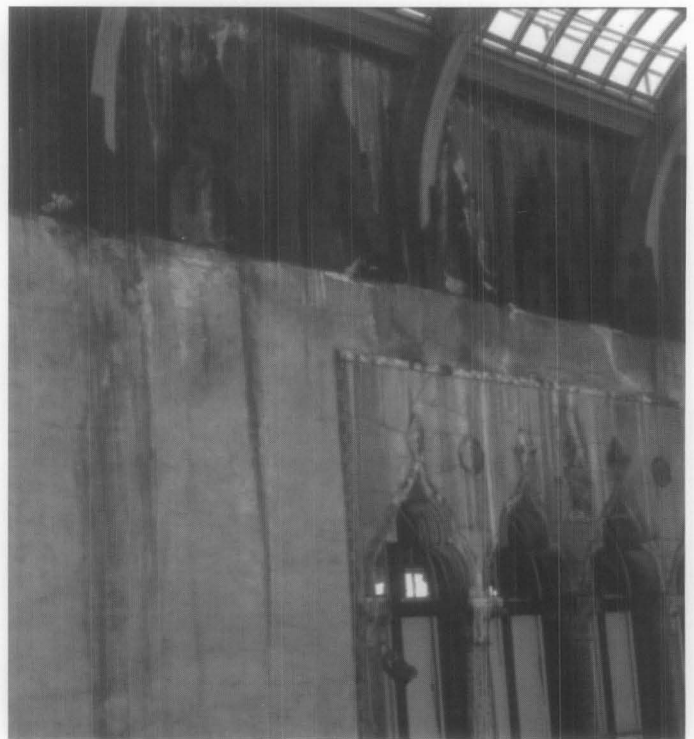
Fig. 7. Condensation dripping from the large overhead courtyard skylight was damaging the masonry in this museum. A new skylight with thermal glazing was installed, replacing the deteriorated single-glazed unit. A new climate control system monitors interior temperature and humidity. Photo: © Isabella Stewart Gardner Museum, Boston.

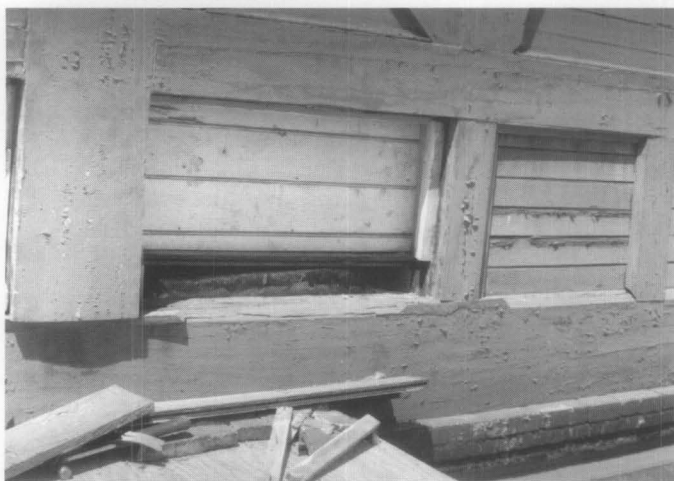
Fig. 8. Damaging moisture conditions can occur during construction. Peeling paint on this newly rehabilitated frame wall was attributed to wall insulation that had become wet during the project and was not discovered. Photo: NPS Files.

plastered interior walls or the construction of new additions attached to historic buildings may hold moisture for months; new plaster, mortar, or concrete should be fully cured before they are painted or finished. The use of materials in projects that have been damaged by moisture prior to installation or have too high a moisture content may cause concealed damage (see fig. 8).

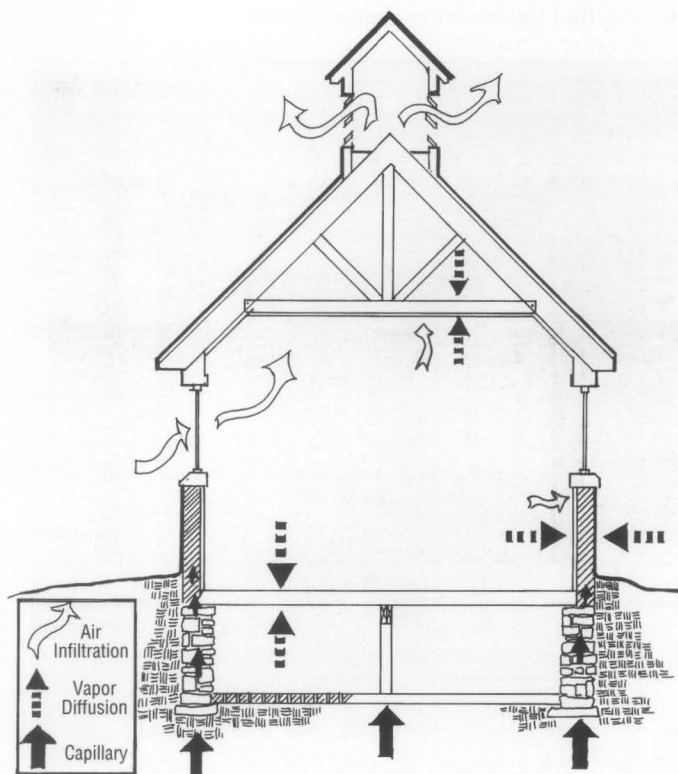
Fig. 9. The dynamic forces that move air and moisture through a building are important to understand particularly when selecting a treatment to correct a moisture problem. Air infiltration, capillary action, and vapor diffusion all affect the wetting and drying of materials. Drawing: NPS Files.

Three forms of moisture transport are particularly important to understand in regards to historic buildings — *infiltration, capillary action, and vapor diffusion* — remembering, at the same time, that the subject is infinitely complex and, thus, one of continuing scientific study (see

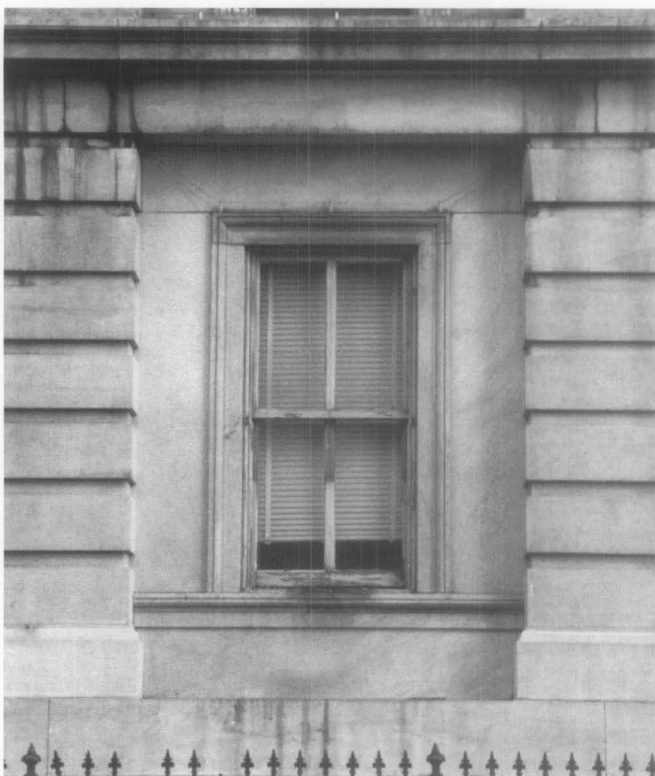
Fig. 10. Infiltration of damp air can occur around loose-fitting or deteriorated window sash and through cracks or open joints in building exteriors. Photo: Ann Brooks Prueher.

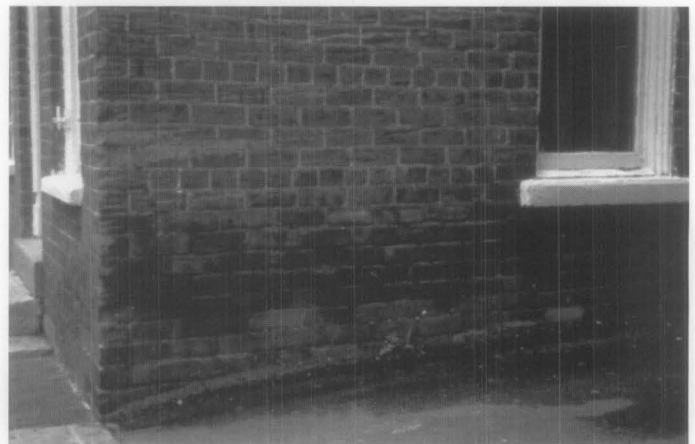
Fig. 11. Capillary rise of moisture in masonry is often accompanied with a horizontal tide-mark line several feet above the grade, as seen here. Removing or redirecting as much ground moisture as possible usually helps reduce moisture within a wall. Photo: NPS Files.

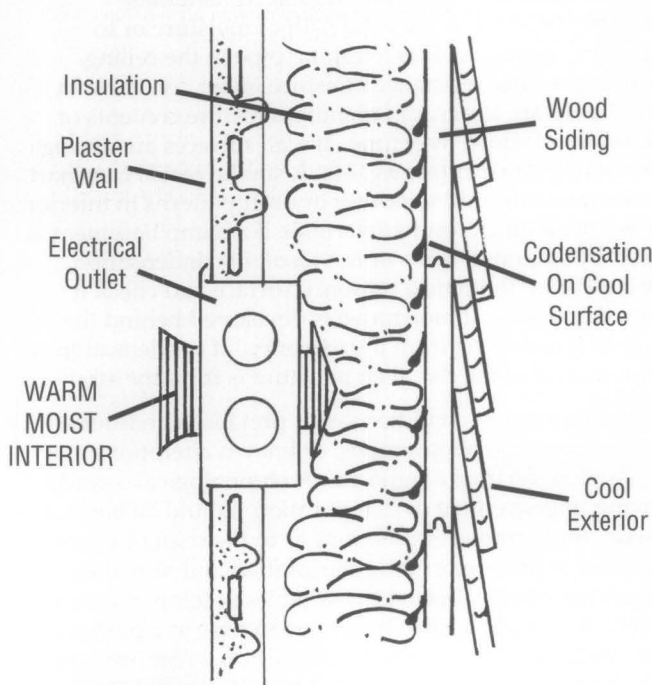
Fig. 12. Vapor diffusion can result in damp air migrating into absorbent materials and condensing on colder surfaces, thereby wetting insulation, damaging electrical conduits, and causing deterioration of the wooden framing. Drawing: NPS Files.

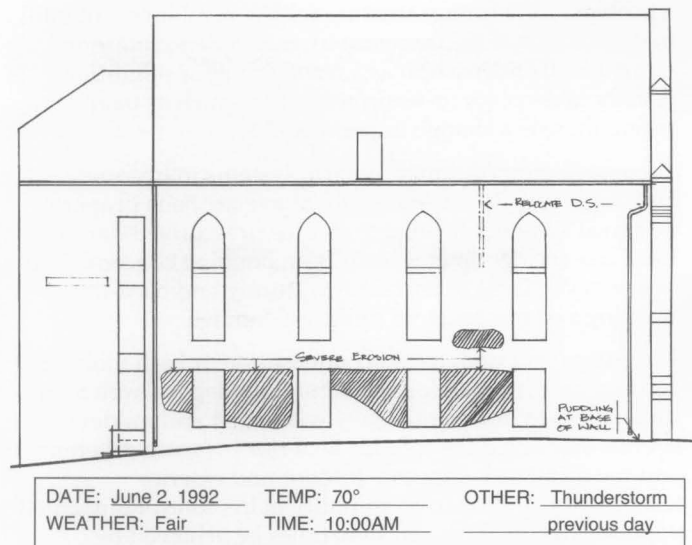
Fig. 13. Using sketch plans and elevation drawings to record the moisture damage along with the date, time, and weather conditions will show how moisture is affecting buildings over time. Drawing: Courtesy, Quinn Evans Architects.

Surveying moisture damage must be systematic so that relative changes can be noted. Tools for investigating can be as simple as a notebook, sketch plans, binoculars, camera, aluminum foil, smoke pencil, and flashlight. The systematic approach involves looking at buildings from the top down and from the outside to the inside. Photographs, floor plans, site plan, and exterior elevations — even roughly sketched — should be used to indicate all evidence of damp or damaged materials, with notations for musty or poorly ventilated areas. Information might be needed on the absorption and permeability characteristics of the building materials and soils. Exterior drainage patterns should be noted and these base plans referred to on a regular basis in different seasons and in differing types of weather (see fig. 13).

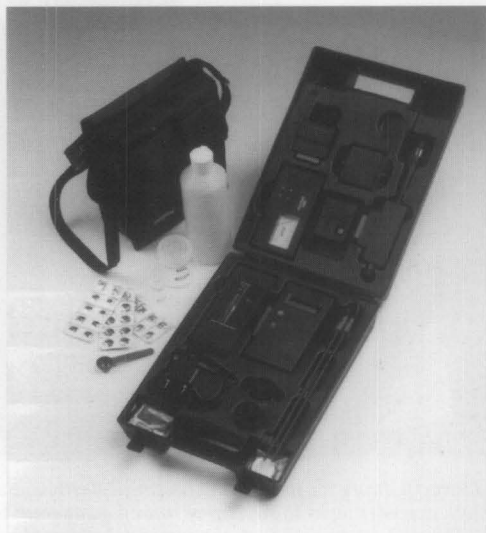
Fig. 14. Using instruments in this damp-check kit can help determine the relative change in wet conditions over time. This involves readings of air temperature, computing dewpoint temperatures, and tracking the moisture content of materials to indicate if they are drying properly. Photo: Dell Corporation.

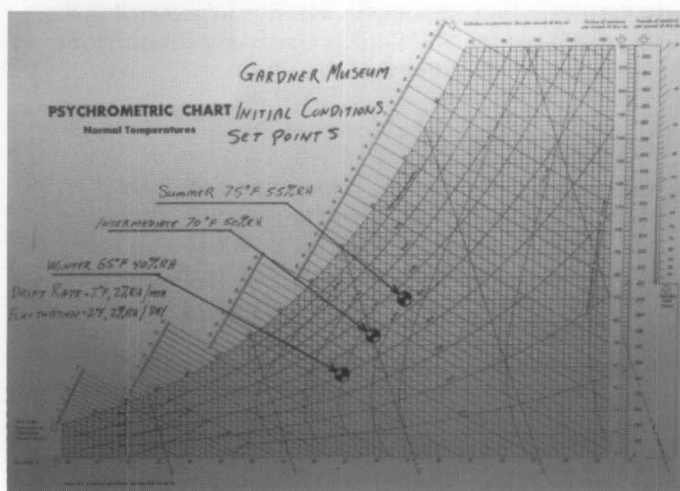
Fig. 15. Psychrometric charts quantify the amount of relative humidity a building can tolerate before dewpoint condensation occurs. This is important when the range of temperature and humidity are critical to both collections management and historic building preservation. Chart: Landmark Facilities Group.

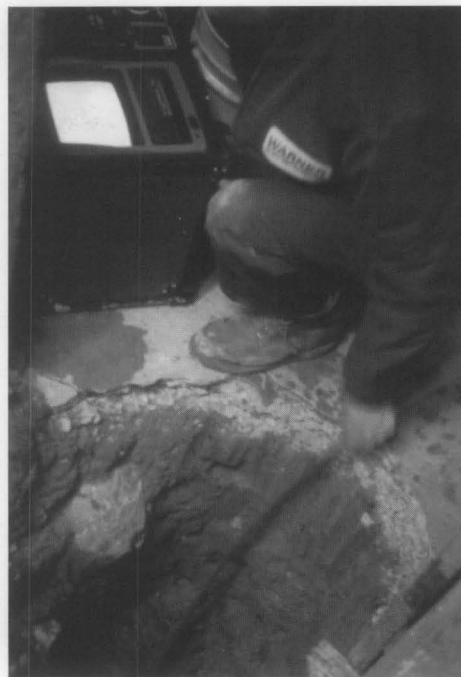
Fig. 16. Contractors specializing in building diagnostics often have video cameras or fiber optic equipment that allow the viewing of inaccessible areas. This is particularly helpful in chimney flues or subsurface drains, as shown here. In the past, these areas would need to be excavated for visual inspection. Photo: author.

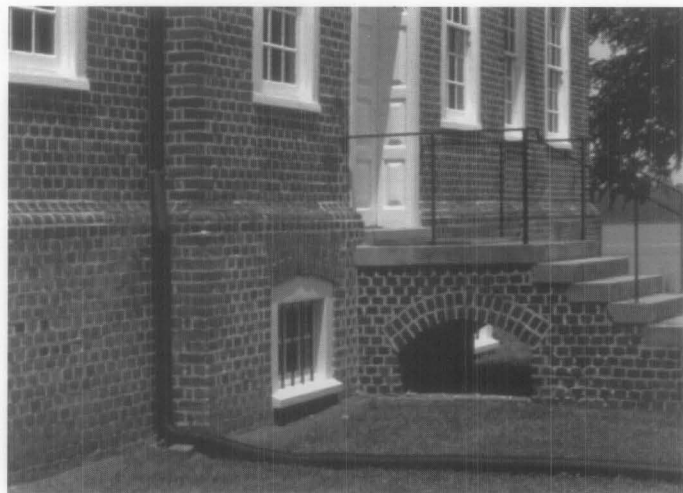
Fig. 17. In testing a theory for the cause of basement wetness, the owner used long black extender pipes to direct roof run-off away from the foundation. This test established that the owner did not need expensive waterproofing of the foundation, but a better drainage system. Photo: Baird M. Smith.

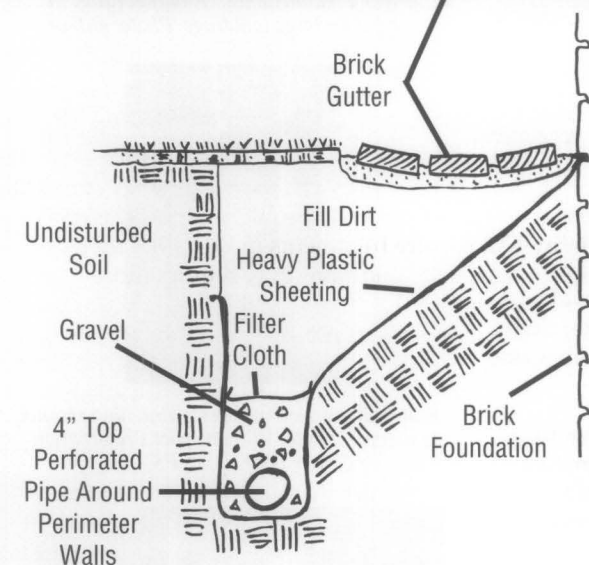
Fig. 18. This detail drawing shows a sub-surface perimeter drain in conjunction with a historic brick ground gutter system to help control roof run-off moisture from entering the historic foundation. Detail: Courtesy, Gunston Hall Plantation. Photo: Elizabeth Sasser.

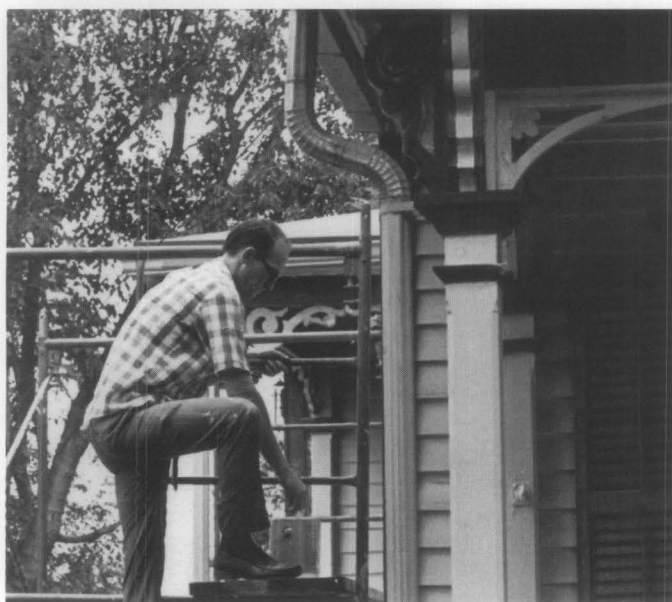
Fig. 19. Maintaining gutters and downspouts in good operable condition, repairing exteriors to keep water out, redirecting damaging moisture away from foundations and controlling interior moisture and condensation are all important when holding the line on moisture deterioration. Photo: Nebraska State Historical Society.

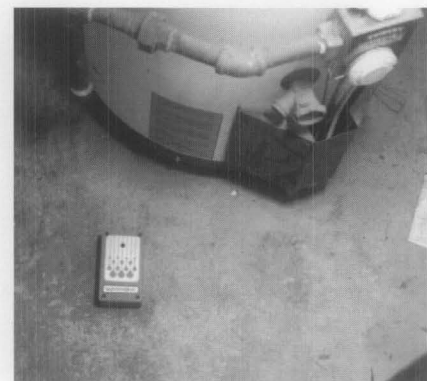
D. Protect the building from damage by maintaining equipment and using alarms, like this floor water sensor. Photo: Dell Corporation.

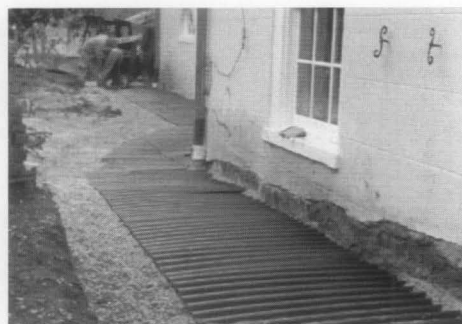
A. Mitigate poor drainage with gravel, filter cloth, or the use of subsurface drainage mats under finished paving. Photo: Larry D. Dermody.

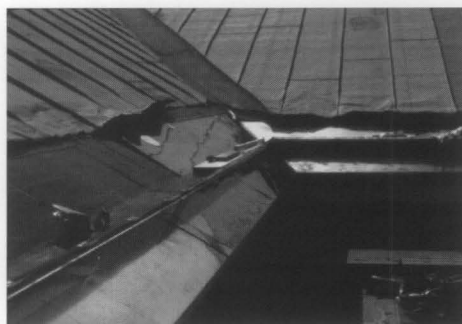
B. Repair roofs and add ice and water shields at eaves and under valleys in cold climates. Photo: Larry D. Dermody.

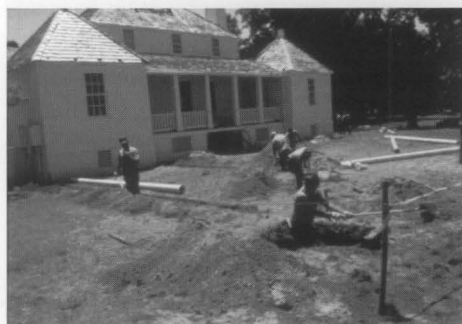
C. Develop new drainage systems for roof run-off that remove moisture from the base of the building. Photo: WPTC, NPS.

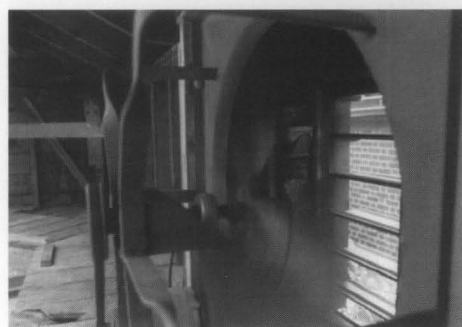
D. Install ventilating fans when additional air circulation will improve damp conditions in buildings or reduce cooling loads. Photo: Ernest A. Conrad, P. E.

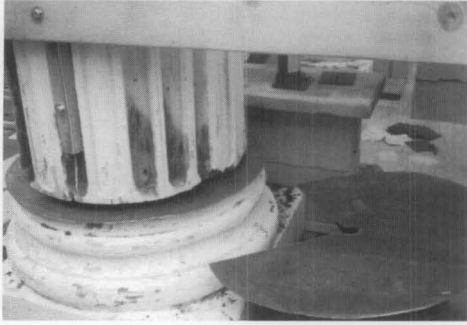
A. This lead sheet was installed at the base of the replacement column to stop rising damp. Photo: Bryan Blundell.

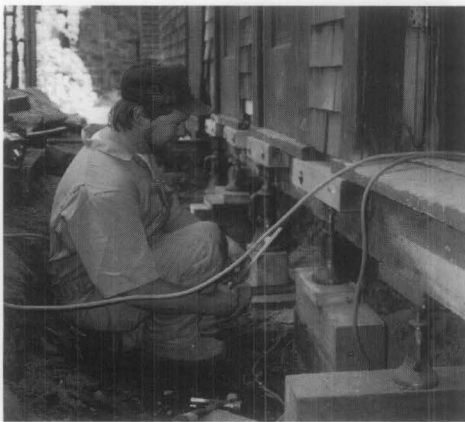
B. Wood sills set on grade were replaced with concrete pier foundation and new wooden sill plates. Changes were not visible on the exterior (see C). Photo: WPTC, NPS.

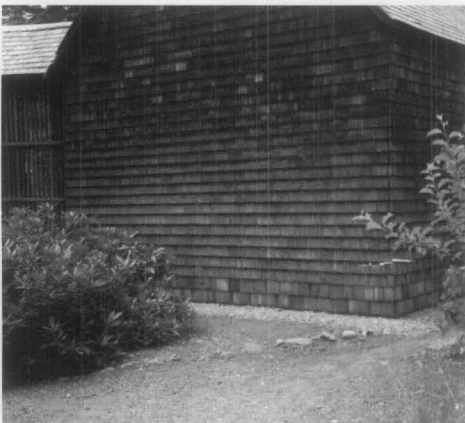
C. The new ground gutter gravel base helps drainage around the concrete foundation (see B above) which is not visible behind the replaced wooden wall shingles. Photo: WPTC, NPS.

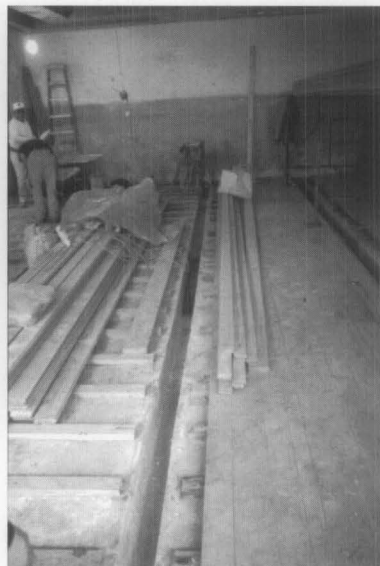
D. In a flood plain, rotted joists were replaced with a concrete slab and sleepers designed to drain water. Spaced flooring allowed drainage and room for damp wood to swell without buckling. Harper's Ferry Center, NPS.

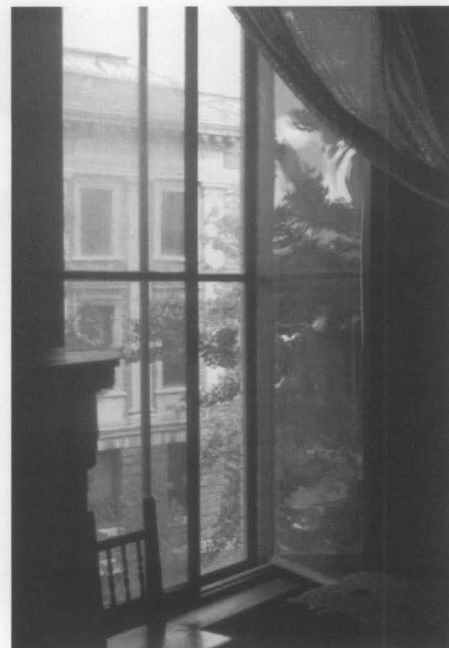
F. Triple glazed windows replaced the originals to control condensation. Photo: © Isabella Stewart Gardner Museum, Boston.

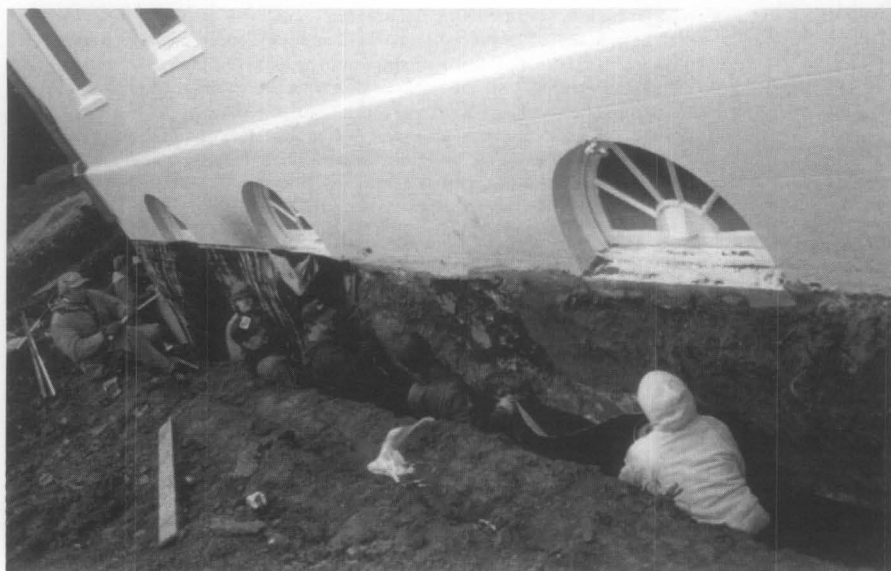
I. Critically damp foundation walls were protected with a layer of bentonite clay to reduce moisture penetration. This work was in combination with new downspouts that were connected to drainage boots that deposited captures roof run-off away from the foundation. Photo: Courtesy, Larry D. Dermody and the National Trust for Historic Preservation.

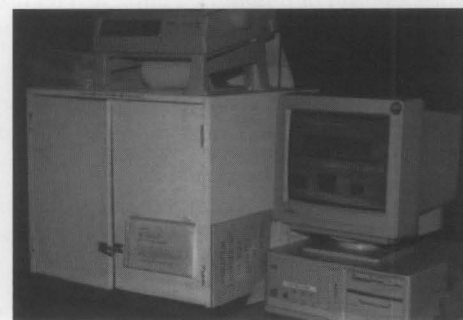
H. New computers tie a variety of monitoring and security features into a comprehensive system which provides warning and backup alerts when any of the system components are not functioning properly. Photo: © Isabella Stewart Gardner Museum, Boston.
