Debris/Ice/TPS Assessment And Photographic Analysis For Shuttle Mission STS-34

Charles G. Stevenson
NASA/Kennedy Space Center

DEBRIS/ICE/TPS ASSESSMENT
AND
PHOTOGRAPHIC ANALYSIS
OF
SHUTTLE MISSION STS-34

October 18, 1989

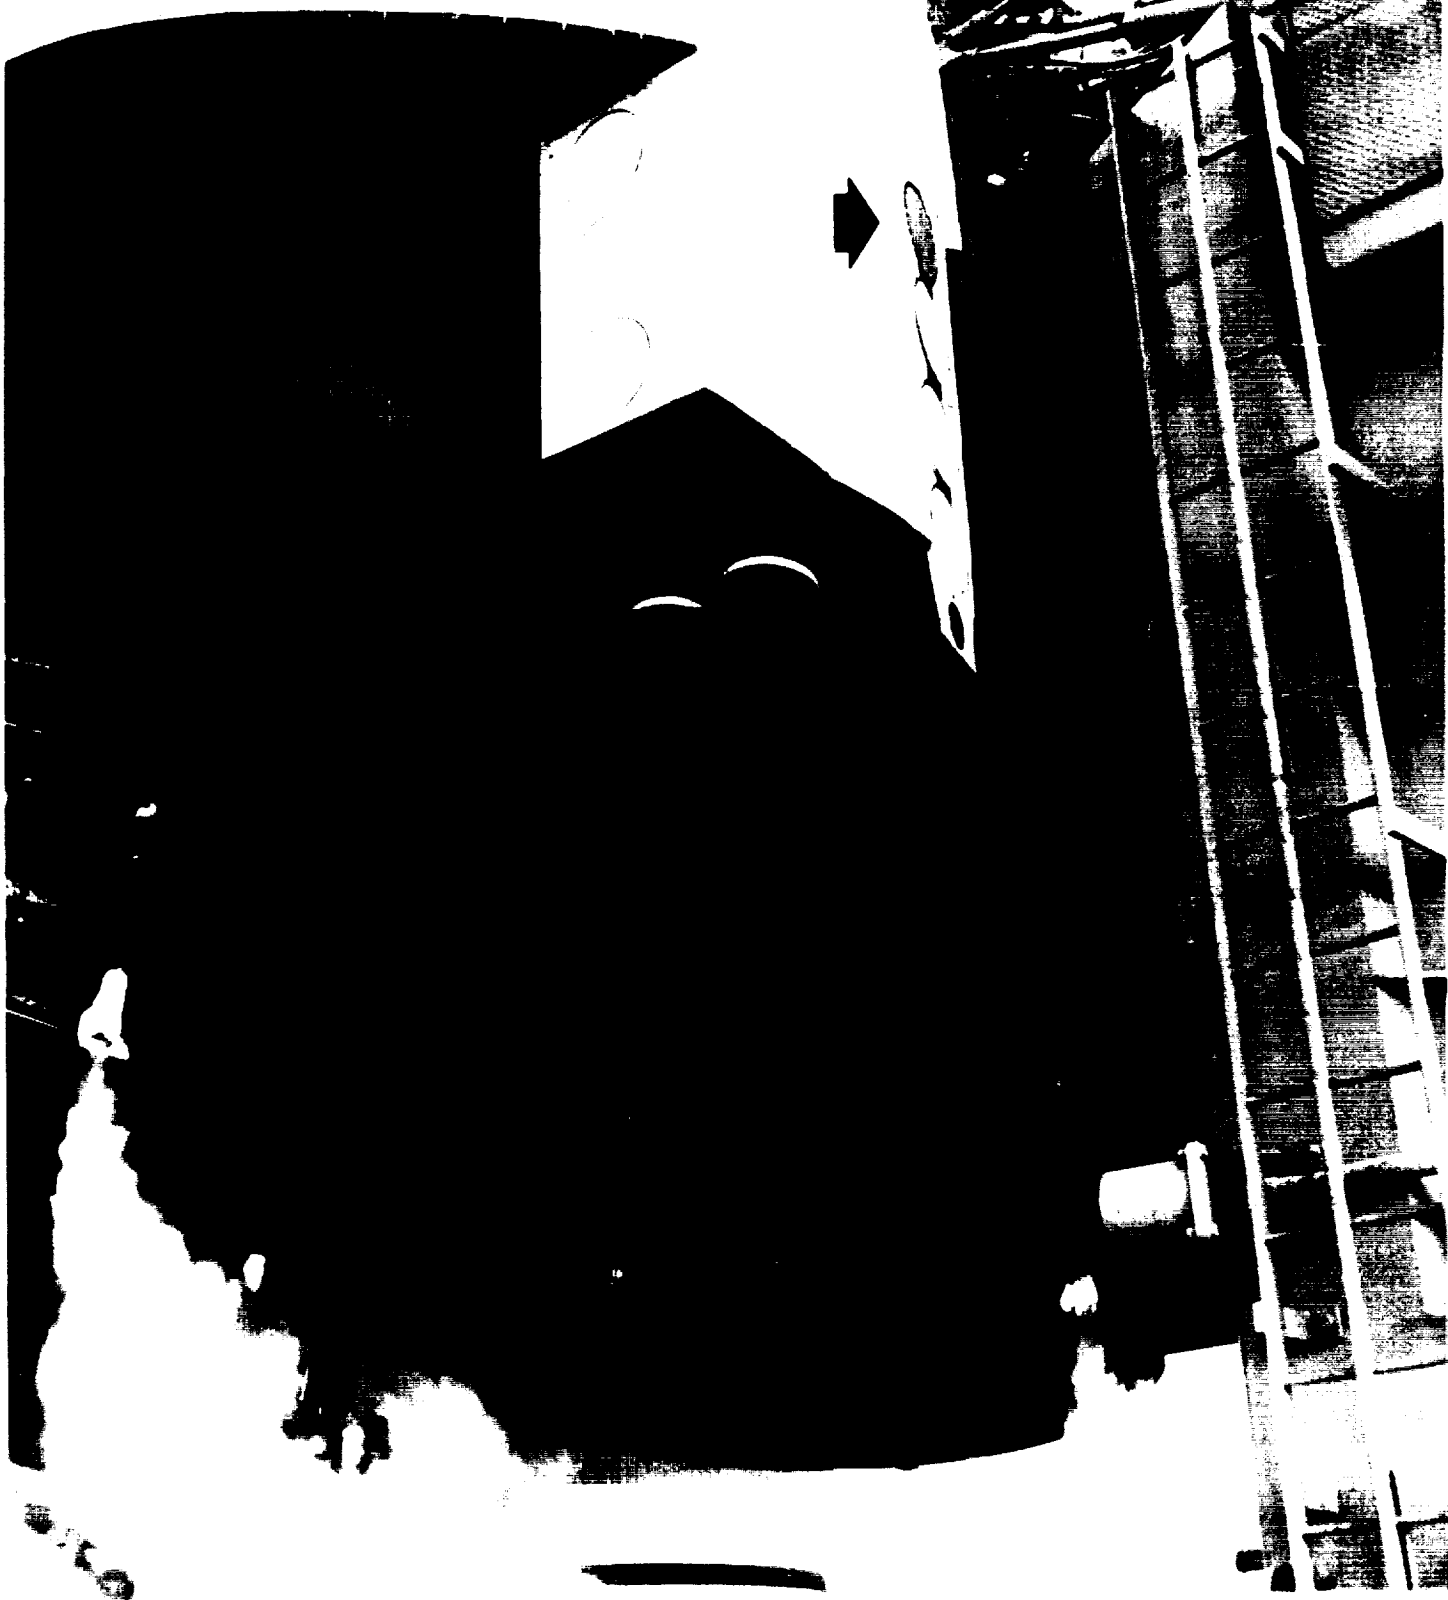
Discolored RCS thruster paper cover may indicate presence of
oxidizer vapors

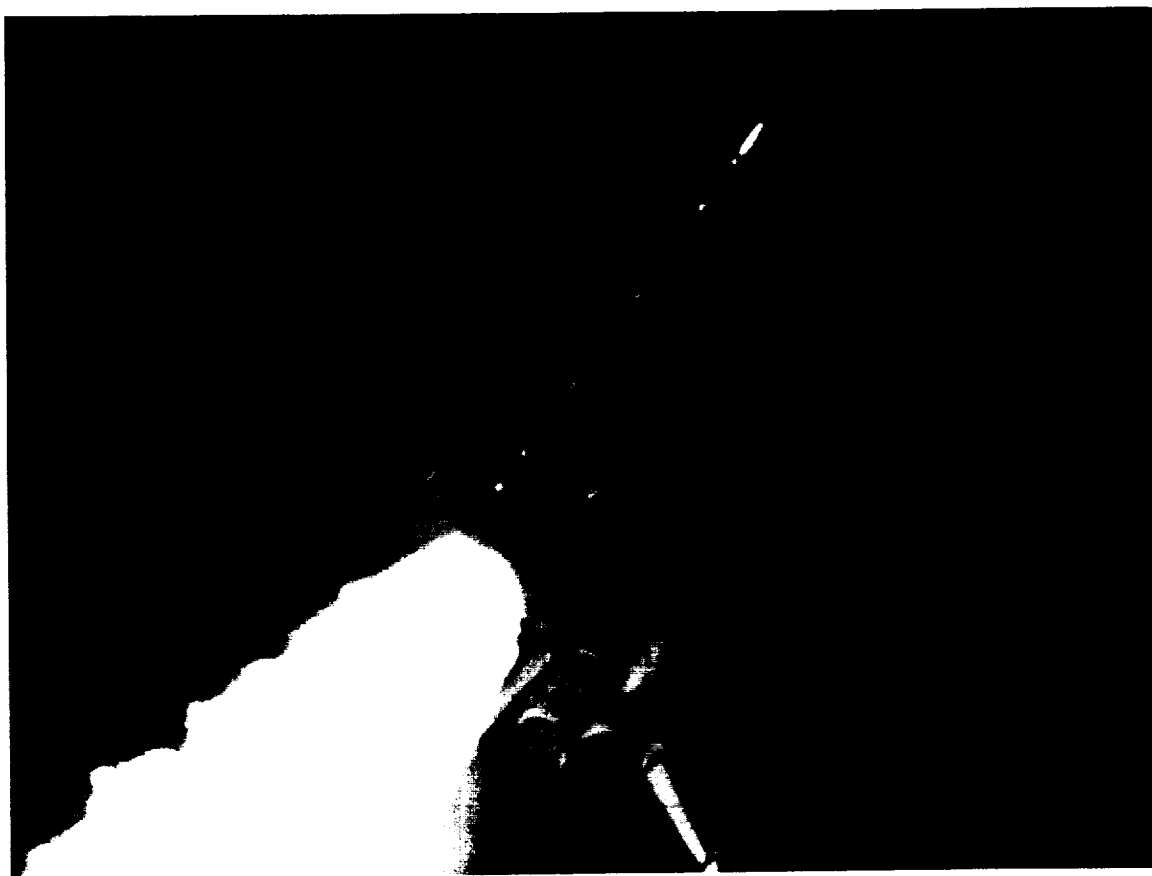
RH RCS thruster paper cover appears at GMT 16:54:33

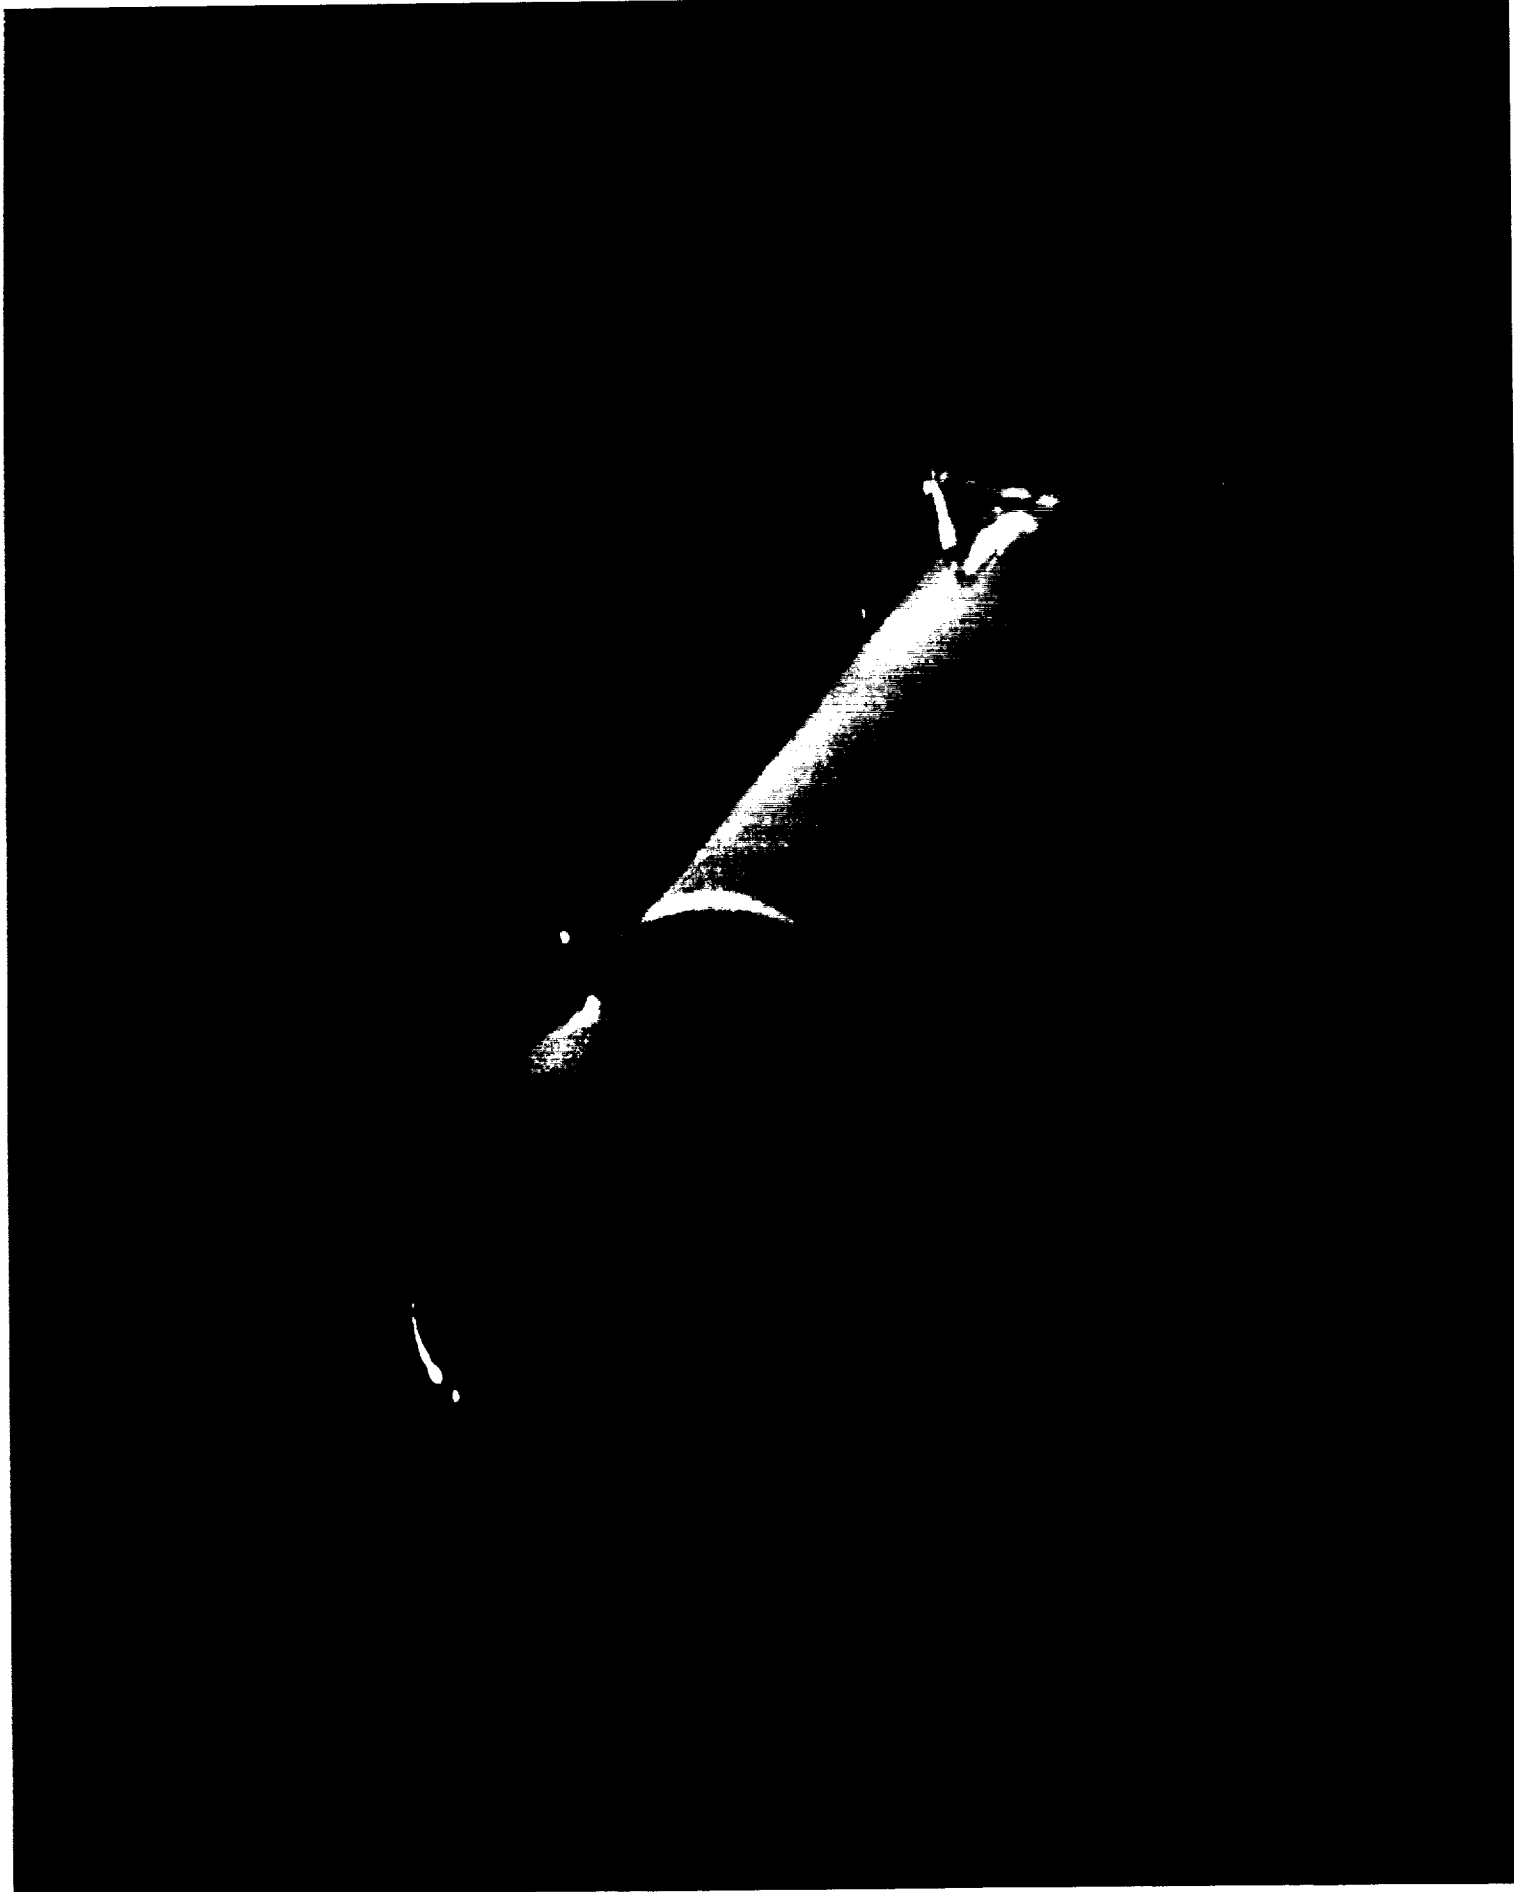
On-orbit view of External Tank after separation from Orbiter.
Some divots occurred on intertank flanges.

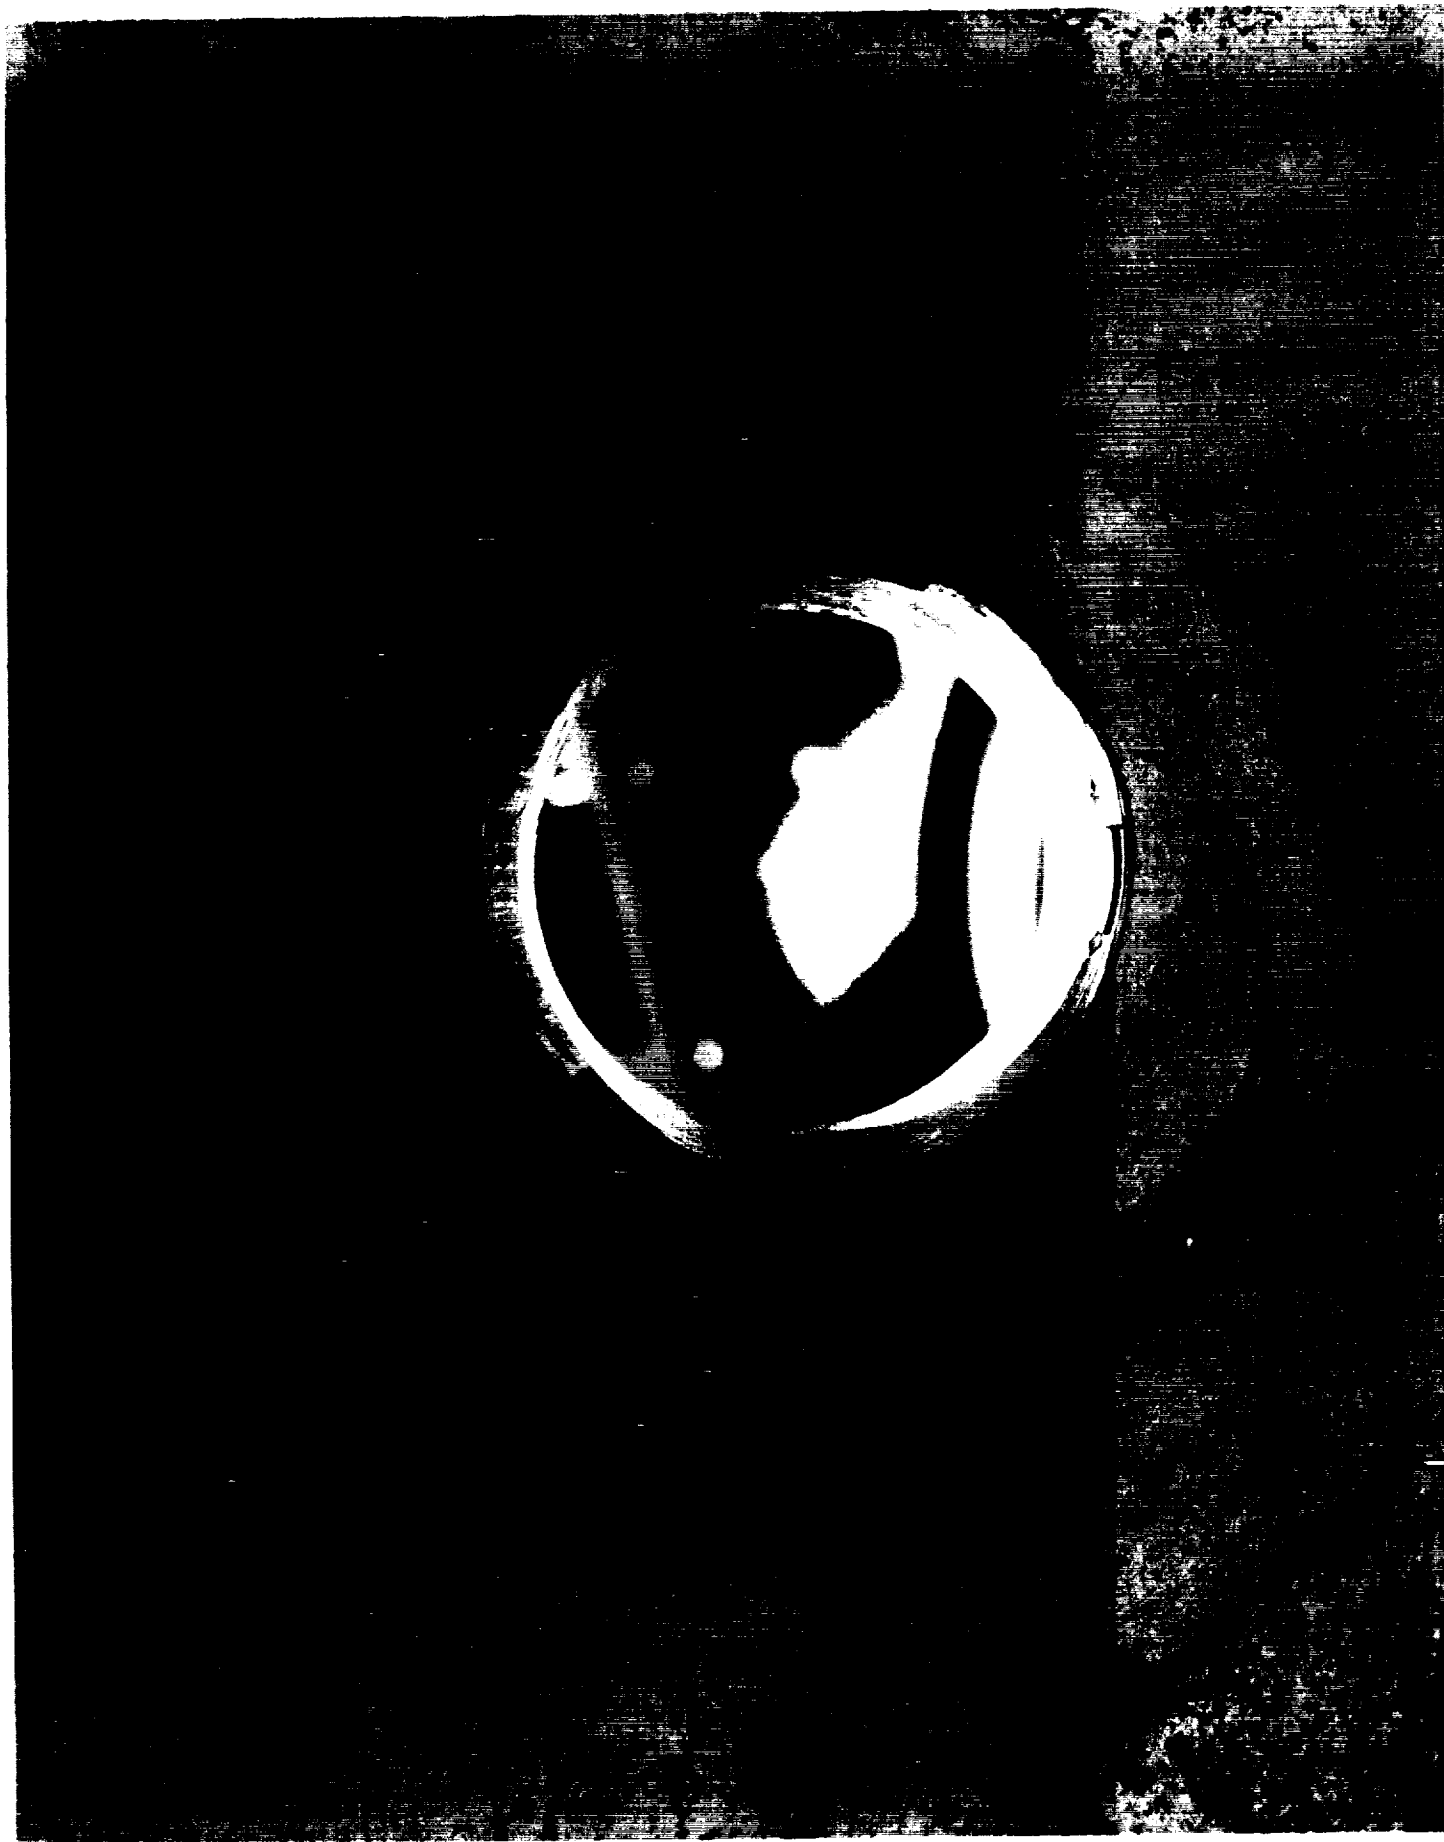
Holddown post #2 aft skirt foot hole showed evidence of stud 'hang-up' (PR PV6-142926, USBI PV4-027704). Thread marks from the Inconel stud were impressed around the aft one-third of the inner aluminum surface of the hole. The stud abraded a 1/2" deep chamfer inclined 45 degrees on the outboard aft edge of the hole, and 3/4 of the paint from the aft inner surface of the hole was removed by the broaching. Some evidence of stud contact was found in all aft skirt stud holes except for HDP #5.

Stud hang-ups have occurred on five previous flights (STS-2, 4, 51-I, 51-J, and 61-A). Broaching similar to that experienced on STS-34 occurred on three of those flights. Minor broaching and thread impressions have occurred on 46 holddown posts of ten previous flights. Holddown post shoes have been lifted on STS-2 and 29. Further investigation revealed HDP #2 stud preload limits and shoe dimensions were within specification just prior to liftoff. The raised inner web on the frangible nut fracture plane exhibited evidence of ductile, tensile failure, indicating this web separated before its pyrotechnic detonated. The web on the frangible nut and the embedded booster cartridge metal on the holddown stud were the most significant contributors to the stud hang-up and were caused by the non-simultaneous firing of the pyrotechnics.

Aft skirt HDP #2 foot bore is broached by stud hang-up
at liftoff

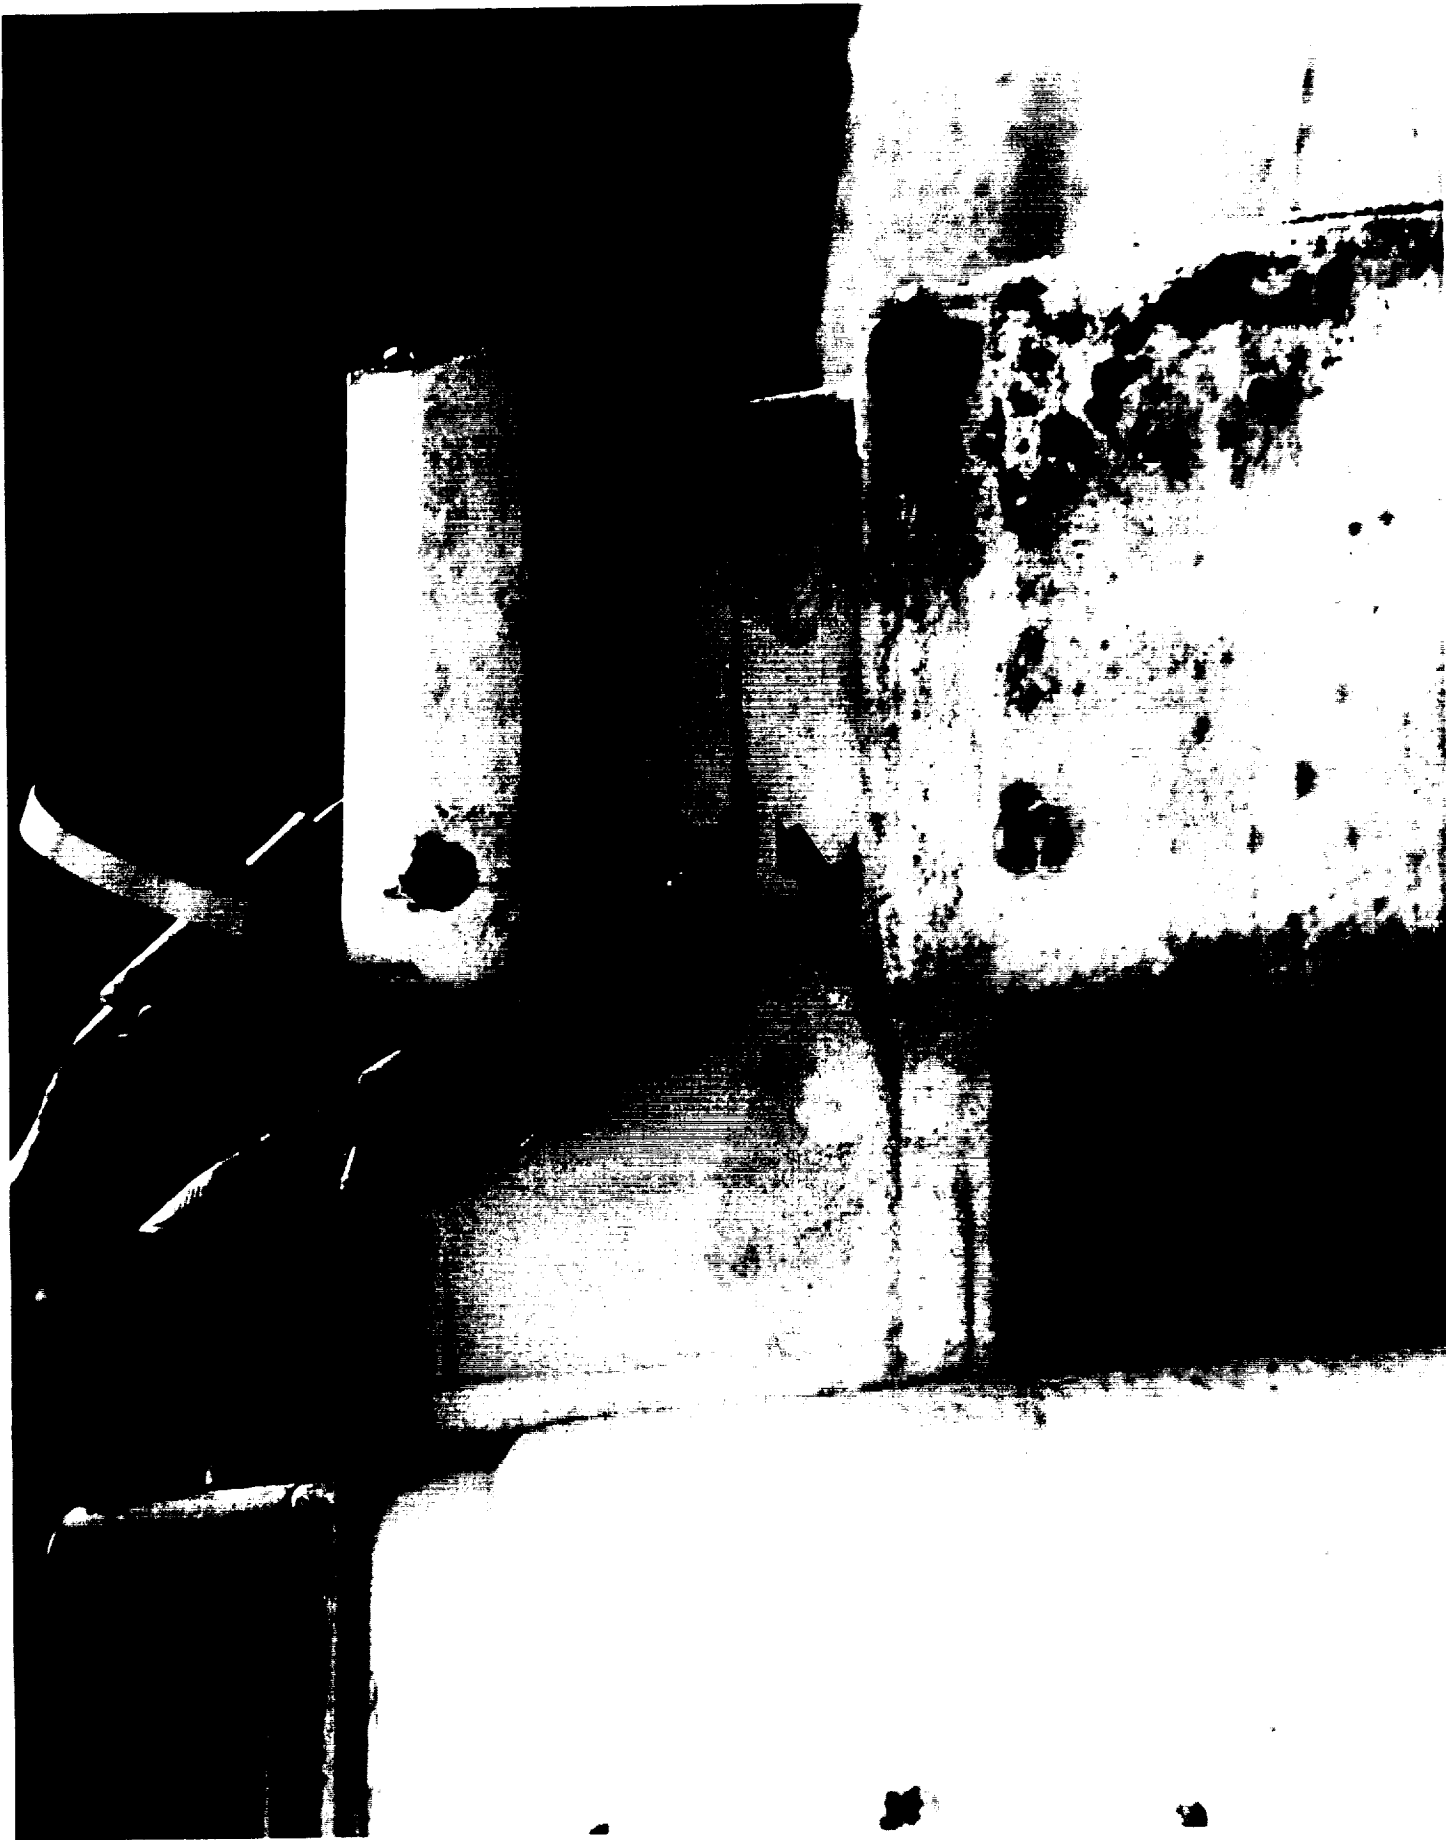
K5NA closeouts were not accomplished on the ET/SRB
forward crossovers
