1968 CESSNA 150

ACCIDENT INVESTIGATED BY:
GALE BRADEN AND DON ROWLAN
CAMI

1946 TEMCO SWIFT

1961 PIPER COLT

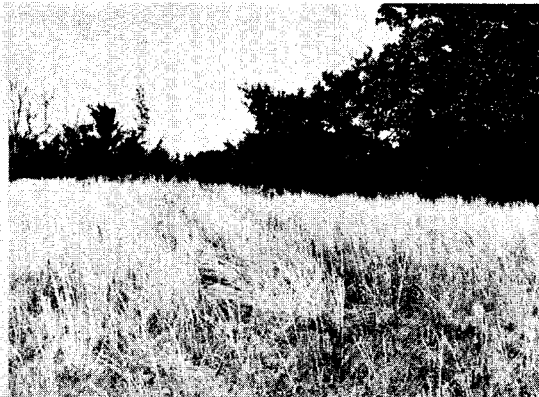
A. Distant view of crash site. Tracks in wheat field were made by rescue personnel as aircraft did not touch the ground before striking the tree.

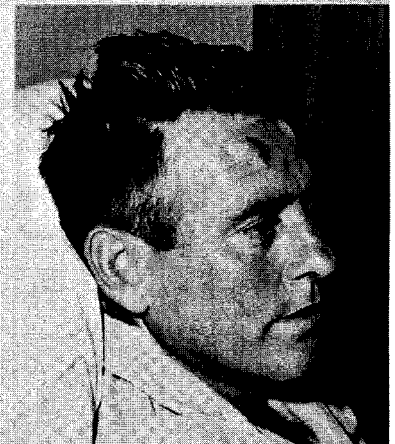
H. Pilot with minor laceration of forehead.

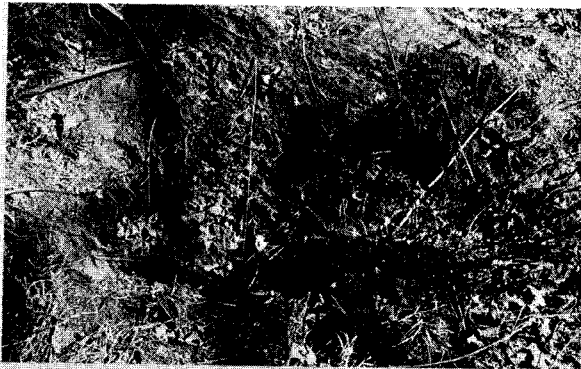
A. Small earthen depression from Pawnee impact.

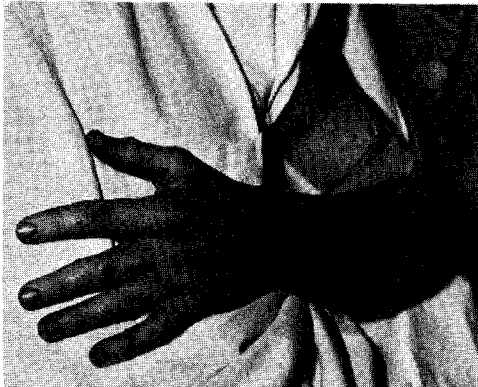
J. Minor laceration of left hand.

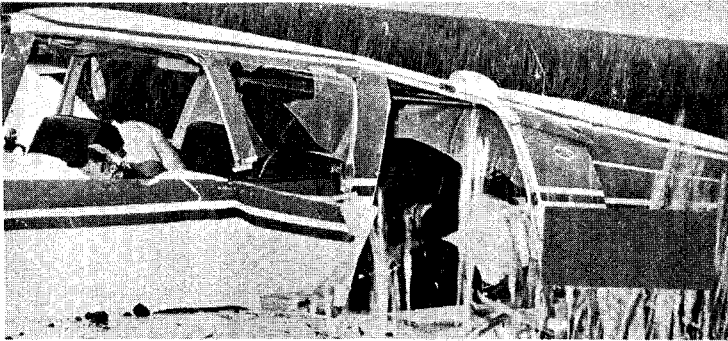
G, H & I All occupants have seat belts fastened, appear to be sitting on the ground, & died from severe internal injuries produced by vertical forces.
